DAWSON
TOWNSHIP

2024 ASSET MANAGEMENT PLAN

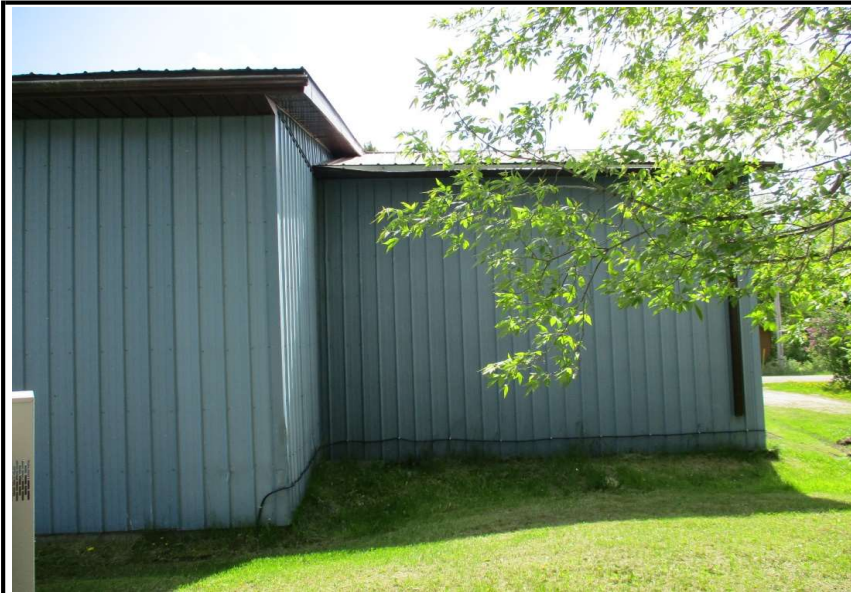
Photo No.: 3

Description:
Exterior view of building
Repair eavestrough

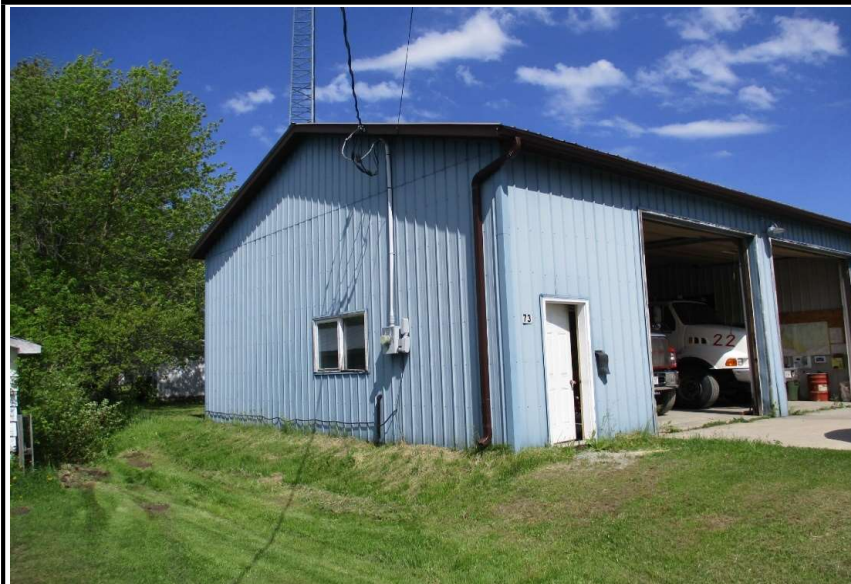
Photo No.: 4

Description:
Exterior view of building
Repaint door trim

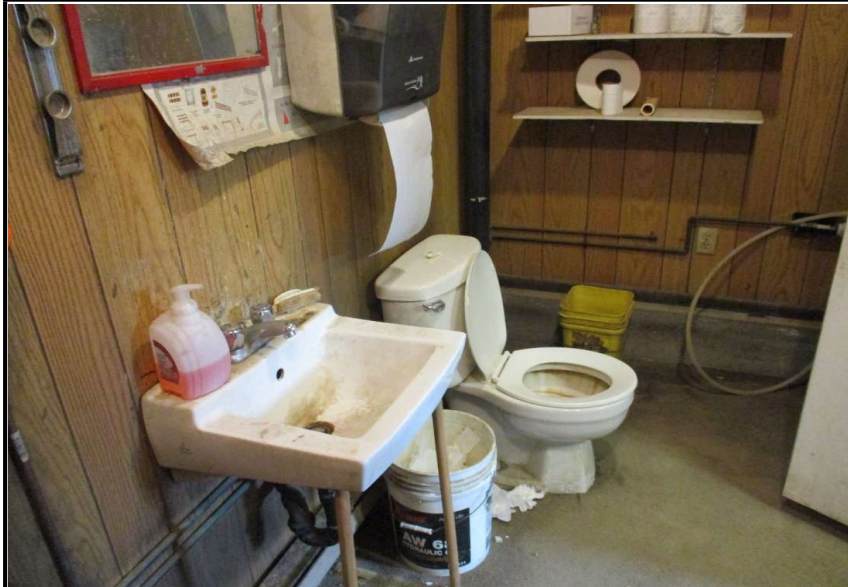
Photo No.: 14

Description:
Interior view of building
Investigate and replace water
stained ceiling in washroom

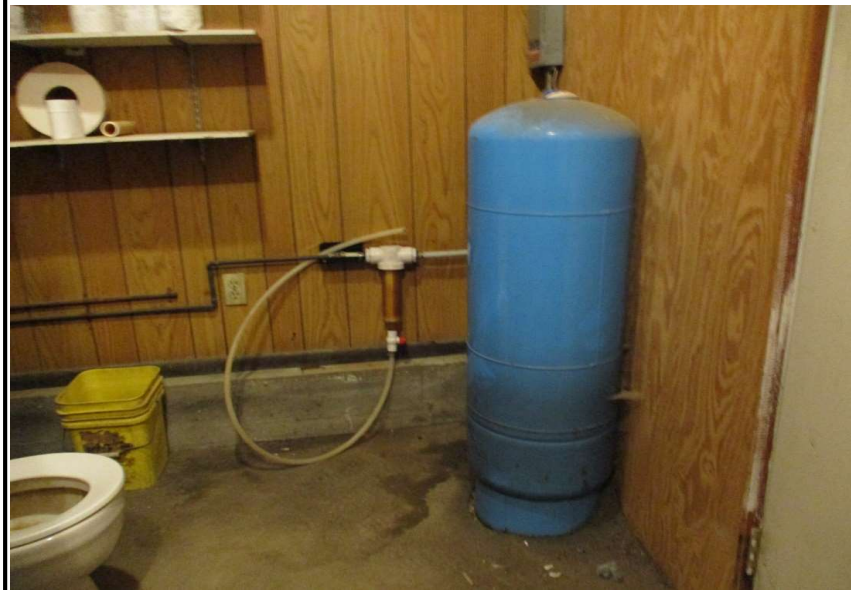
Photo No.: 16

Description:
Interior view of building
Repair washroom fan

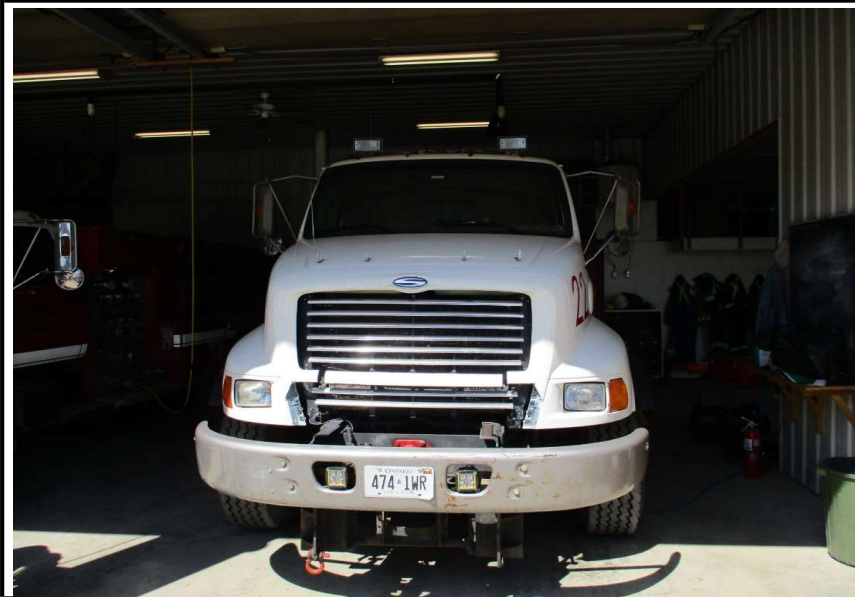
Photo No.: 1

Description:
Front of the truck
Repaint rusting bumper

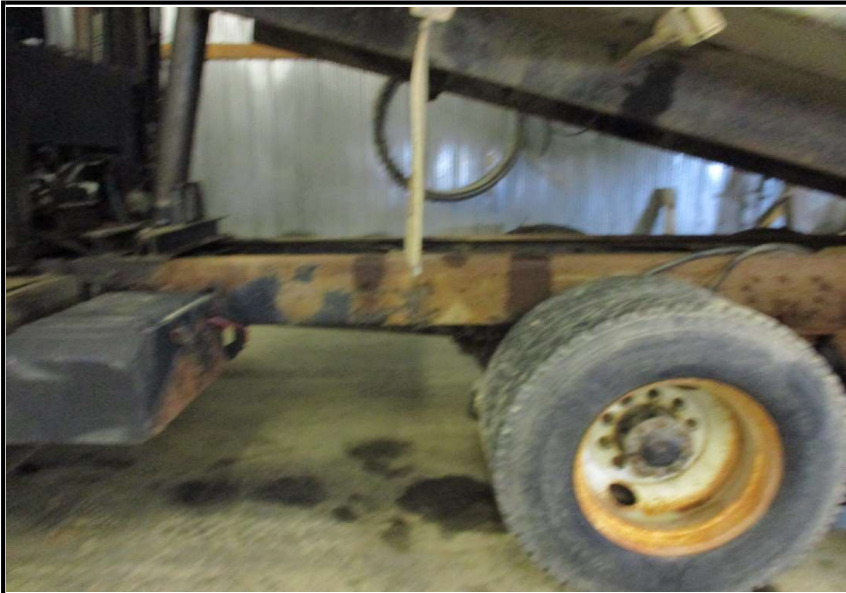
Photo No.: 3

Description:
Chasis of the truck
Paint rusting parts

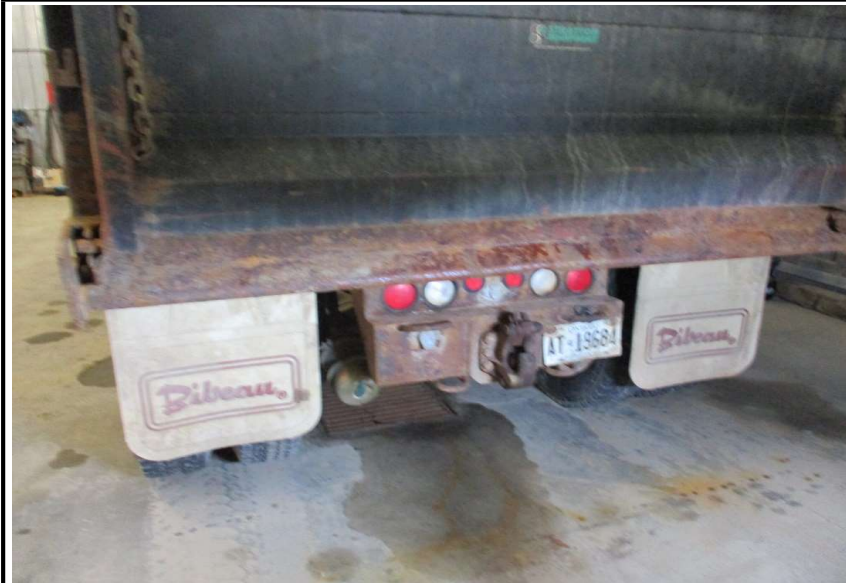
Photo No.: 4

Description:
Rear view of truck
Paint rusting parts

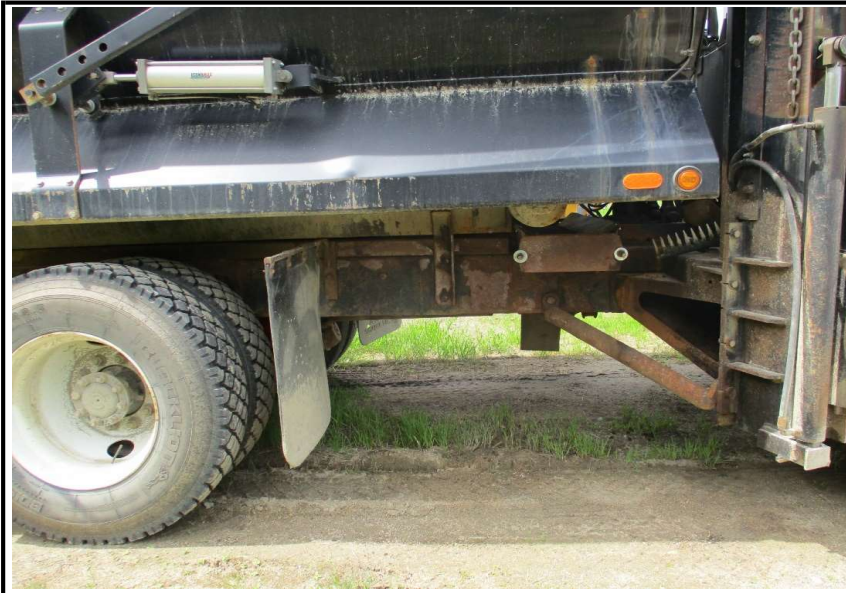
Photo No.: 3

Description:
Rusting part

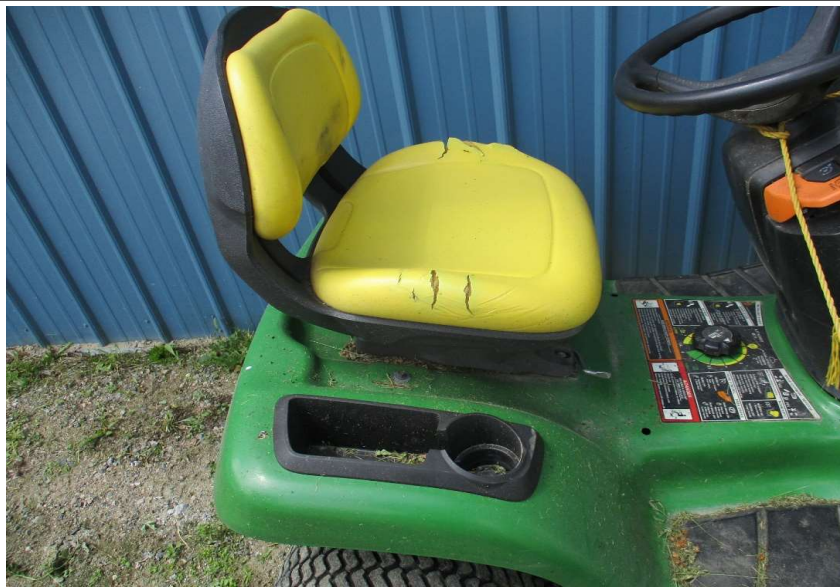
Photo No.: 3

Description:
View of broken seat

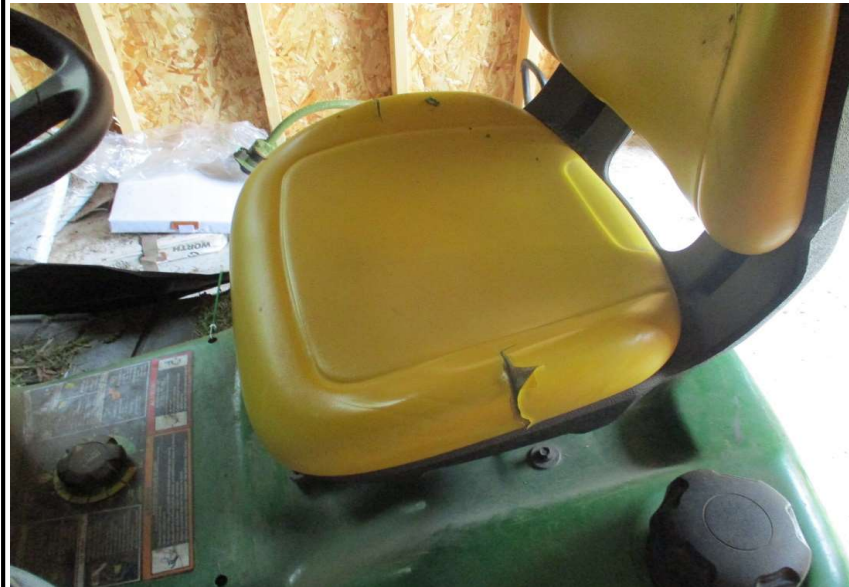
Photo No.: 4

Description:
View of broken seat
