DAWSON
TOWNSHIP

2024 ASSET MANAGEMENT PLAN

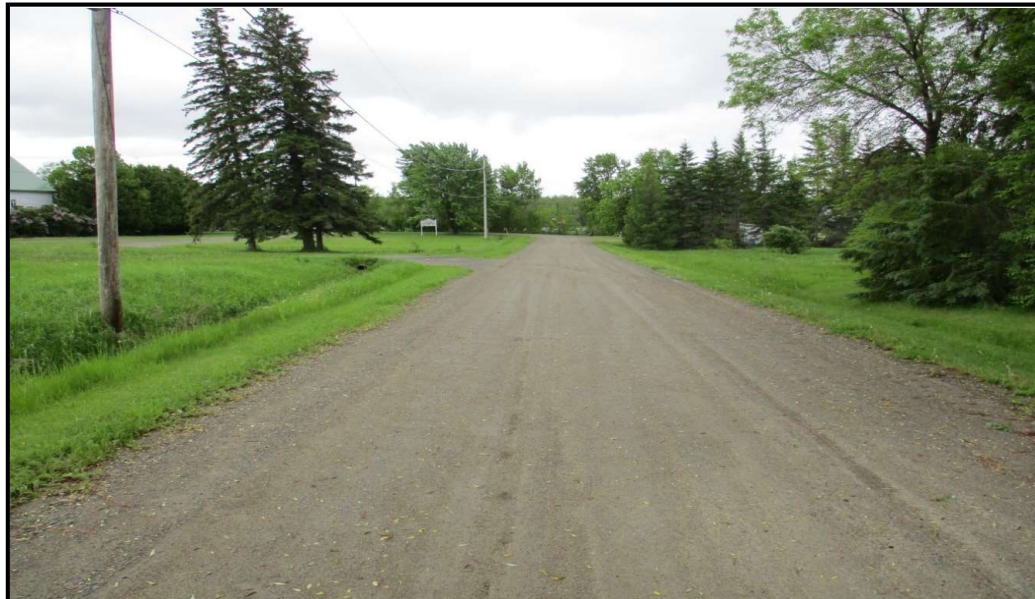
Photo No.: 1

View of the road heading South.
Install speed limit sign

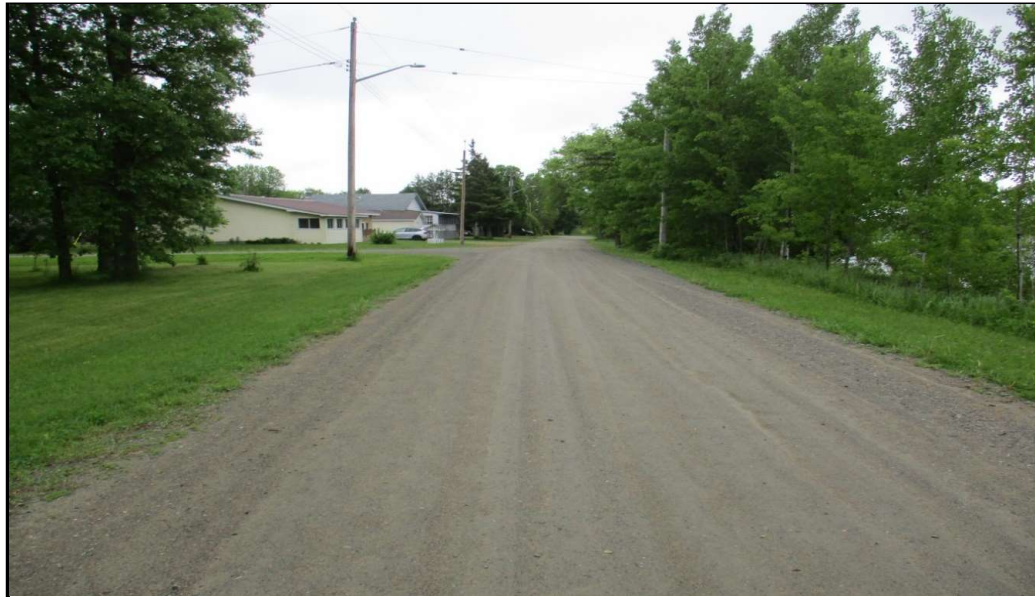
Photo No.: 1

View of road heading East.
Install speed limit sign

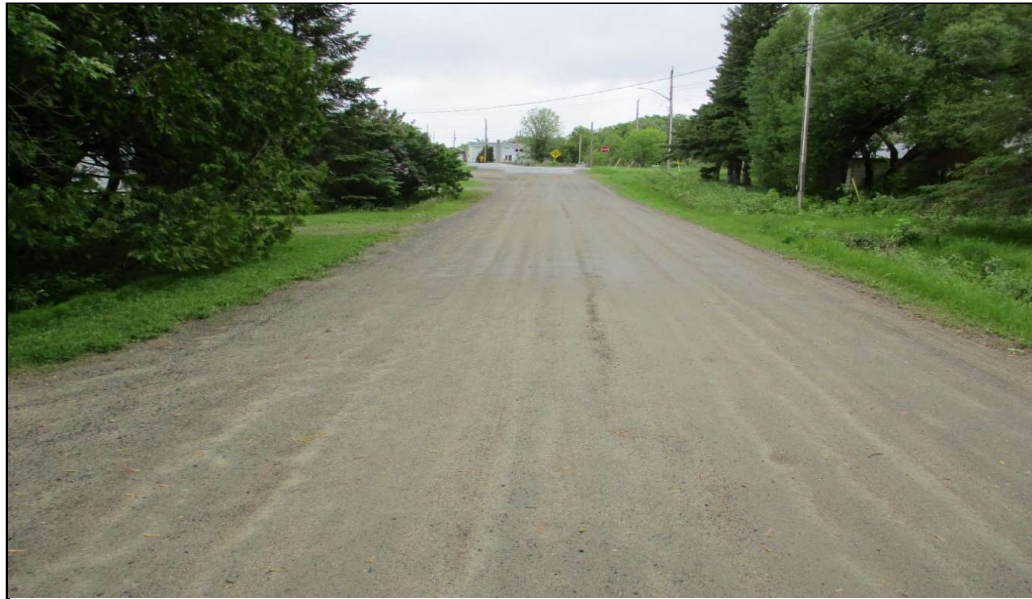
Photo No.: 1

View of road heading North
Install speed limit sign

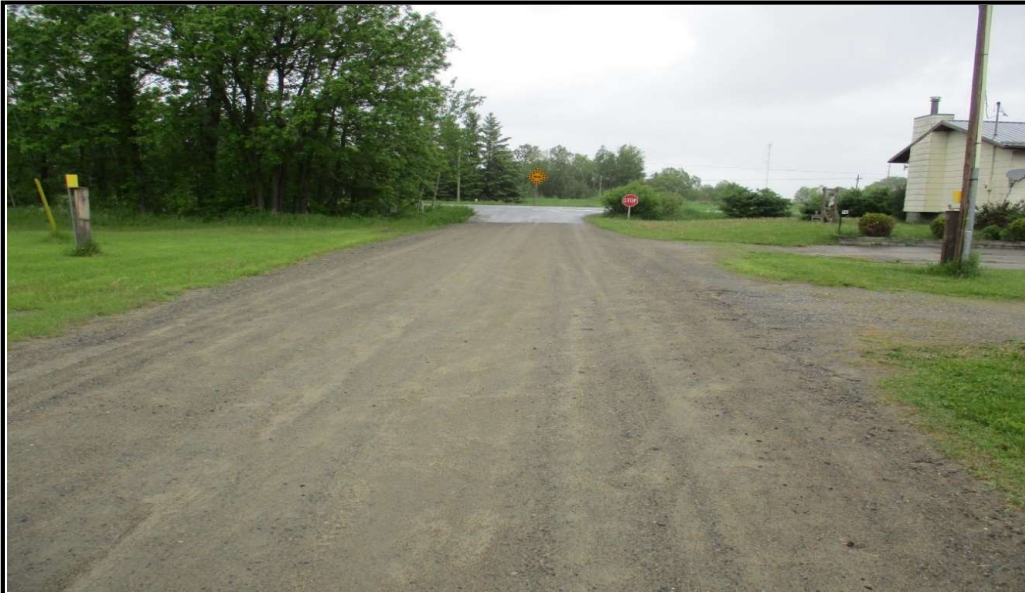
Photo No.: 1

View of road heading North.
Install name sign

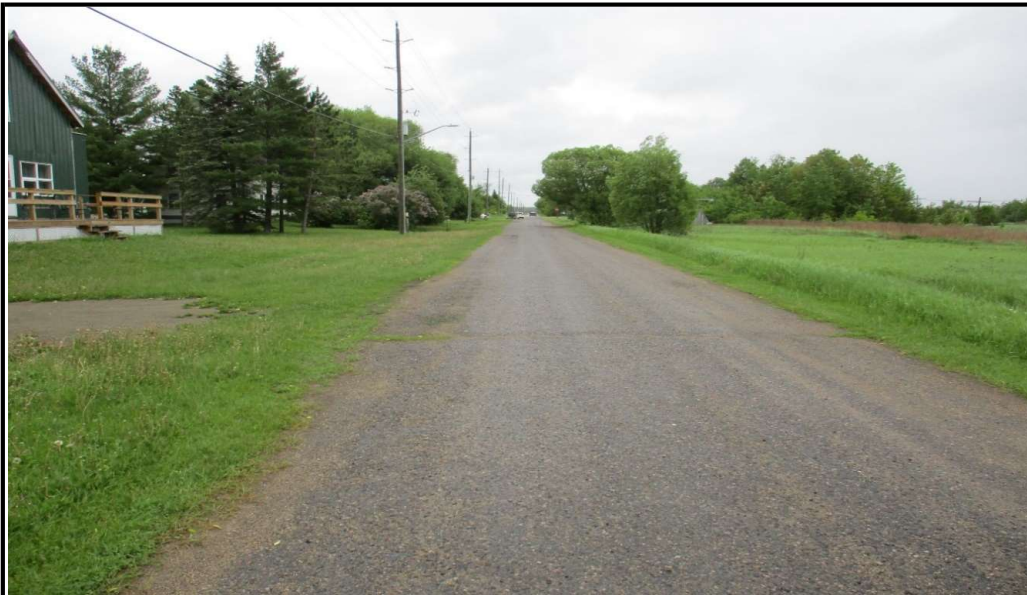
Photo No.: 1

Description:
View of road heading East.
Resurface entire road.

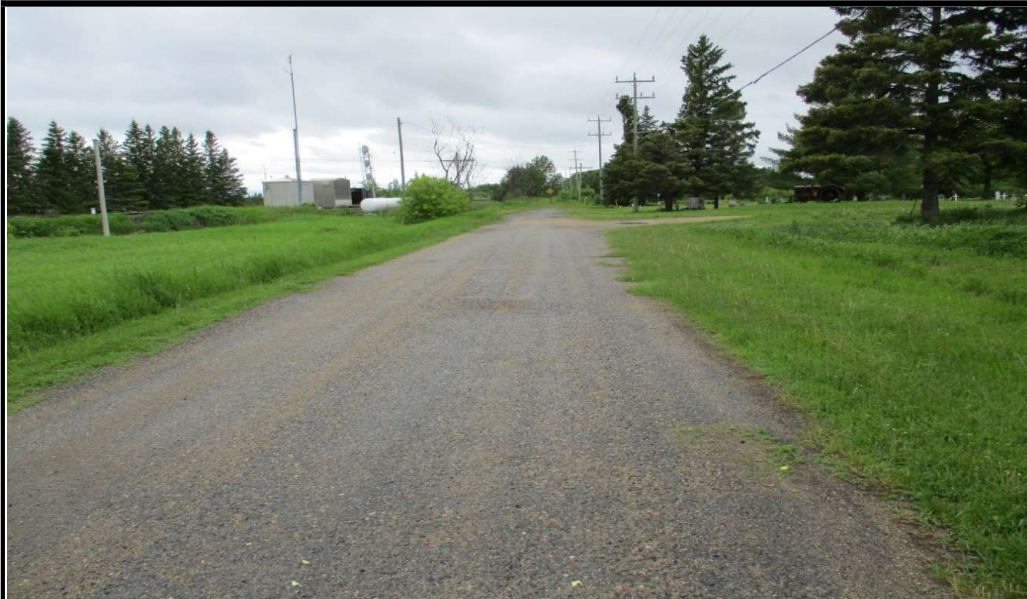
Photo No.: 2

Description:
View of road heading West.
Install speed limit sign.

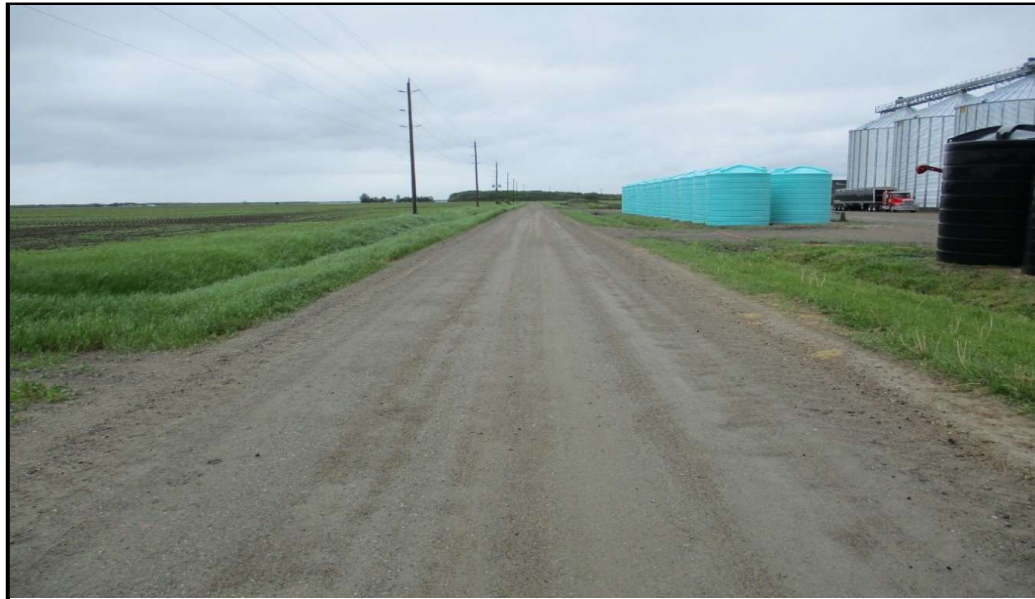
Photo No.: 1

View of road heading East. Cut brush in shoulder.

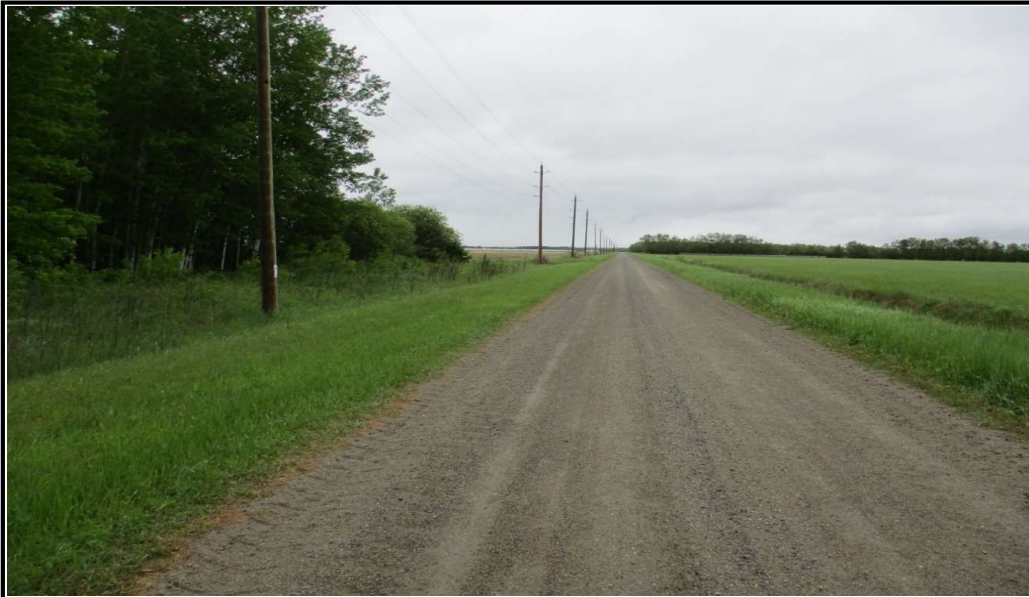
Photo No.: 1

View of road heading East.
Cut brush in shoulder (lite)

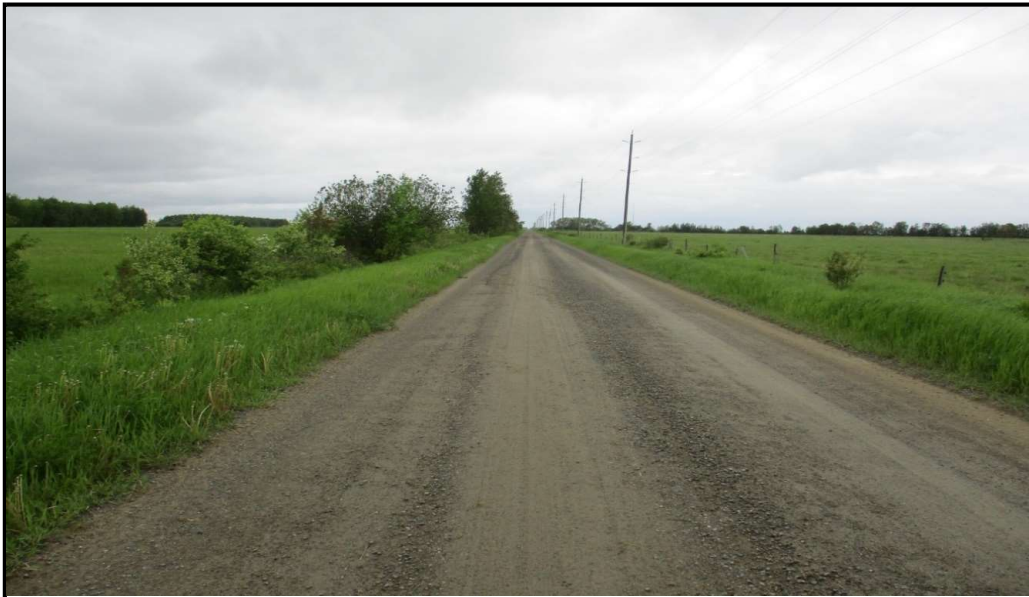
Photo No.: 1

Description:
View of road heading North.
Install speed limit signs.

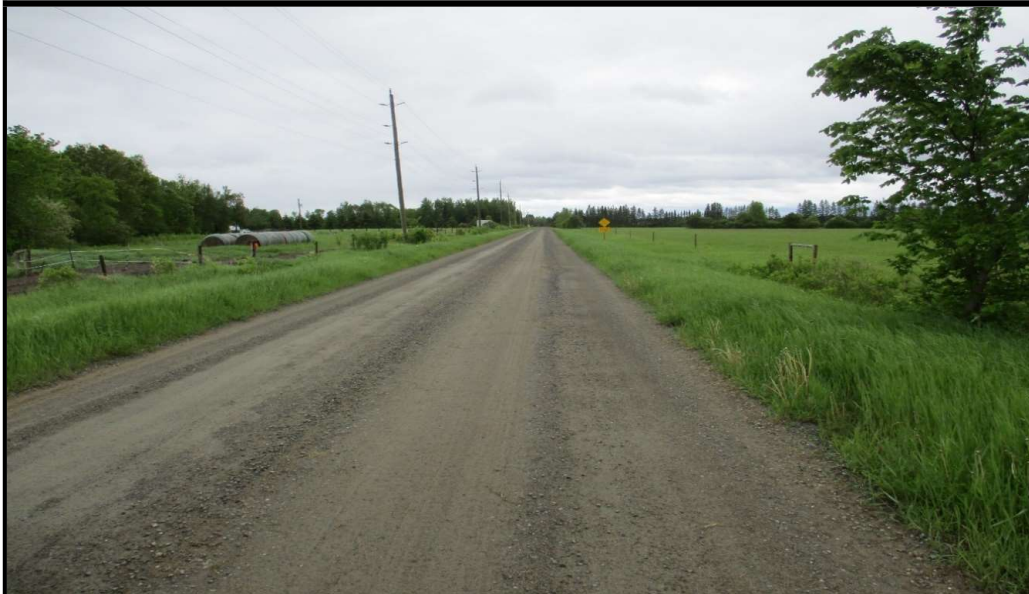
Photo No.: 2

Description:
View of road heading South.
Cut brush in shoulder

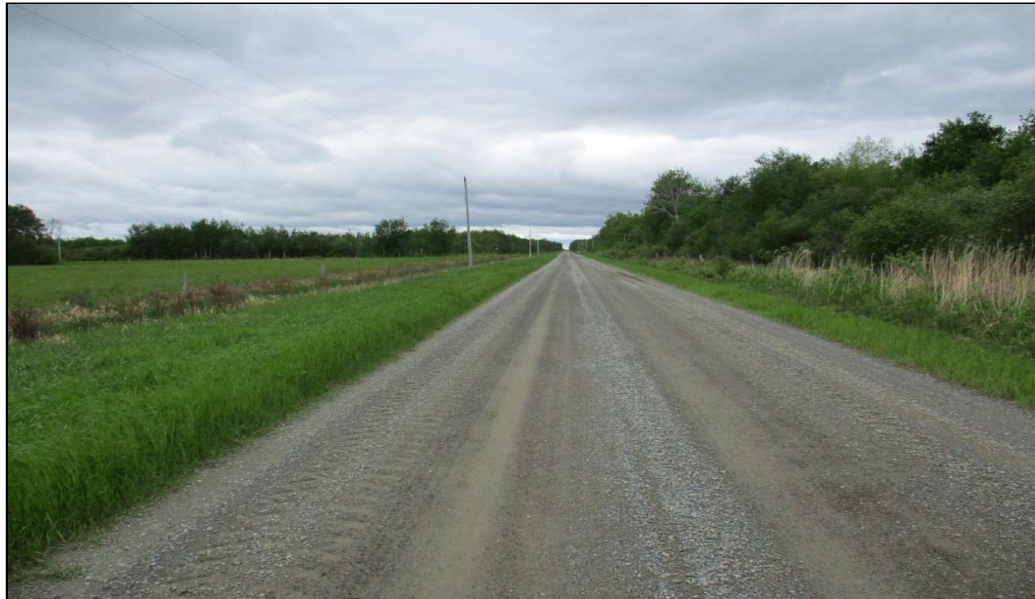
Photo No.: 1

Description:
View of road heading West.
Install speed limit signs

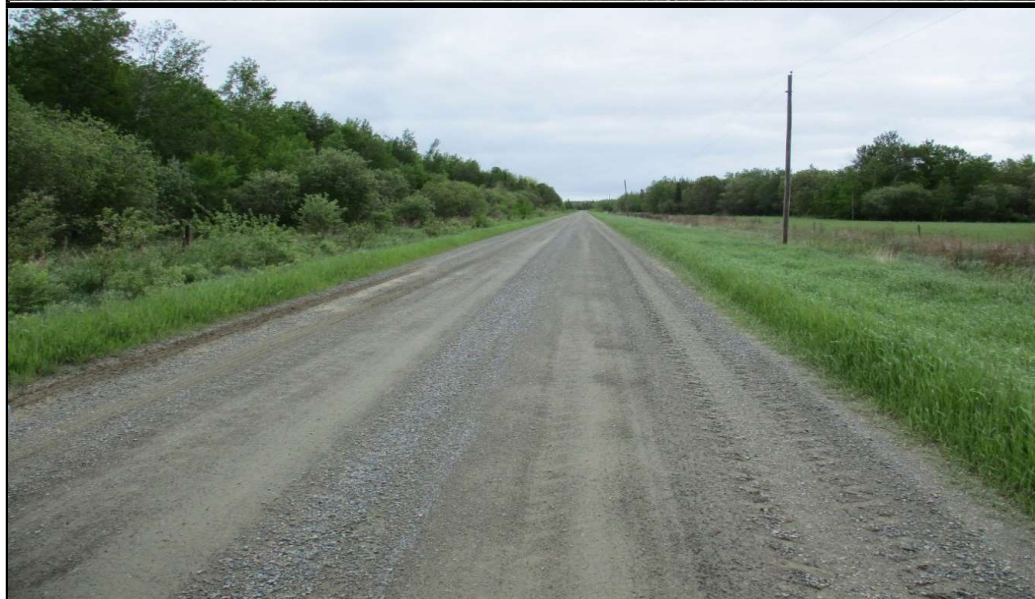
Photo No.: 2

Description:
View of road heading East.
Install name signs

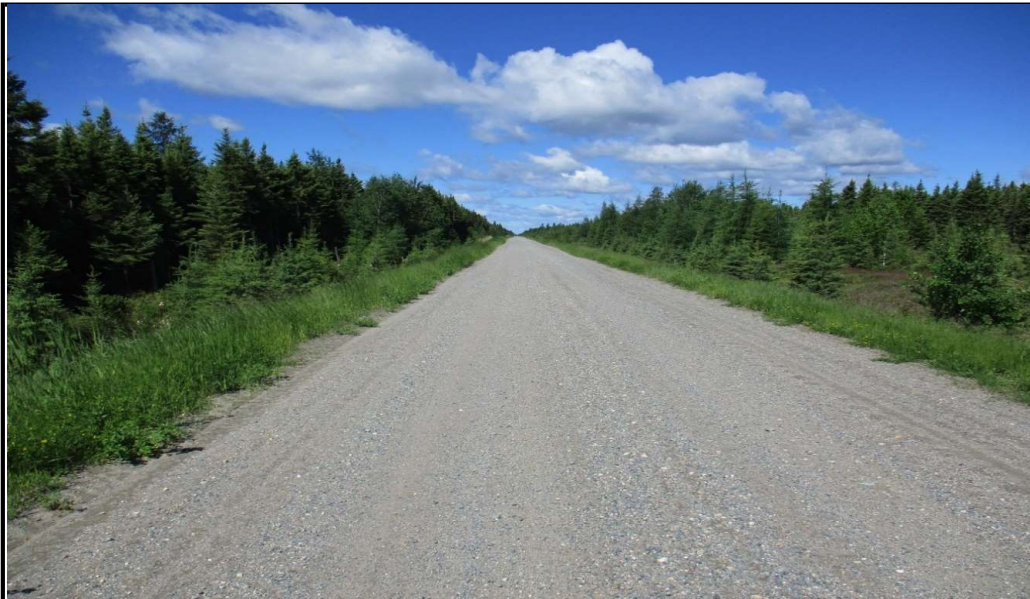
Photo No.: 3

View of road heading West. Cut
brush in shoulder

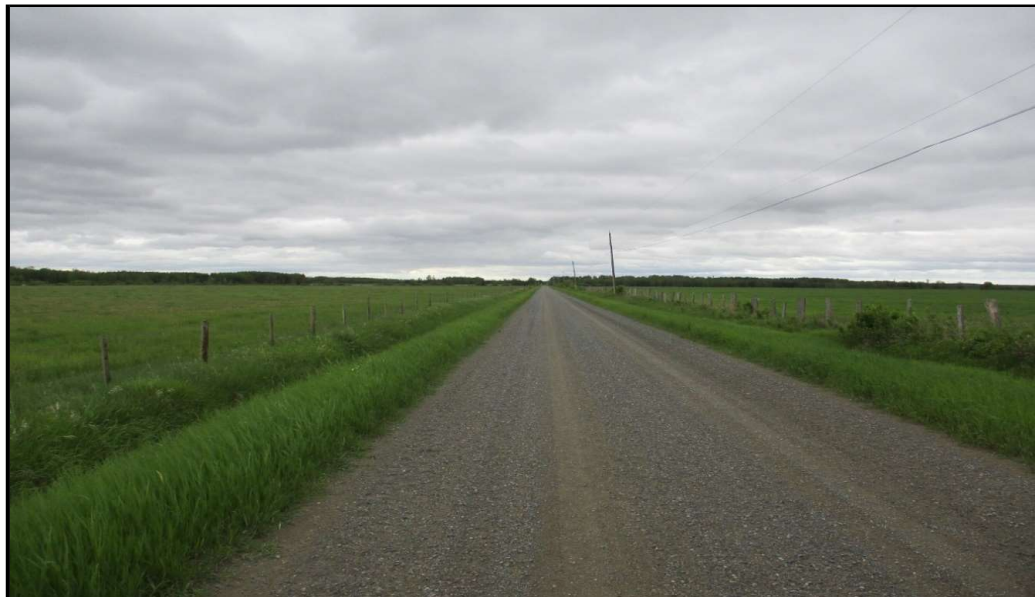
Photo No.: 1

View of road heading South.
Install 6 speed limit signs.

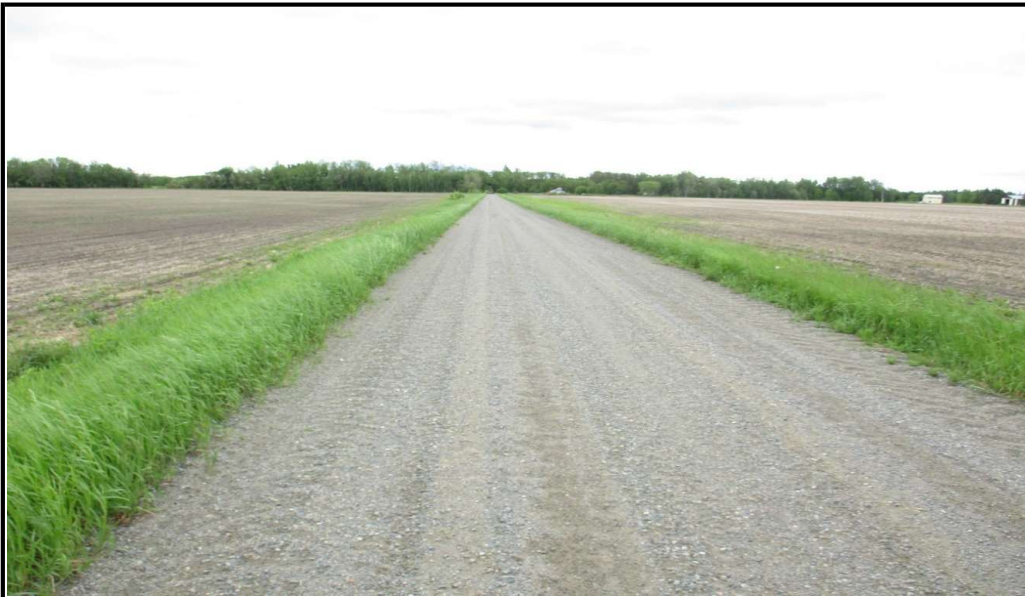
Photo No.: 1

View of road heading South.
Restore drainage (ditching).

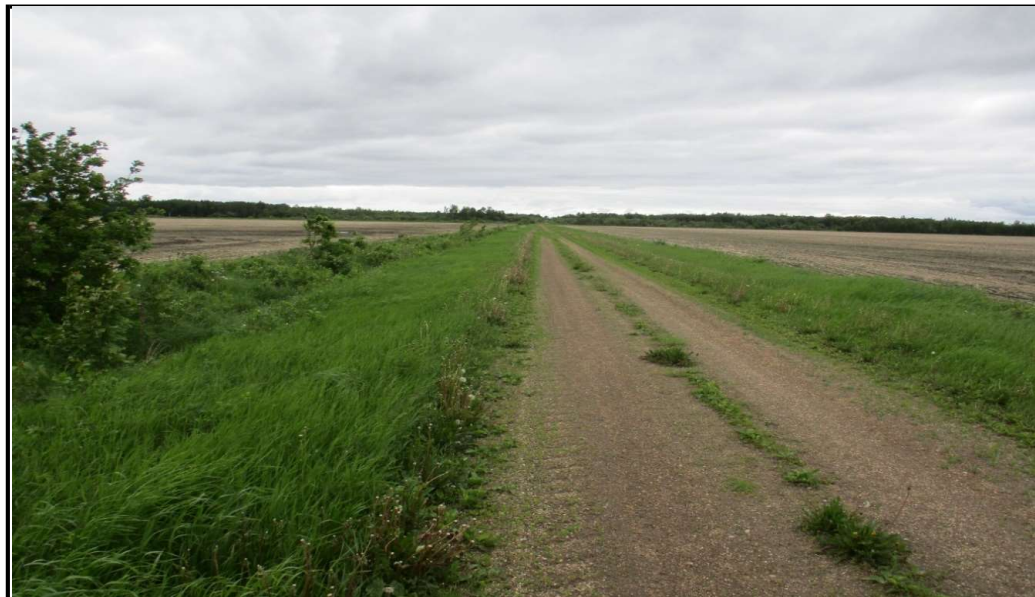
Photo No.: 1

View of road heading North. Cut grass in roadway. Install sign "Use at own risk" at railway track

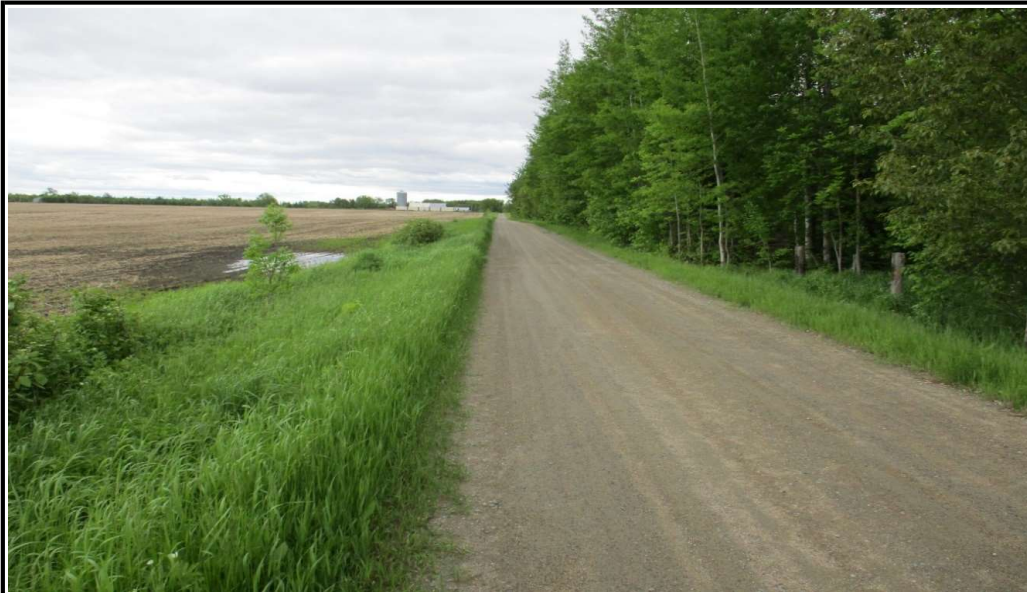
Photo No.: 1

View of road heading South.
Install speed sign, stop sign and
dead end sign

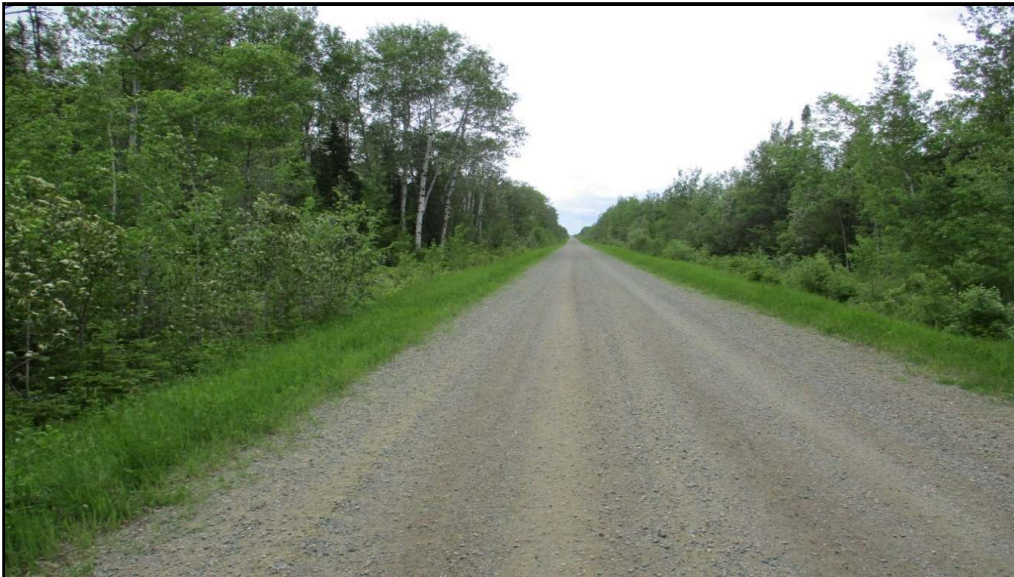
Photo No.: 1

View of road heading South.
Cut brush in shoulder

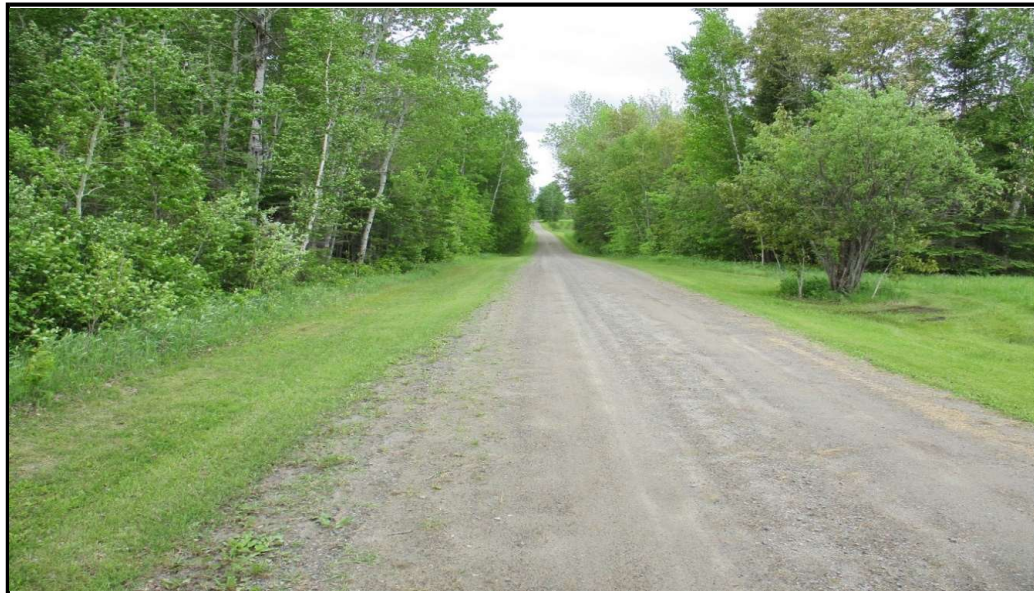
Photo No.: 1

View of road heading South.
Install "Dead end" sign.

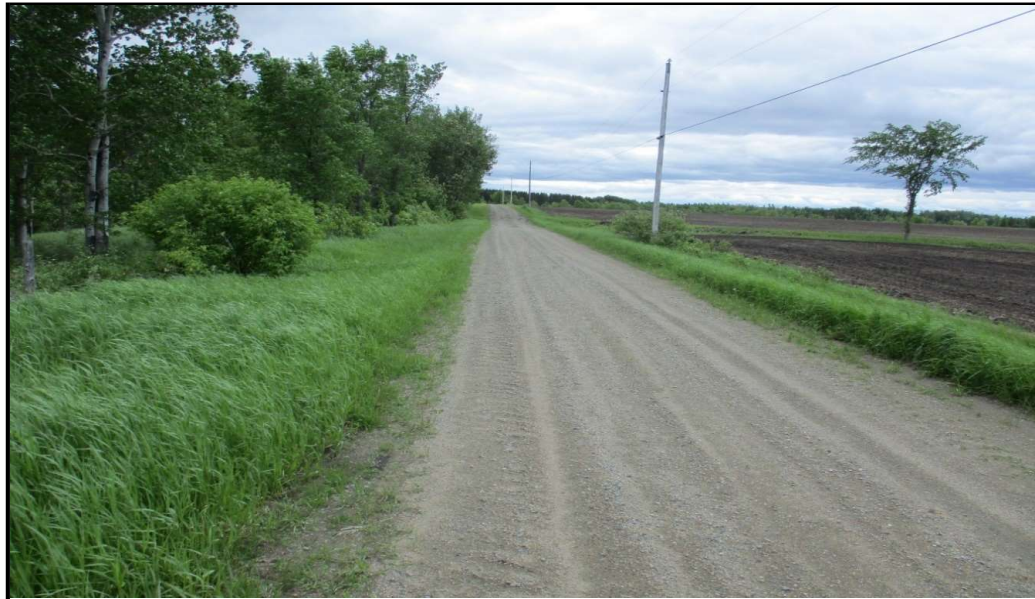
Photo No.: 1

View of road heading South.
Install speed limit sign.

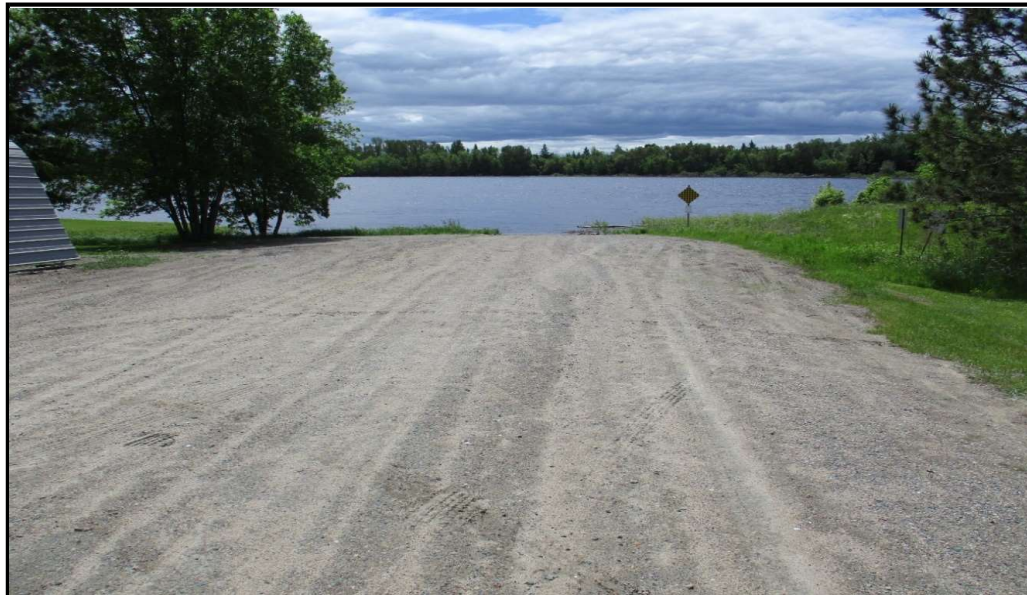
Photo No.: 1

View of road heading South.
Install speed limit sign.

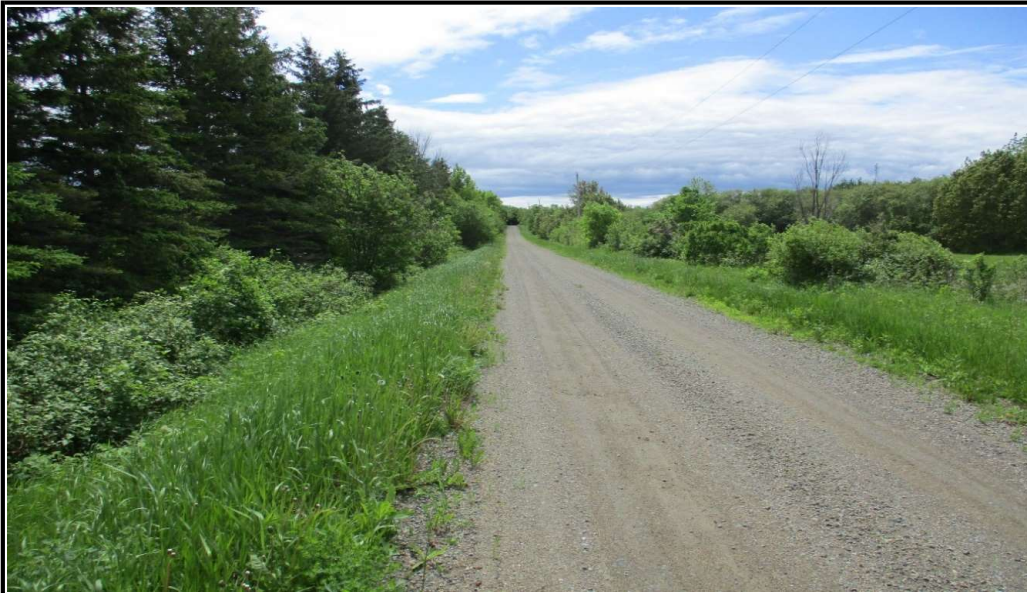
Photo No.: 1

View of road heading South.
Install speed limit sign.

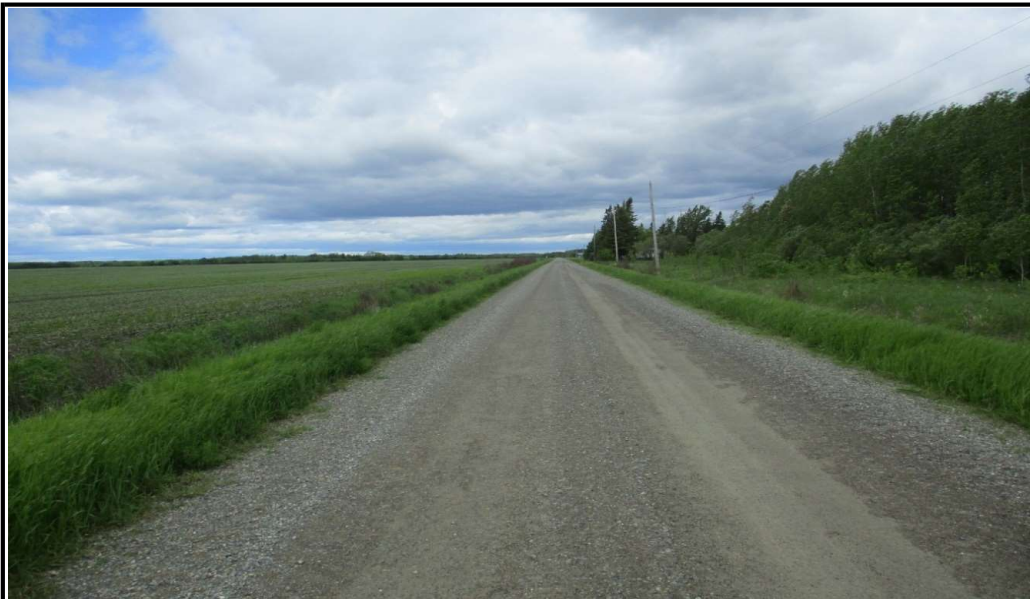
Photo No.: 1

View of road heading North.
Install name sign.

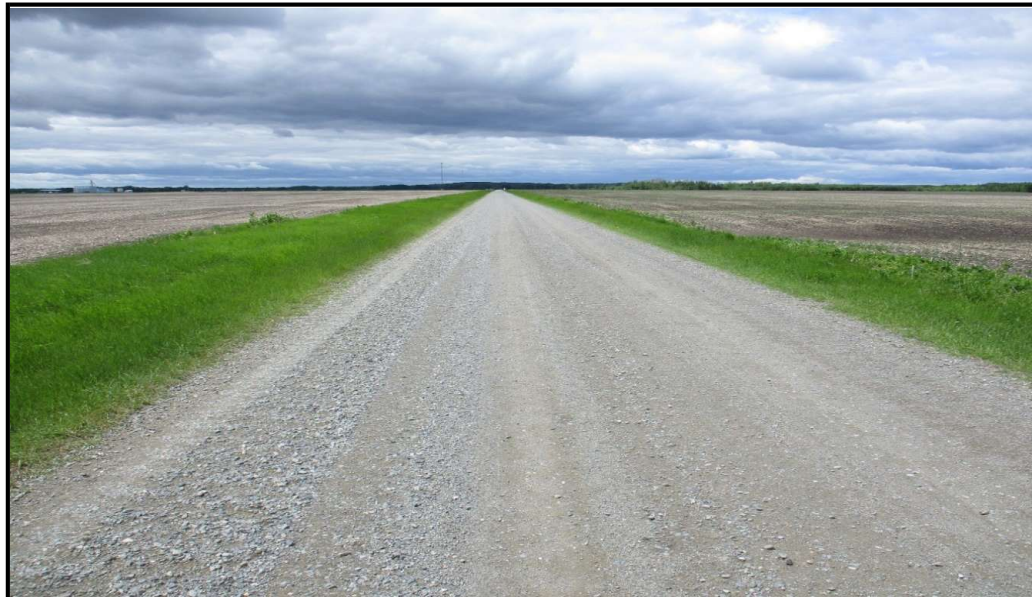
Photo No.: 1

View of road heading West.
Install name sign.

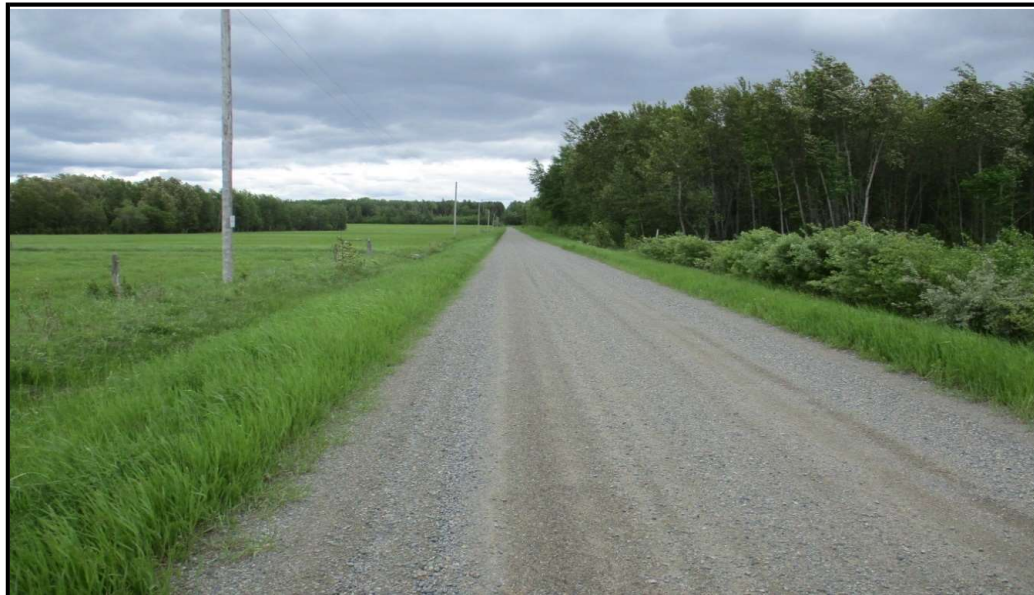
Photo No.: 1

View of road heading South. Cut brush in ditches

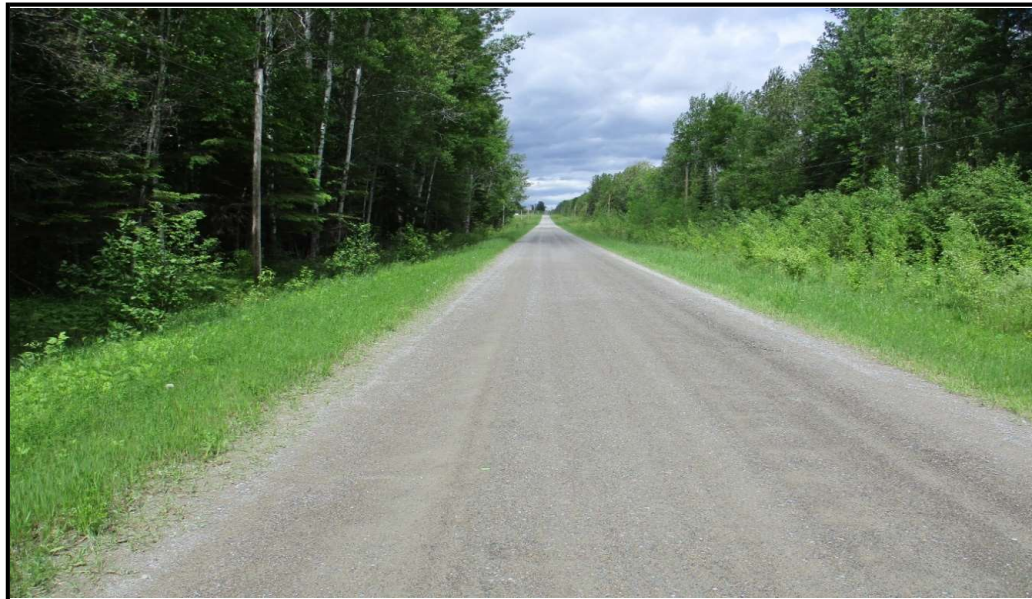
Photo No.: 1

View of road heading North.
Install speed limit sign.

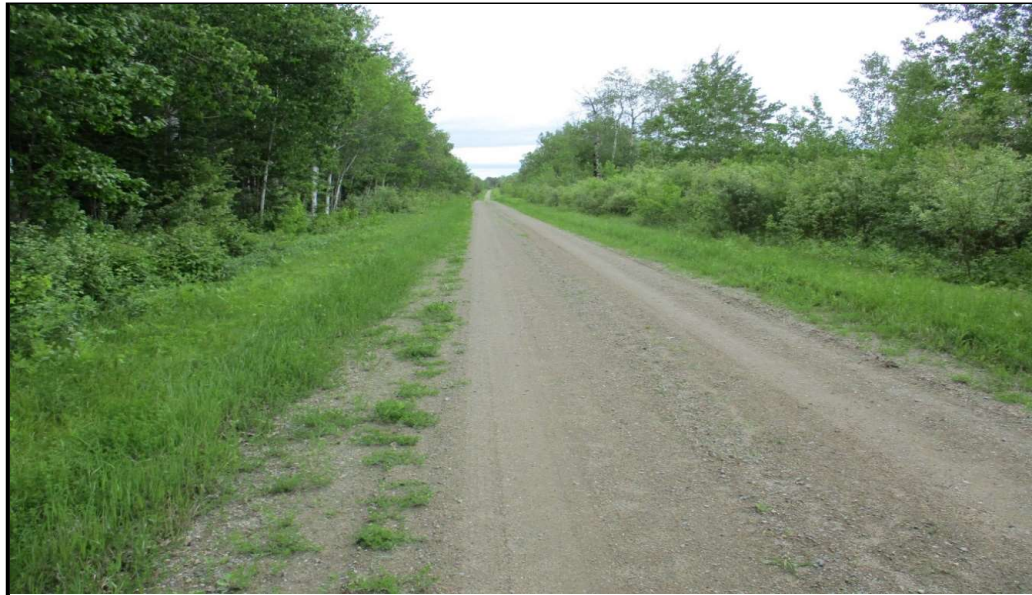
Photo No.: 1

View of road heading East.
Cut brush in ditches.

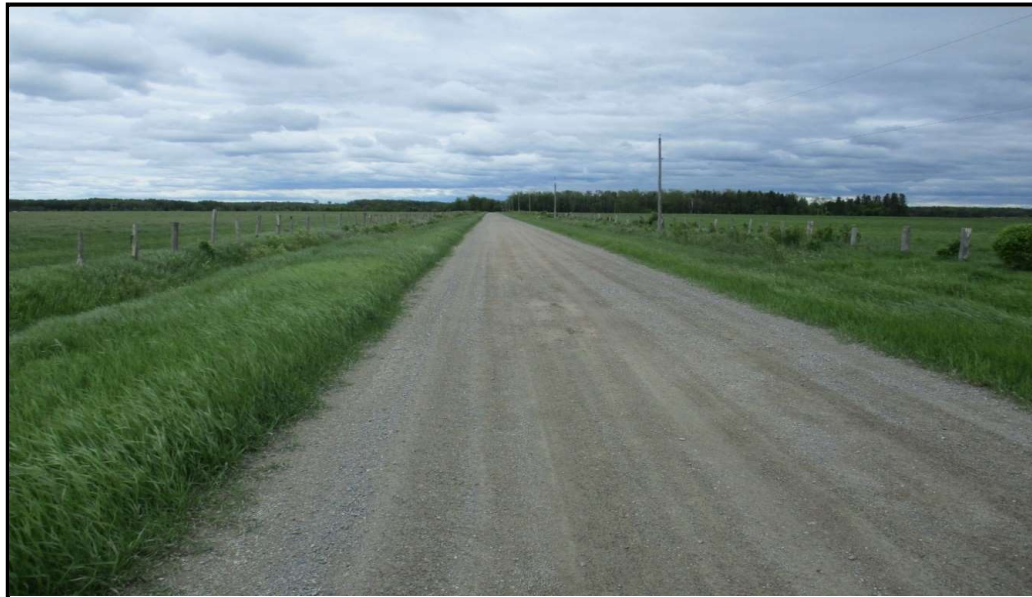
Photo No.: 1

View of road heading South.
Install speed limit signs.

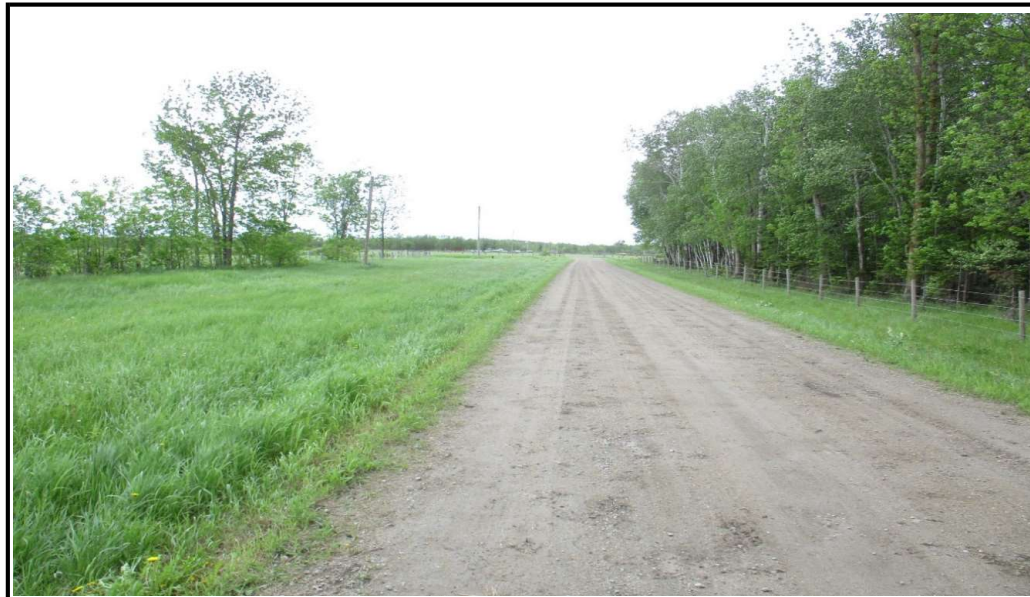
Photo No.: 1

View of road heading East.
Install speed limit sign.

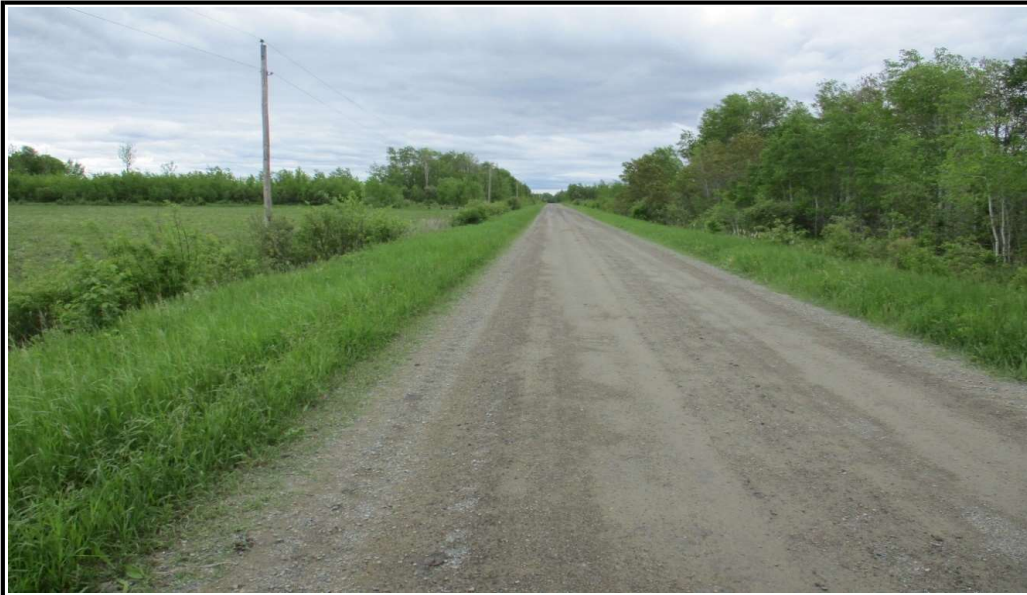
Photo No.: 1

View of road heading South.
Install 2 speed limit signs.

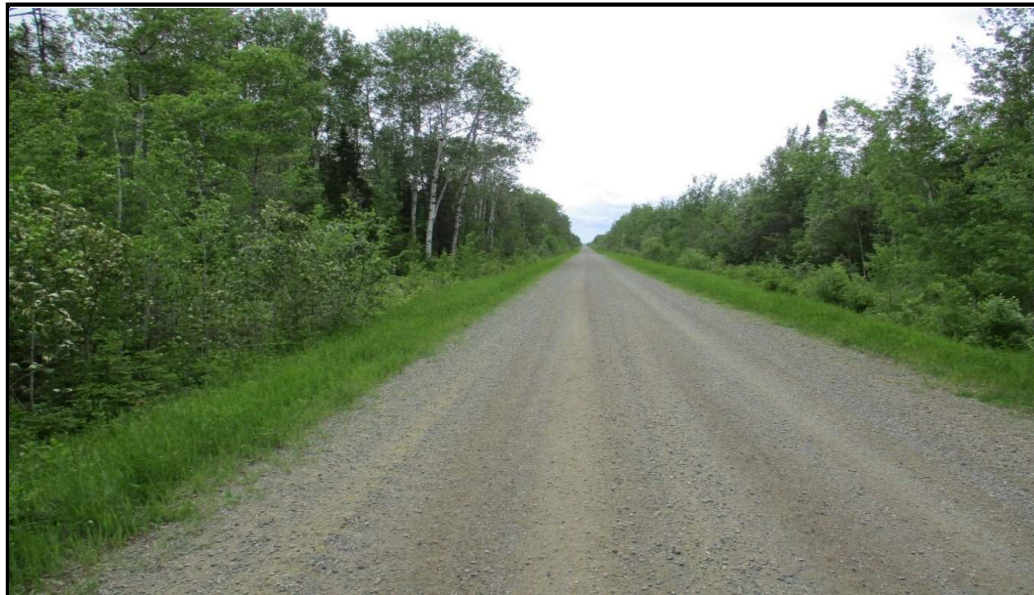
Photo No.: 1

View of road heading West.
Install speed limit signs

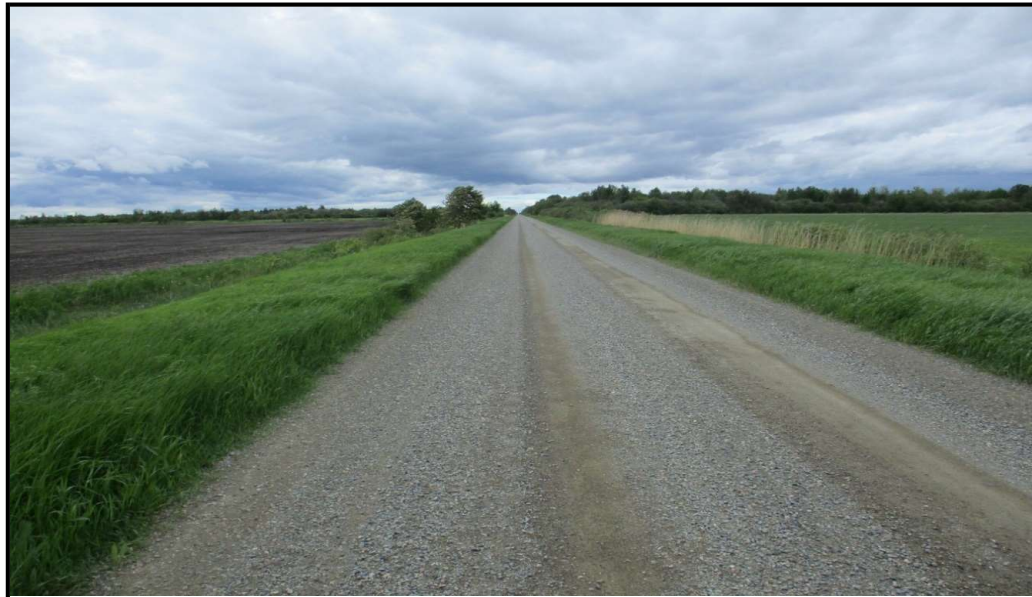
Photo No.: 1

View of road heading North. Cut brush in ditches.

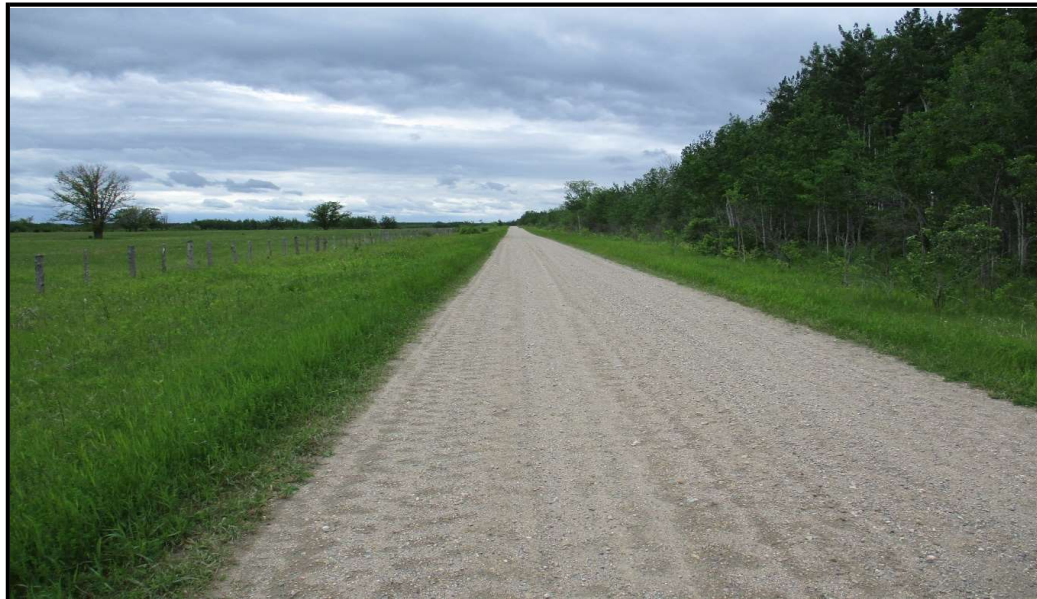
Photo No.: 1

View of road heading West.
Install speed limit signs

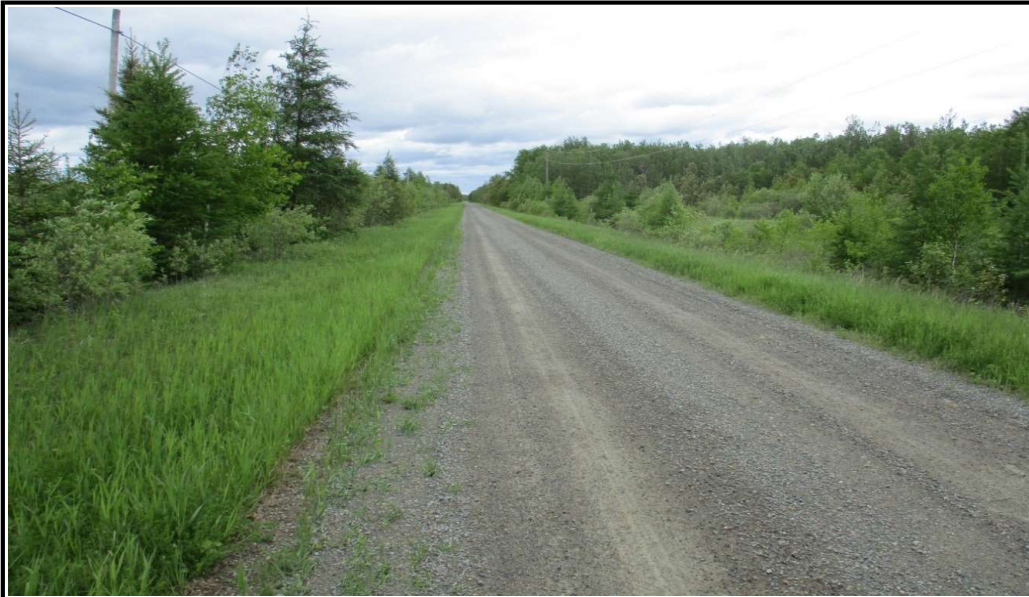
Photo No.: 1

View of road heading East. Cut brush in ditches

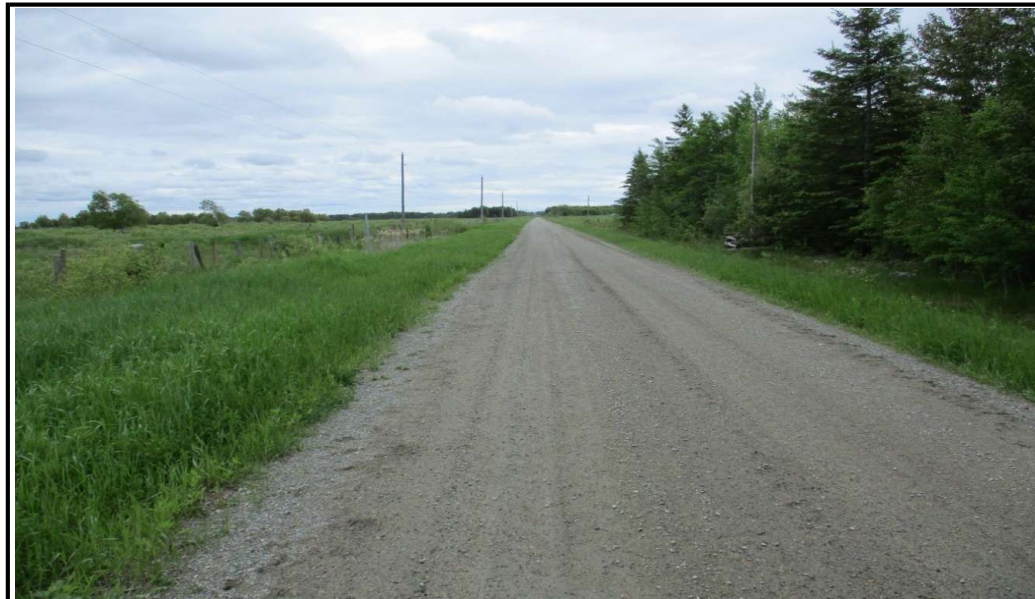
Photo No.: 1

View of road heading South.
Install speed limit signs. Cut
brush in ditches (light).

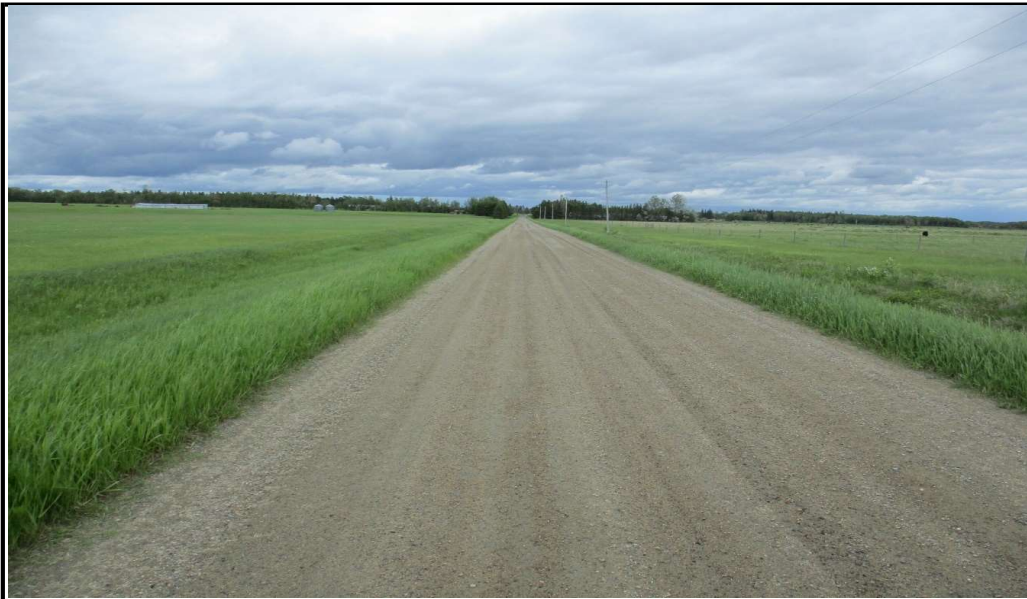
Photo No.: 1

View of road heading East.
Cut grass in shoulder
