DAWSON
TOWNSHIP

2024 ASSET MANAGEMENT PLAN

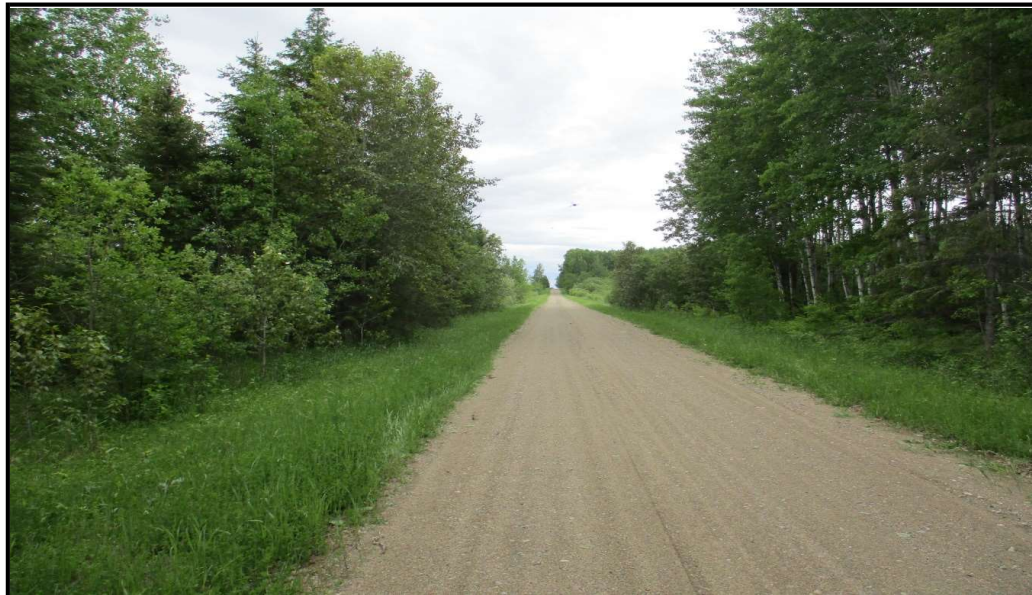
Photo No.: 1

View of road heading South.
Install 2 speed limit signs

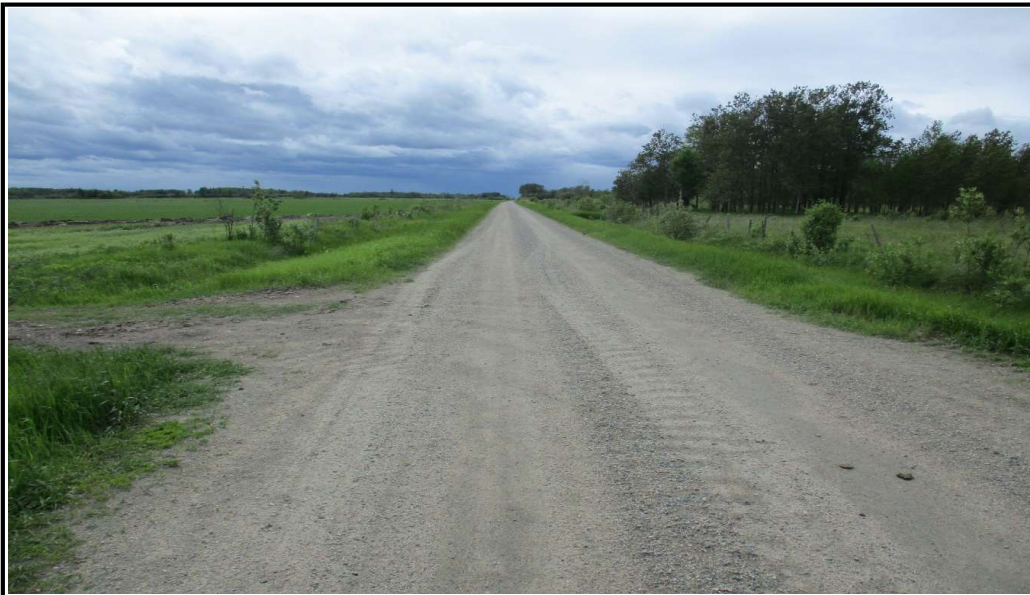
Photo No.: 1

View of road heading West.
Install speed limit signs

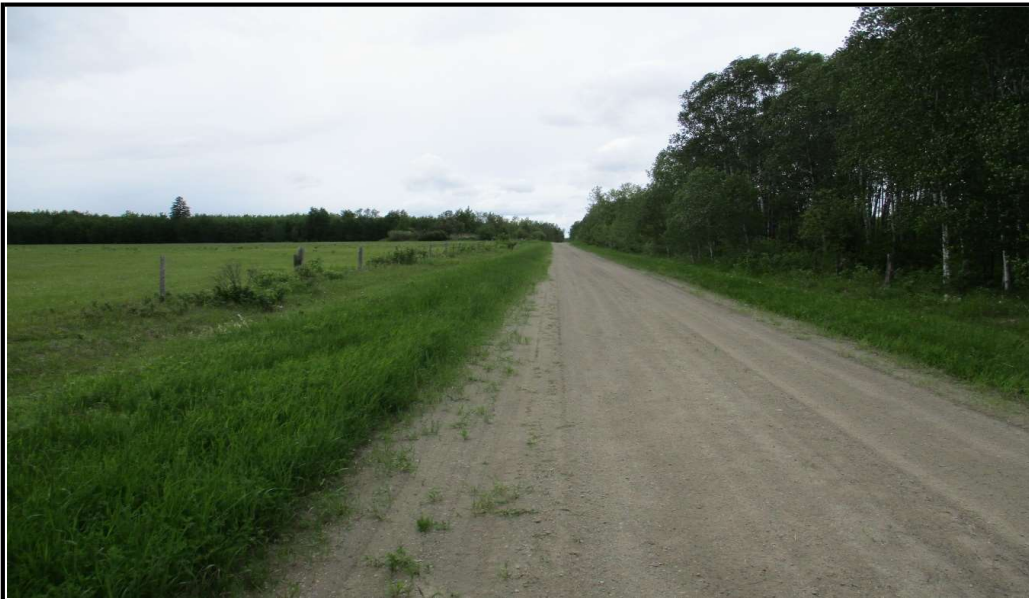
Photo No.: 1

View of road heading North.
Install speed limit sign

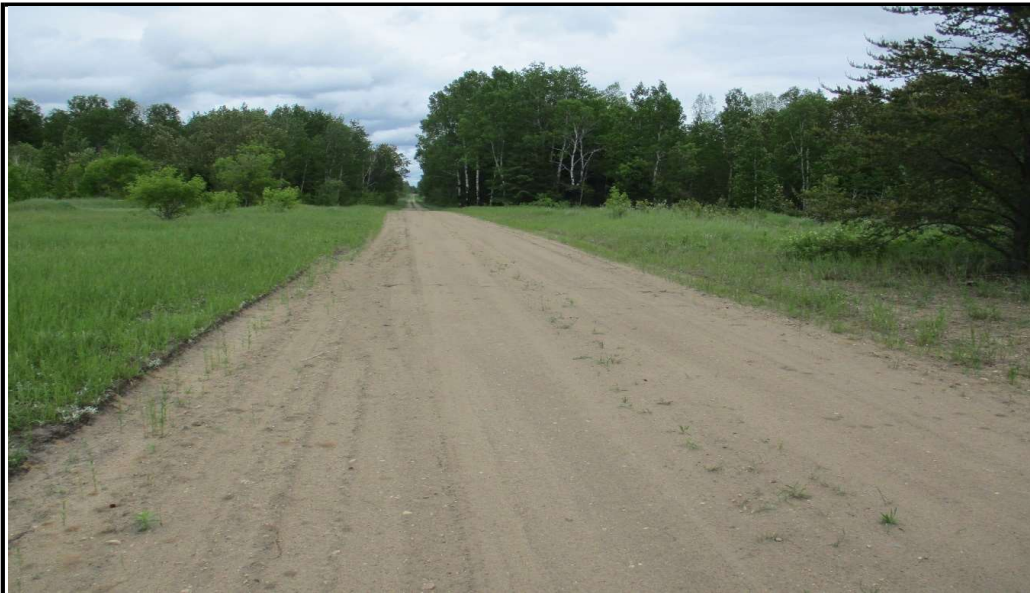
Photo No.: 1

View of road heading East. Cut grass in shoulder

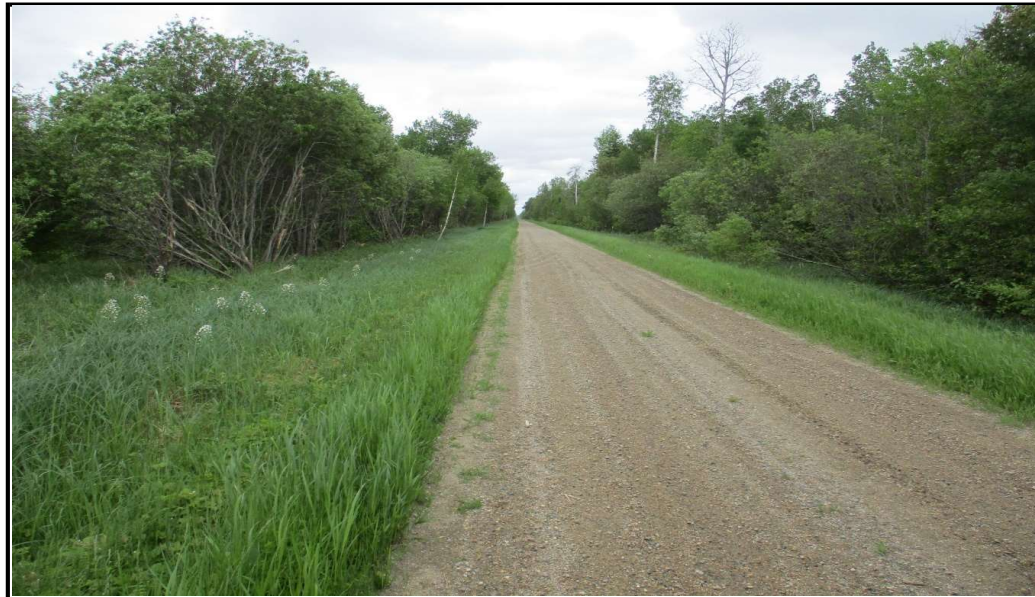
Photo No.: 1

View of road heading East.
Install speed limit signs.

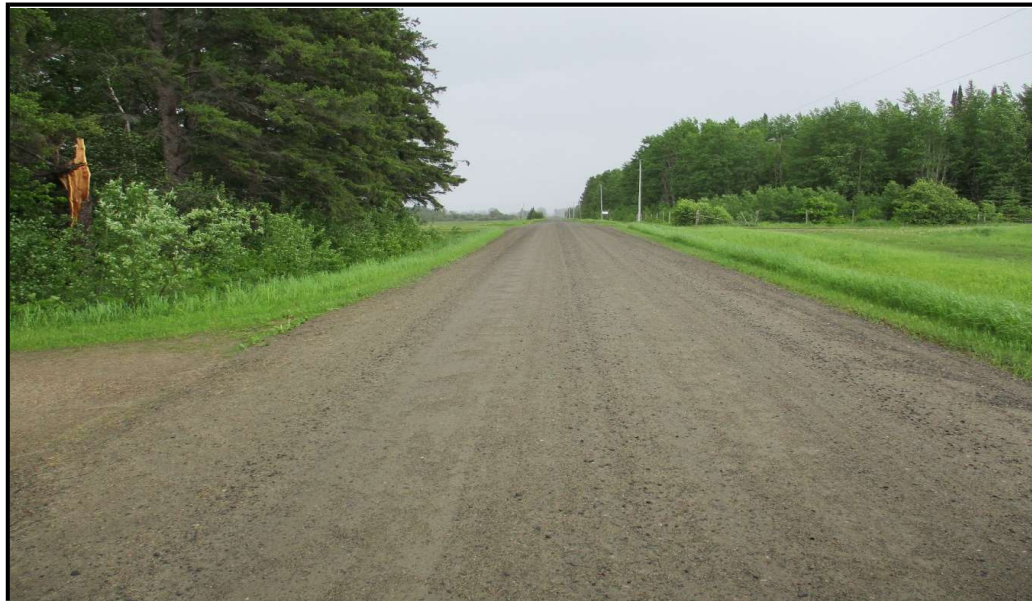
Photo No.: 1

View of road heading South. Cut brush in ditches

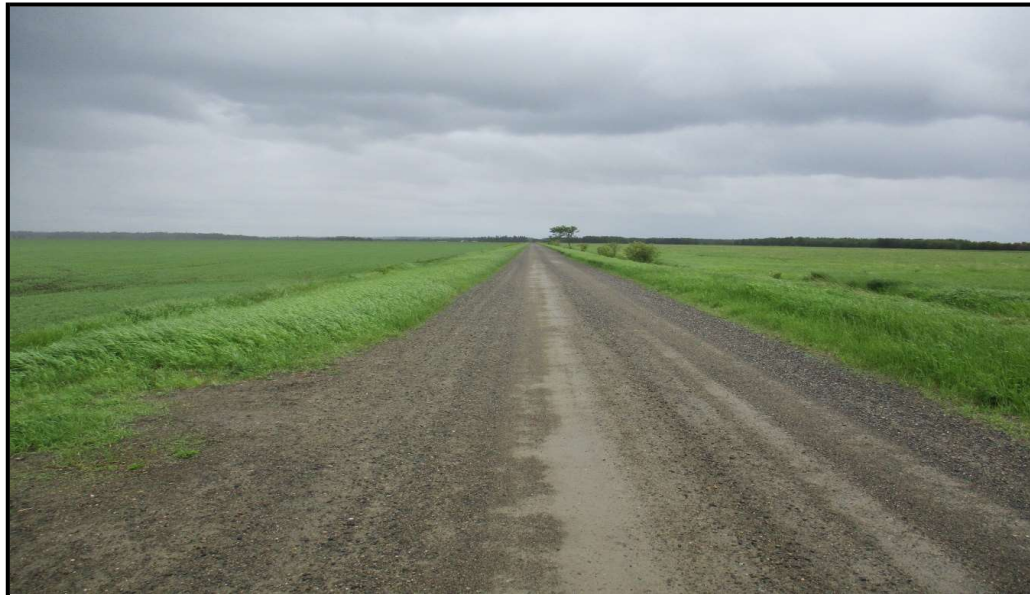
Photo No.: 1

View of road heading South.
Install speed limit sign

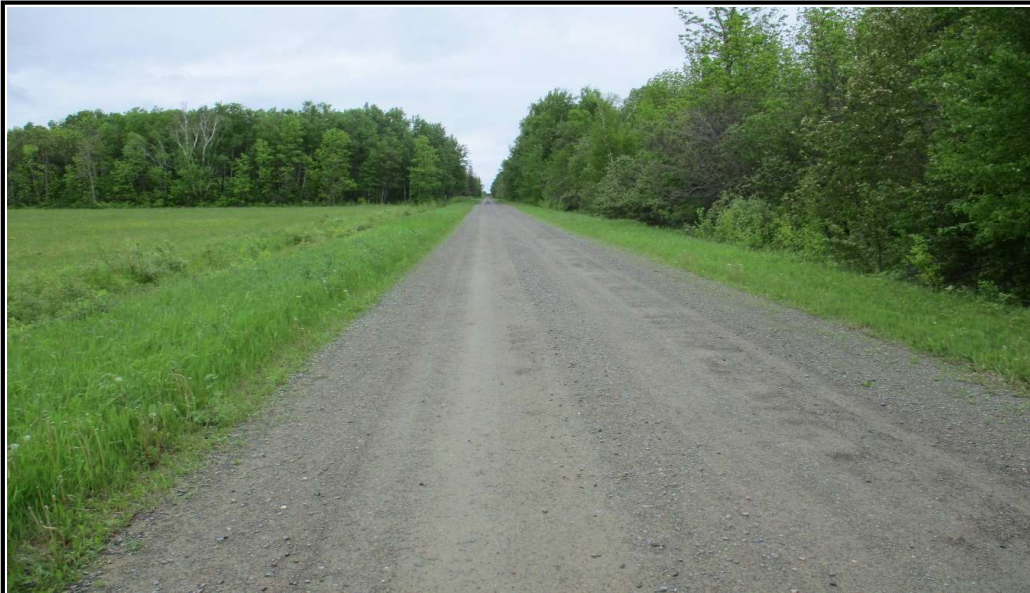
Photo No.: 1

View of road heading North.
Install speed limit sign.

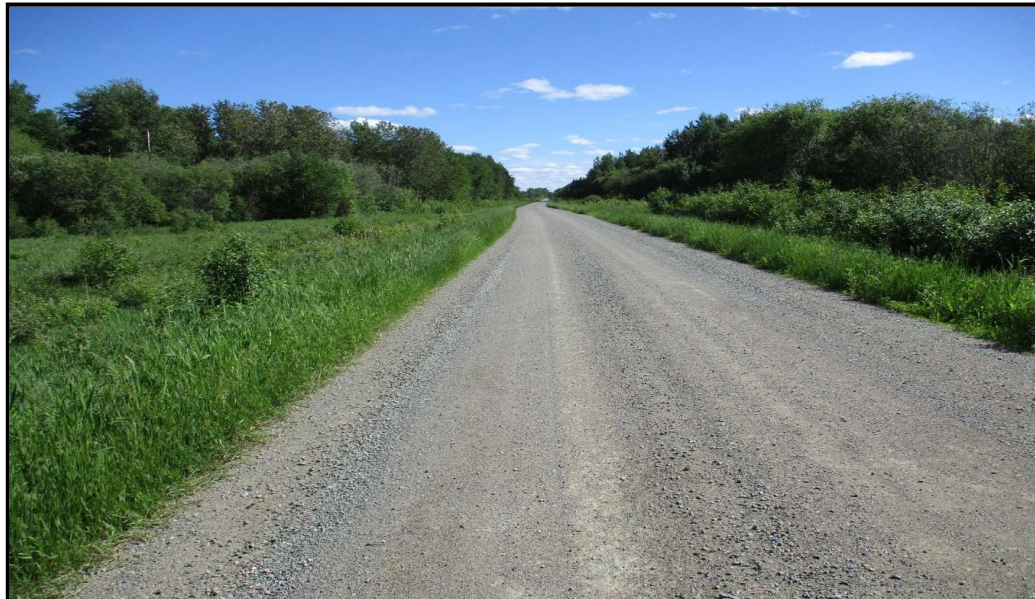
Photo No.: 1

View of road heading South. Cut brush in shoulder & Ditches

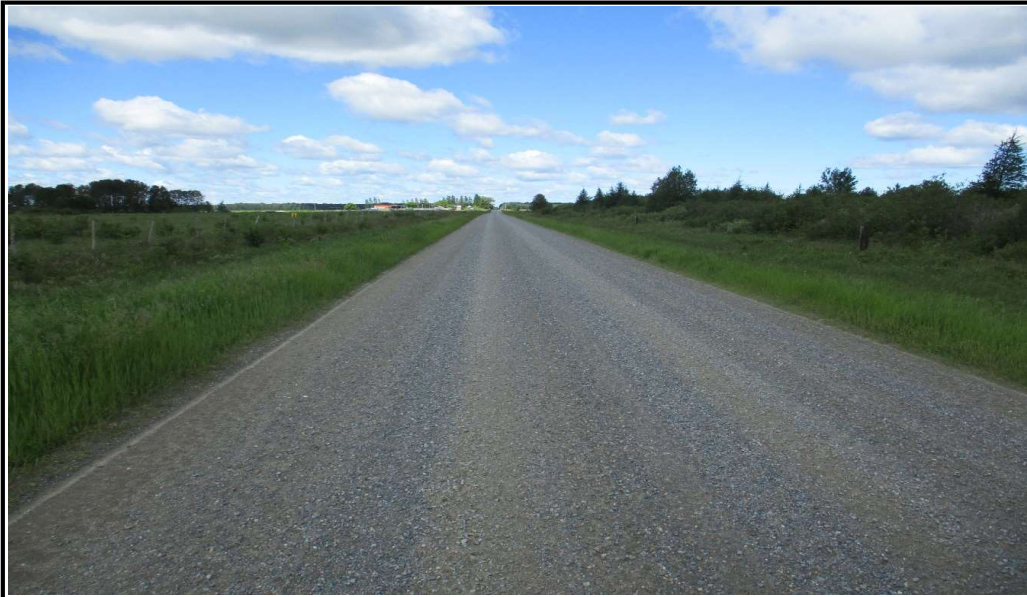
Photo No.: 1

View of road heading West.
Provide name sign

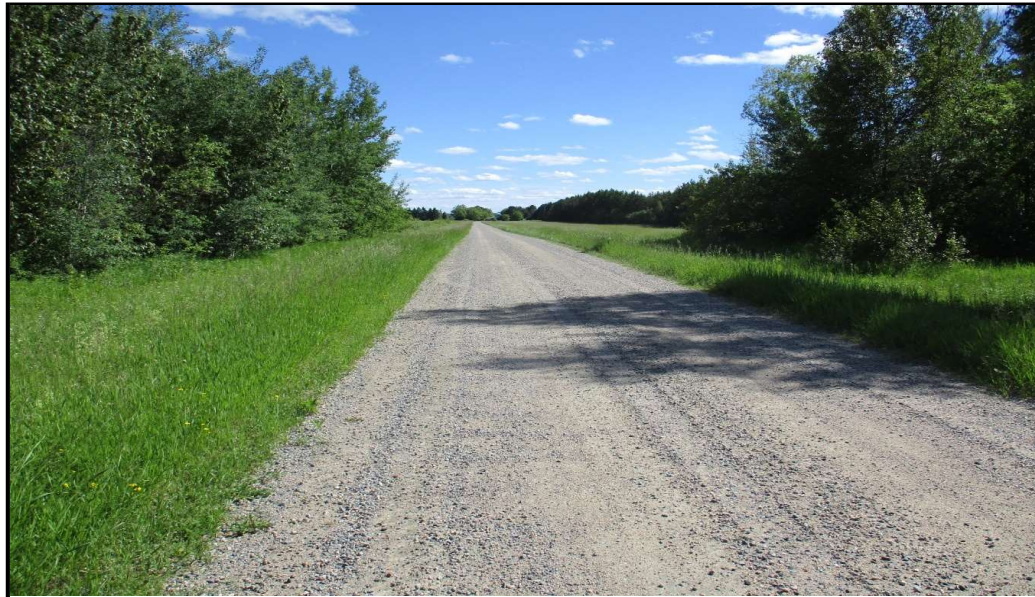
Photo No.: 1

View of road heading South. Cut brush in shoulder & Ditches

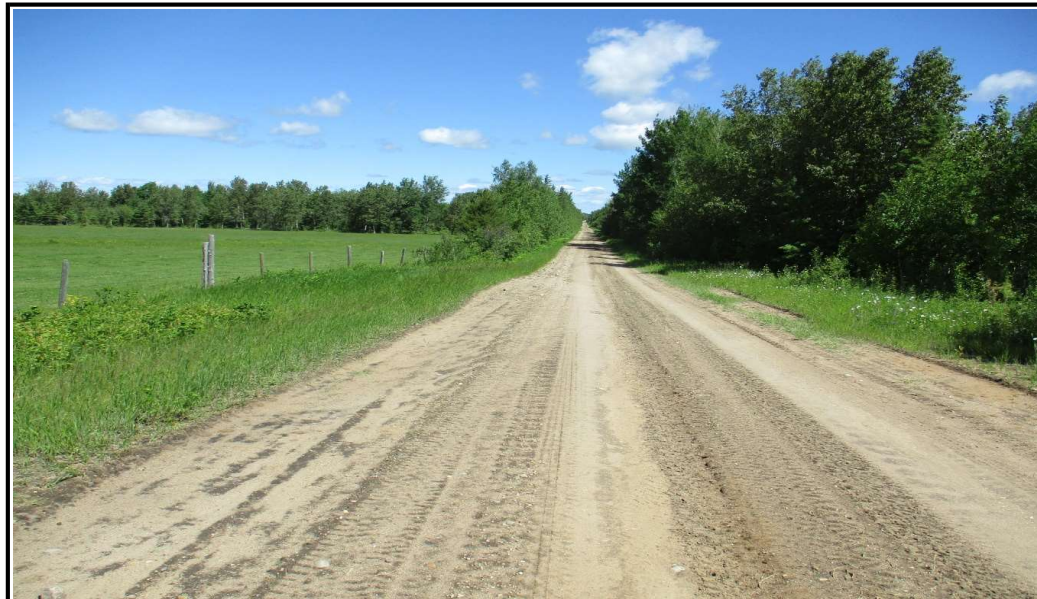
Photo No.: 1

Description:
View of road heading North.
Grade road

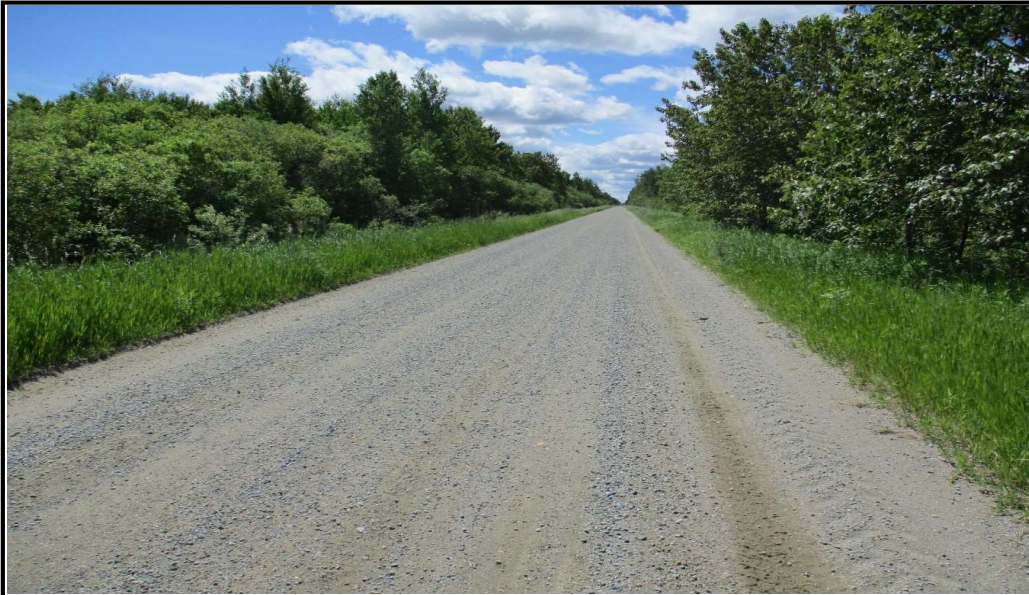
Photo No.: 1

View of road heading South. Cut brush in shoulder & ditches

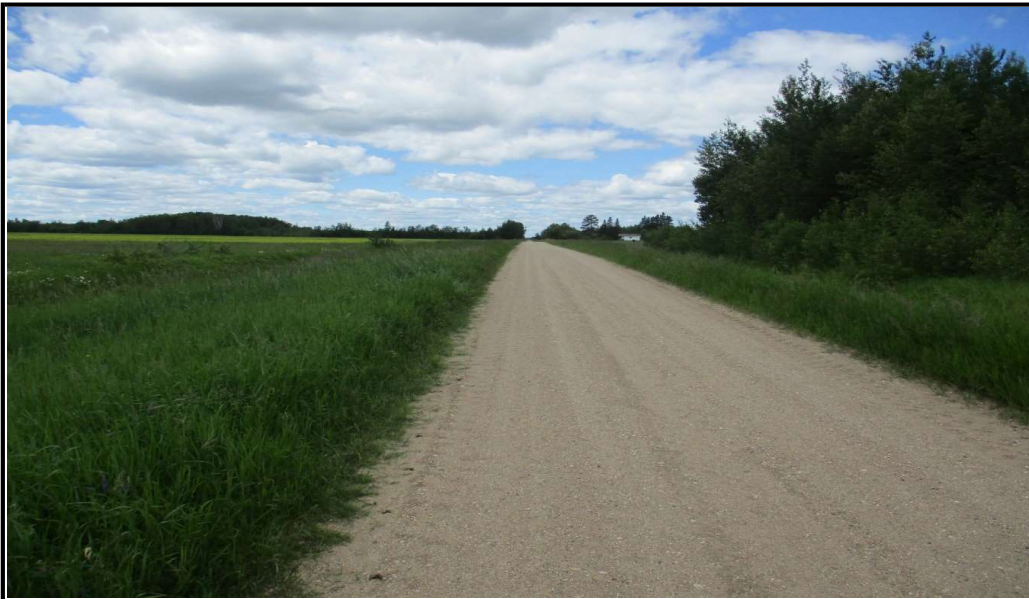
Photo No.: 1

View of road heading West.
Install speed limit sign. Cut grass
in shoulder & grade shoulder

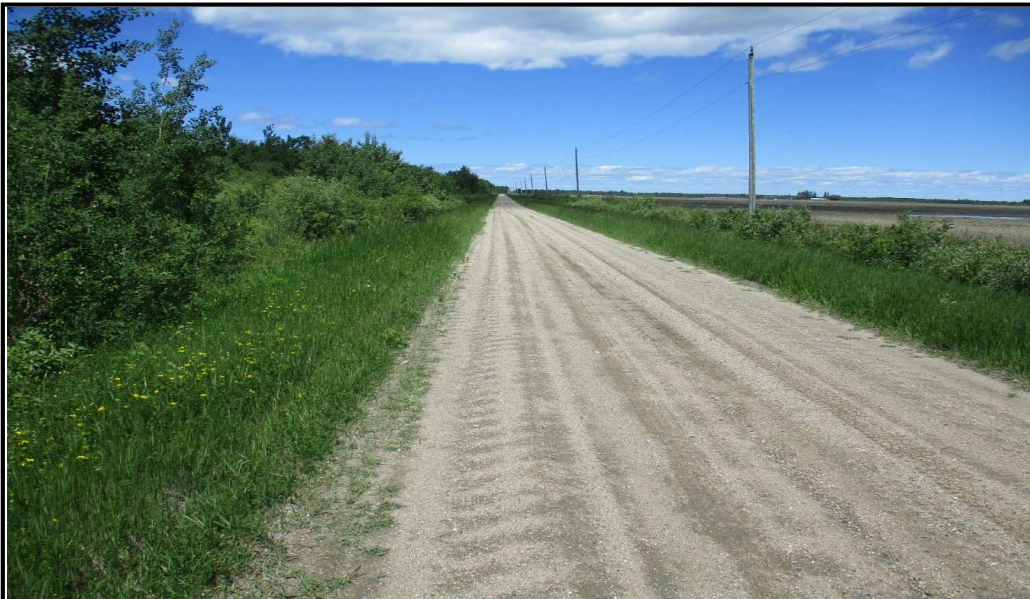
Photo No.: 1

Description:
View of road heading North.
Install speed limit signs

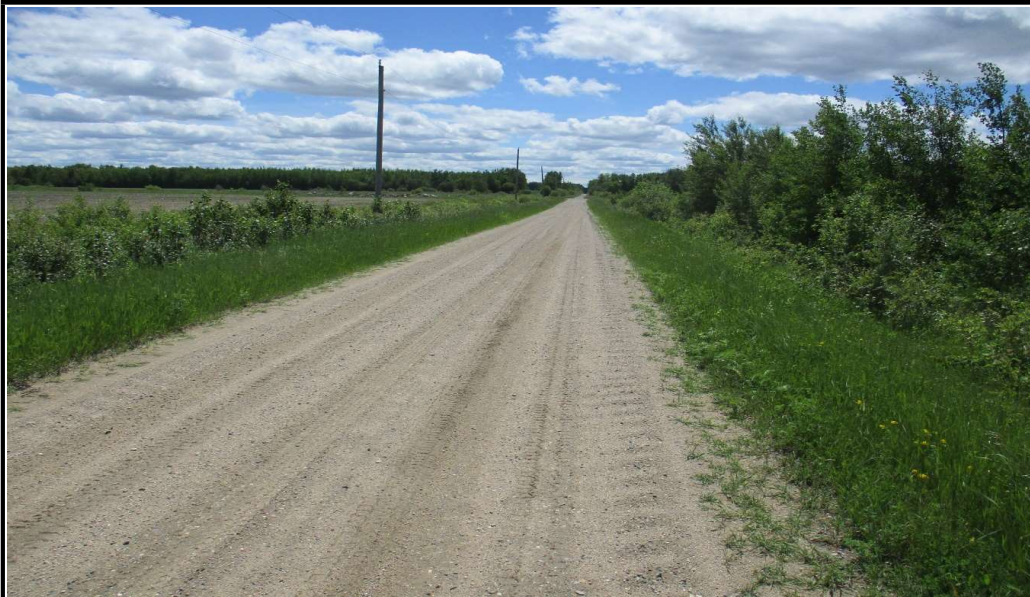
Photo No.: 2

Description:
View of road heading west. Cut
brush in ditches (Medium)

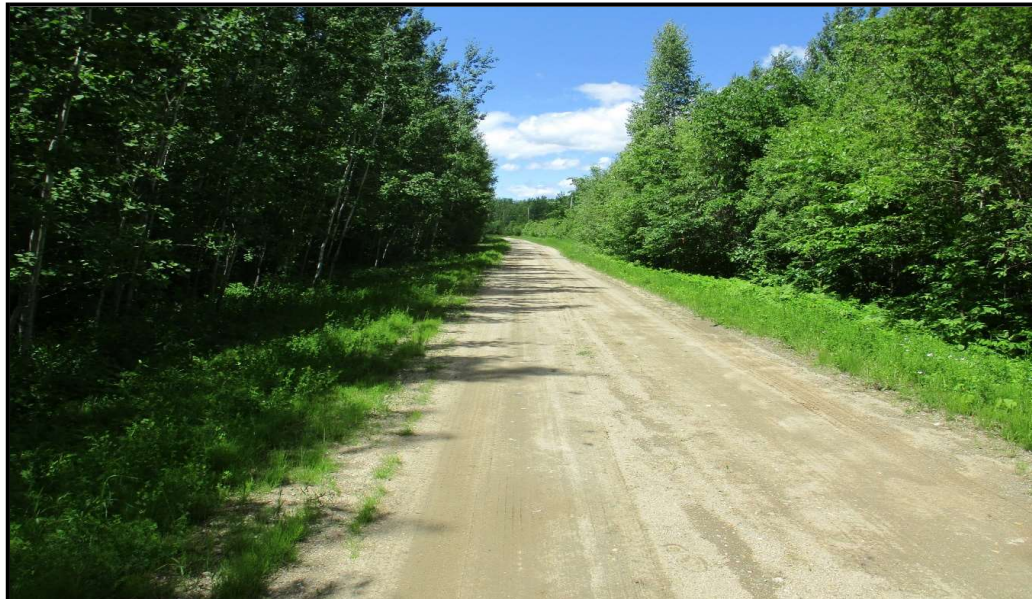
Photo No.: 1

View of road heading North-West. Cut brush in shoulder & ditches

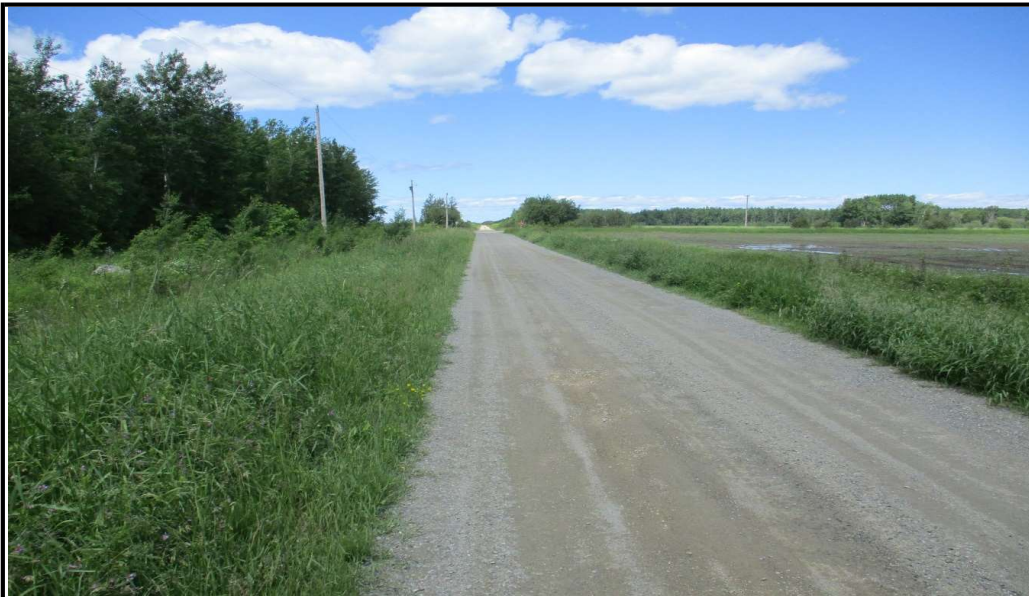
Photo No.: 1

Description:
View of road heading North.
Grade road

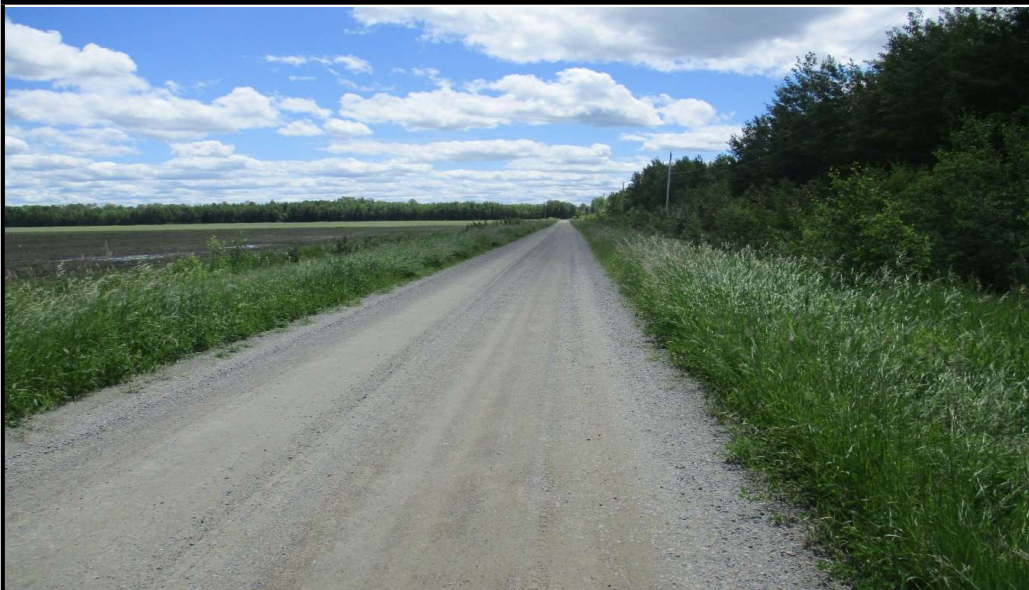
Photo No.: 2

Description:
View of road heading West. Cut
brush in shoulder & ditches

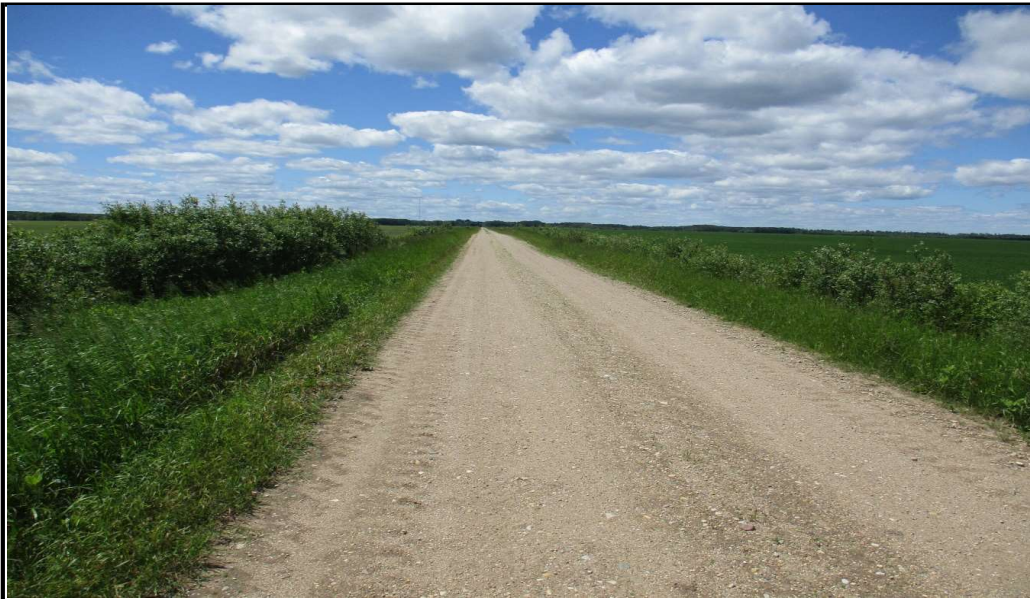
Photo No.: 1

View of road heading West. Cut brush in shoulder & ditches

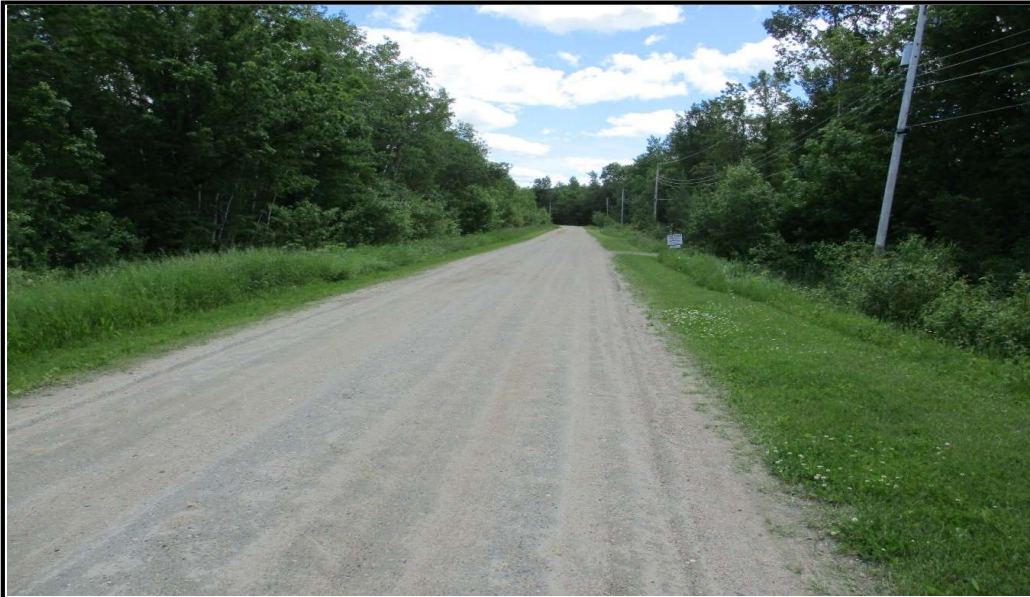
Photo No.: 1

View of road heading South-East. Restore drainage (ditching)

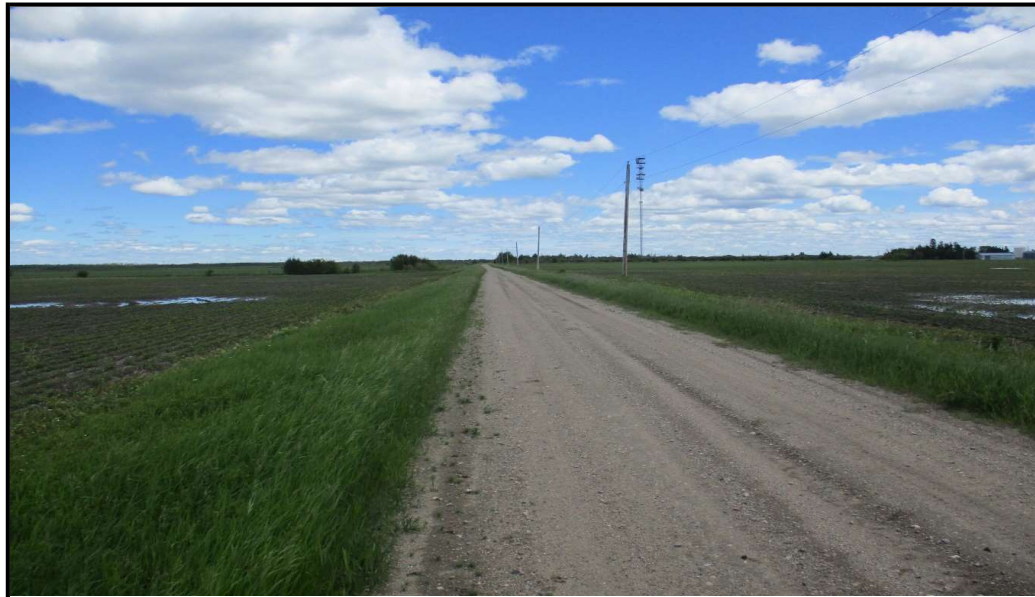
Photo No.: 1

View of road heading East.
Grade road. Cut brush in shoulder.

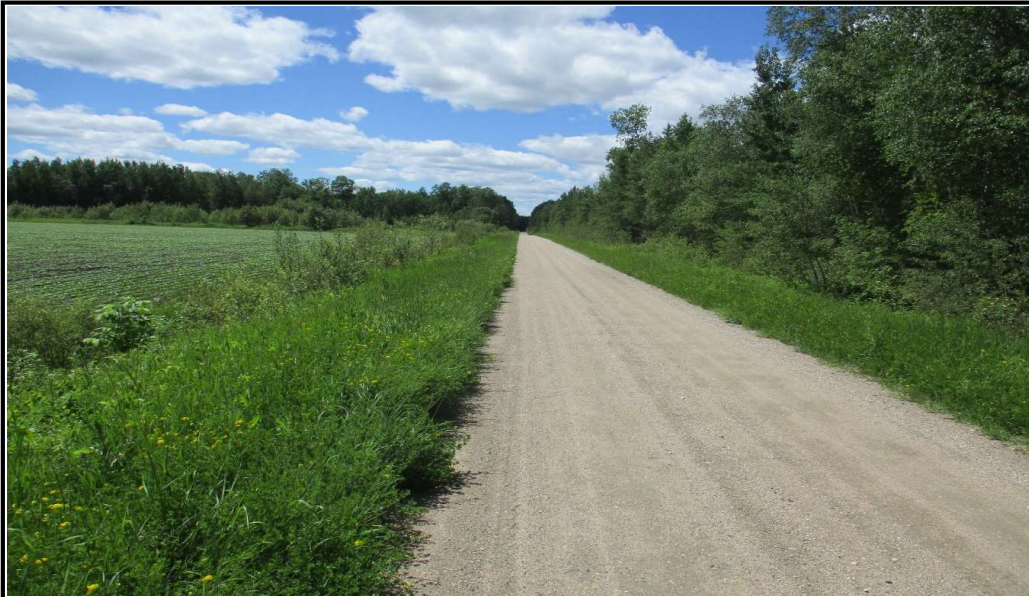
Photo No.: 1

View of road heading West. Cut brush in shoulders & ditches

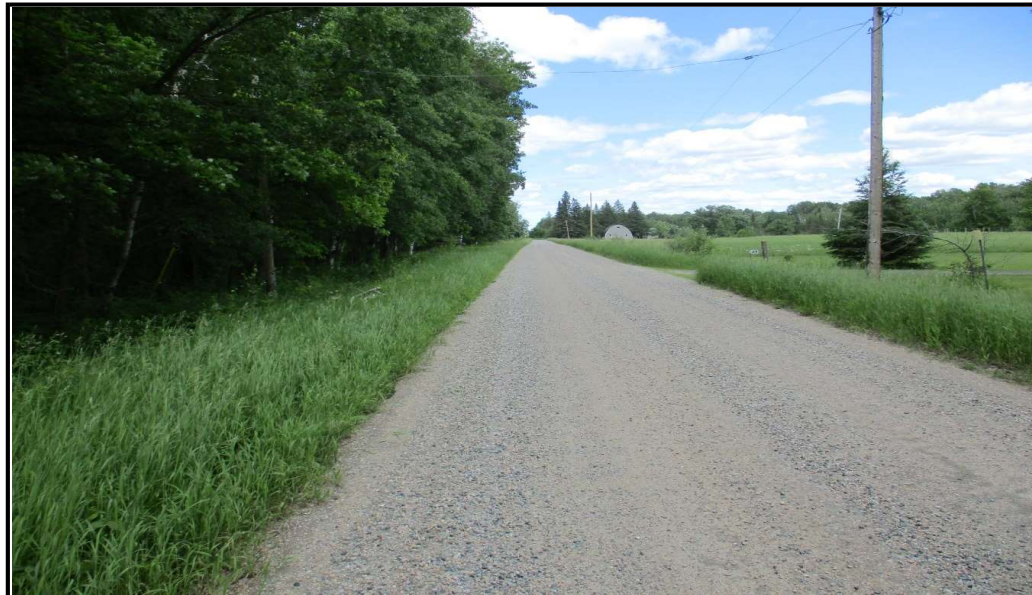
Photo No.: 1

View of road heading East.
Install speed limit signs.

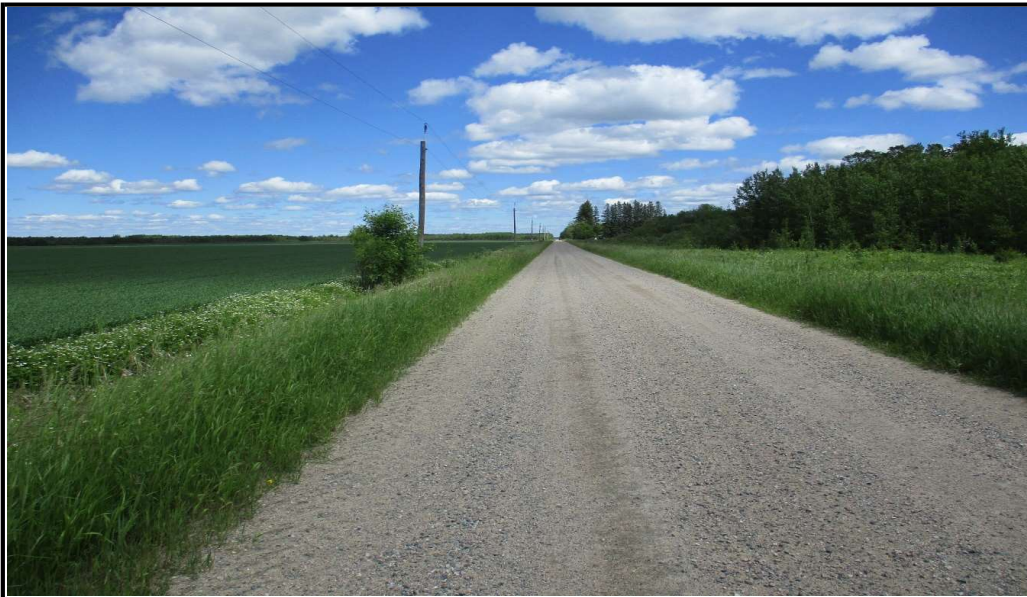
Photo No.: 1

View of road heading East. Cut brush in ditches & cut grass in shoulder.

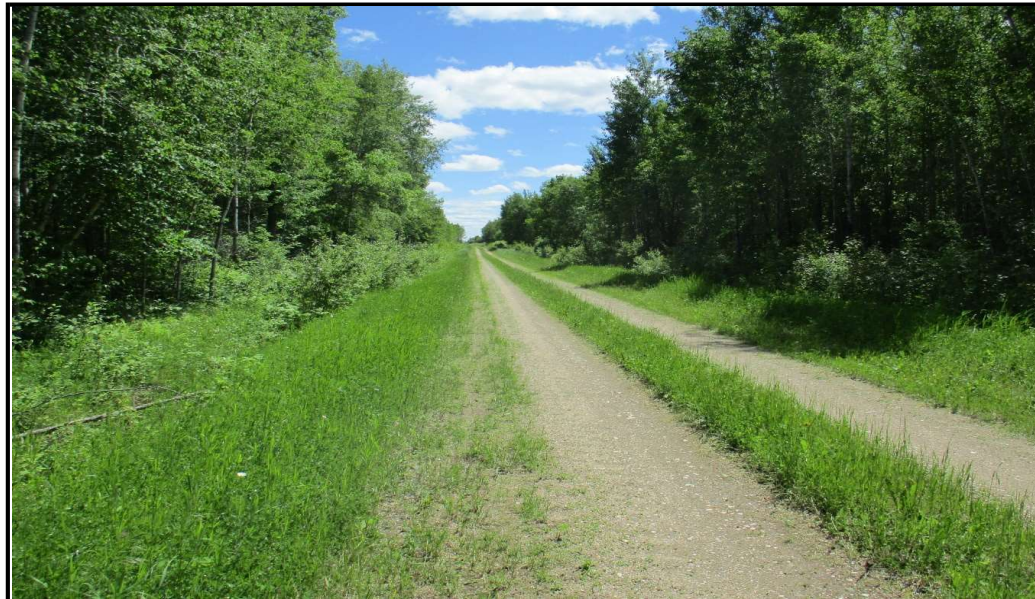
Photo No.: 1

View of road heading South. Cut grass in road, cut brush in shoulder.

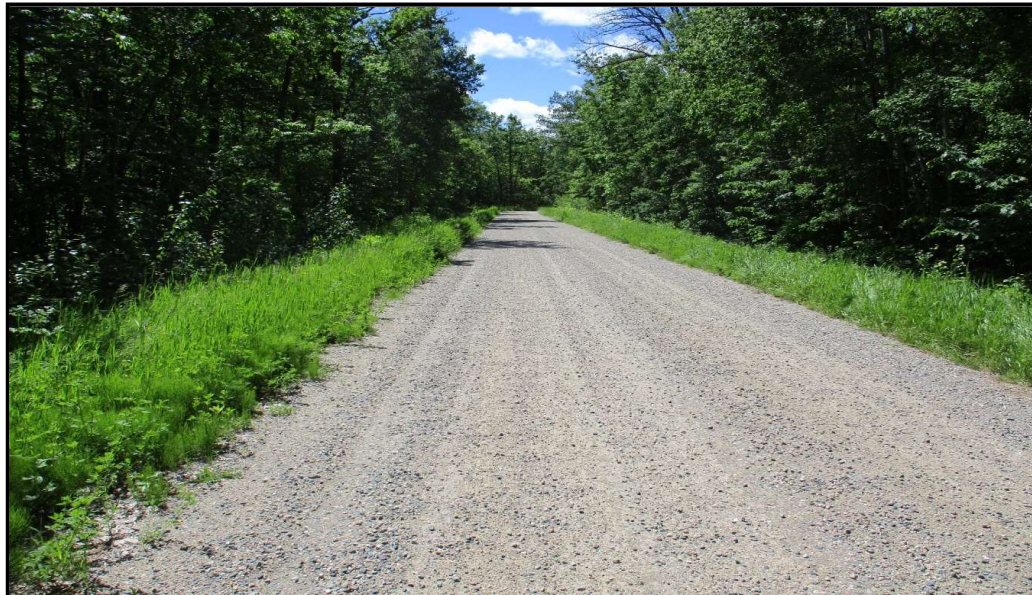
Photo No.: 1

View of road heading North-West. Cut brush in shoulder. Install speed limit sign.

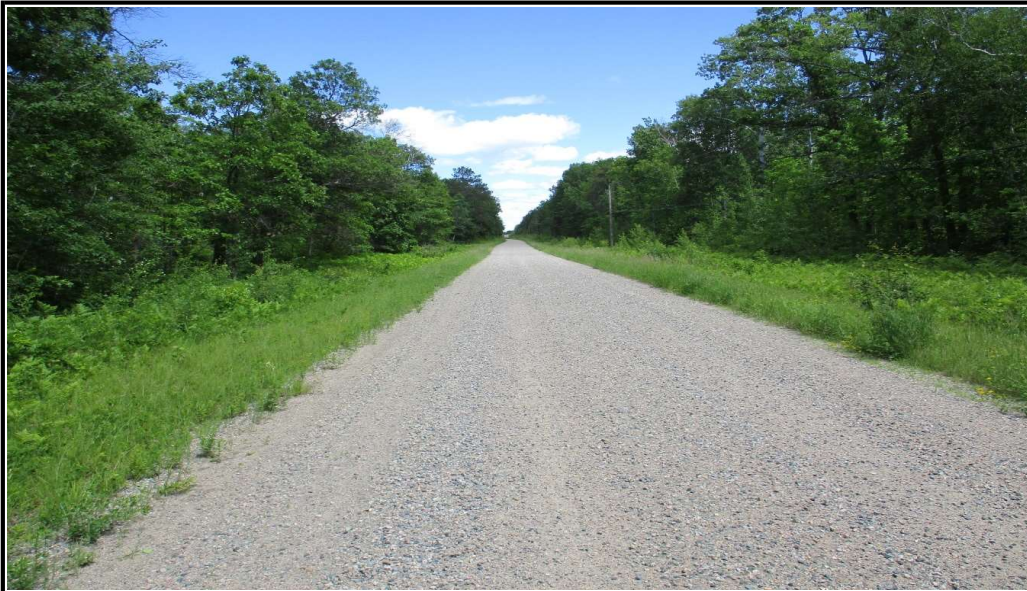
Photo No.: 1

View of road heading East. Cut grass in shoulders.

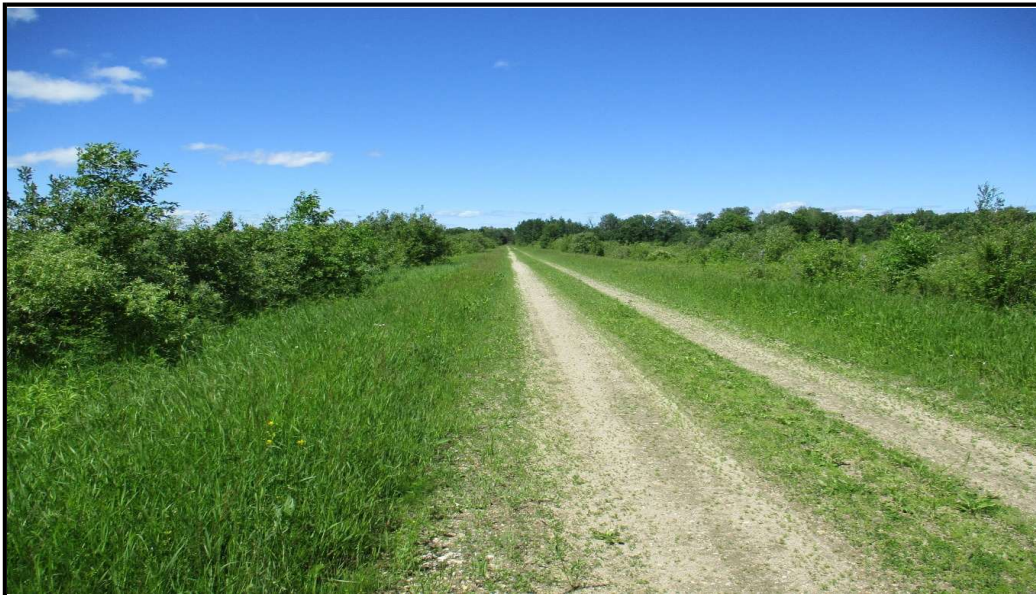
Photo No.: 1

View of road heading North.
Install name sign. Cut brush in
shoulder & Ditches.

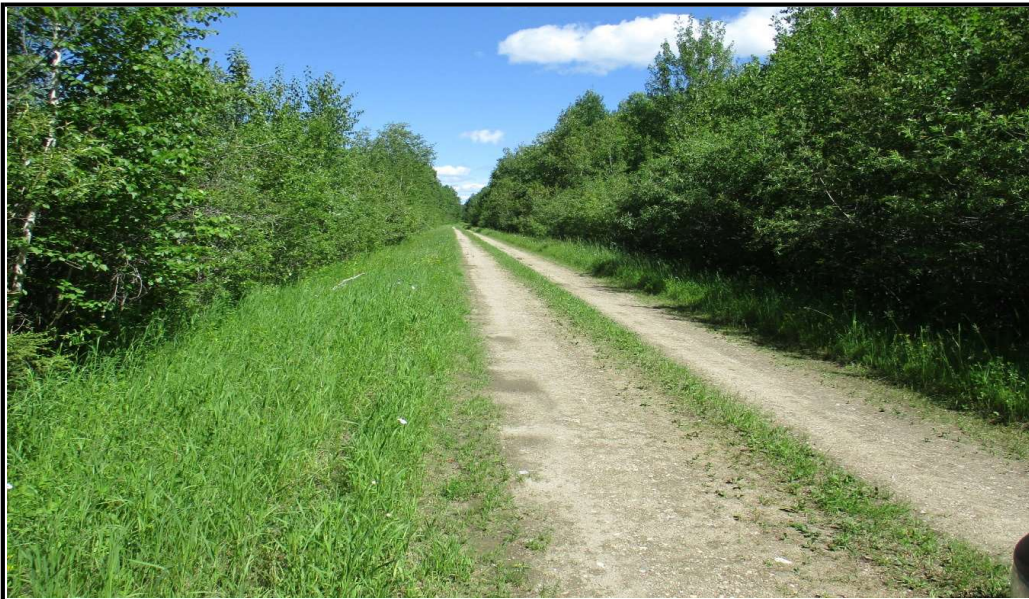
Photo No.: 1

View of road heading East. Cut brush in shoulder & Ditches.

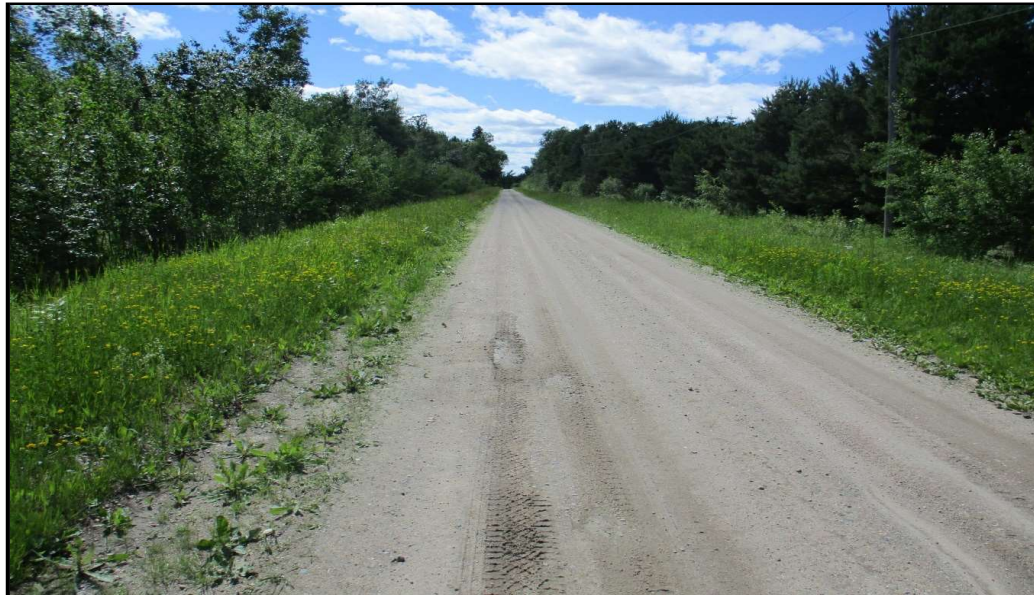
Photo No.: 1

View of road heading West. Cut brush in shoulder & Ditches.

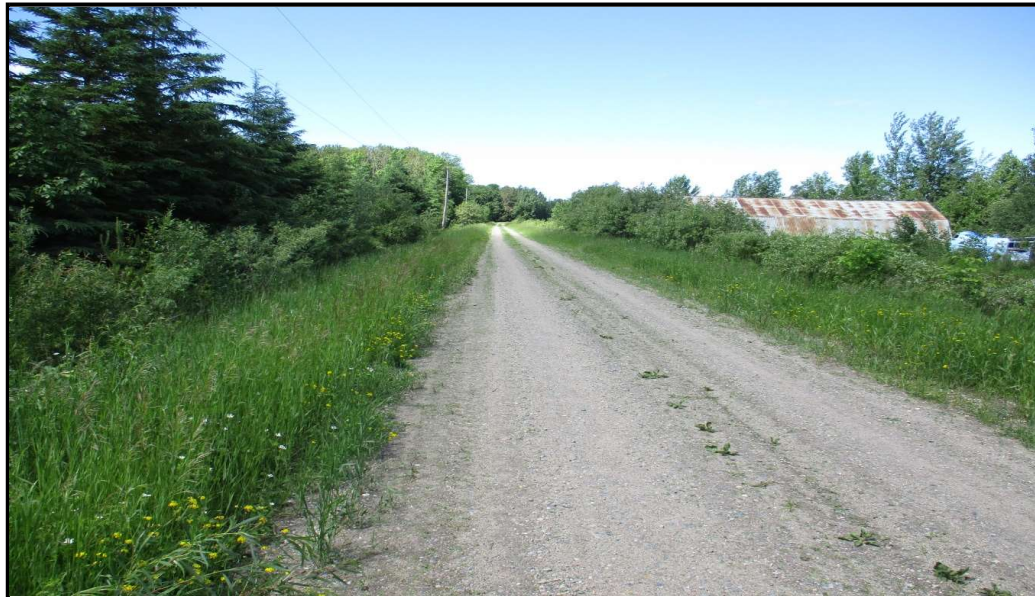
Photo No.: 1

View of road heading North. Cut brush in shoulder & ditches.

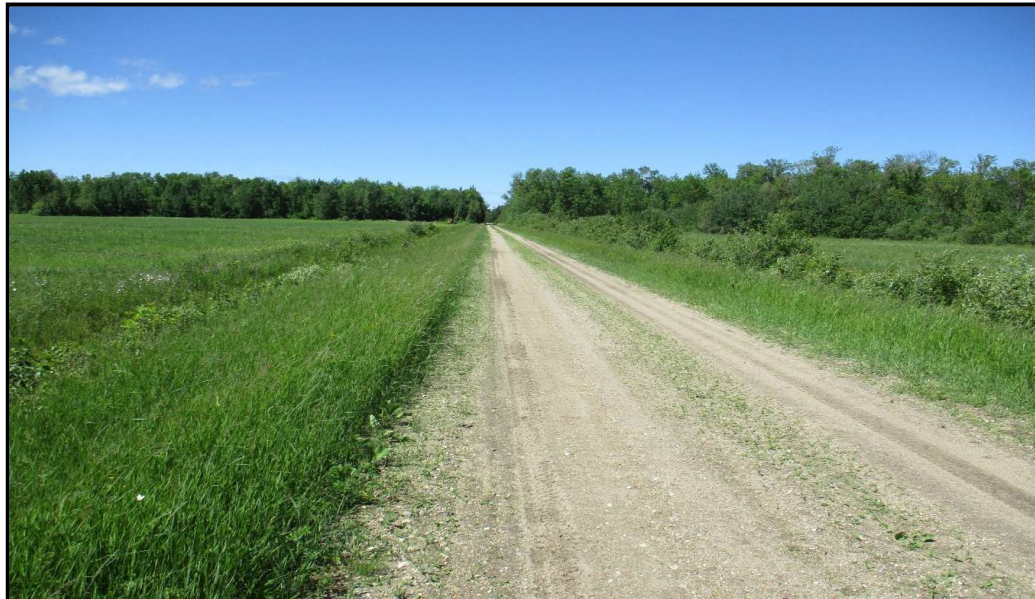
Photo No.: 1

View of road heading North. Cut brush in shoulder. Install speed limit sign.

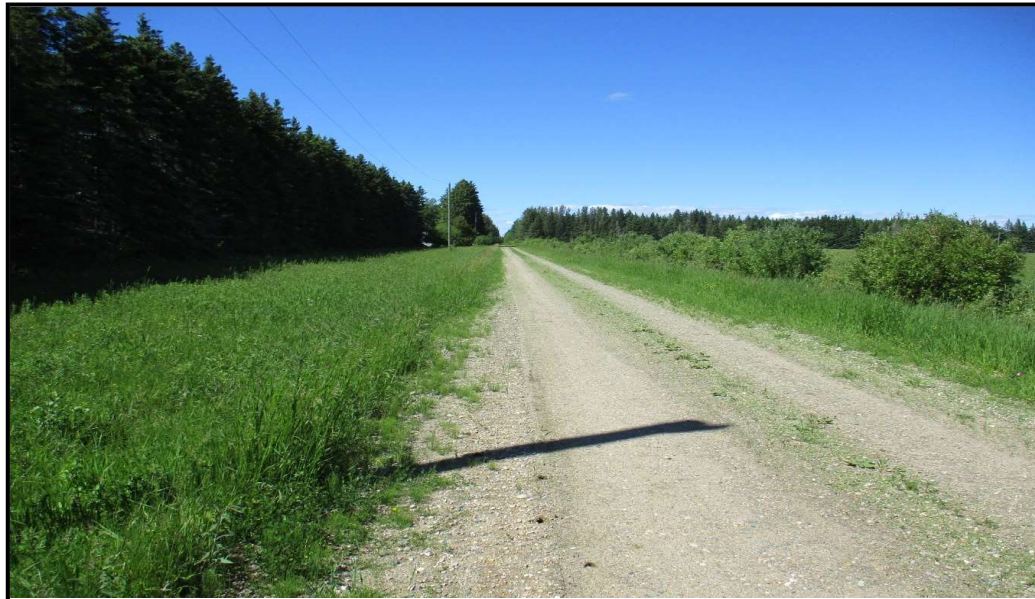
Photo No.: 1

View of road heading North. Cut brush in shoulder. Grade shoulder.

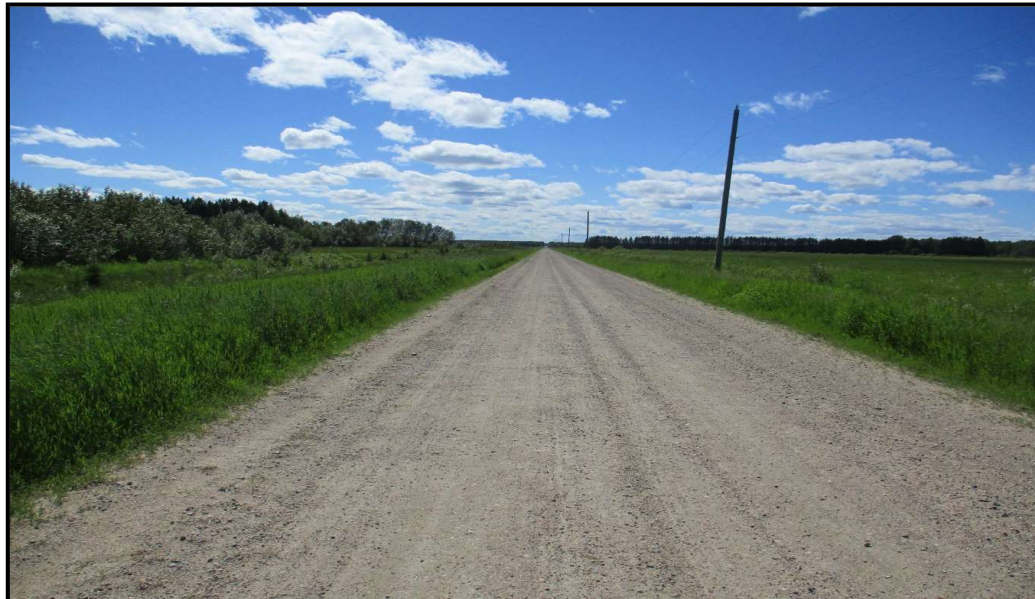
Photo No.: 1

View of road heading West. Install speed limit signs.

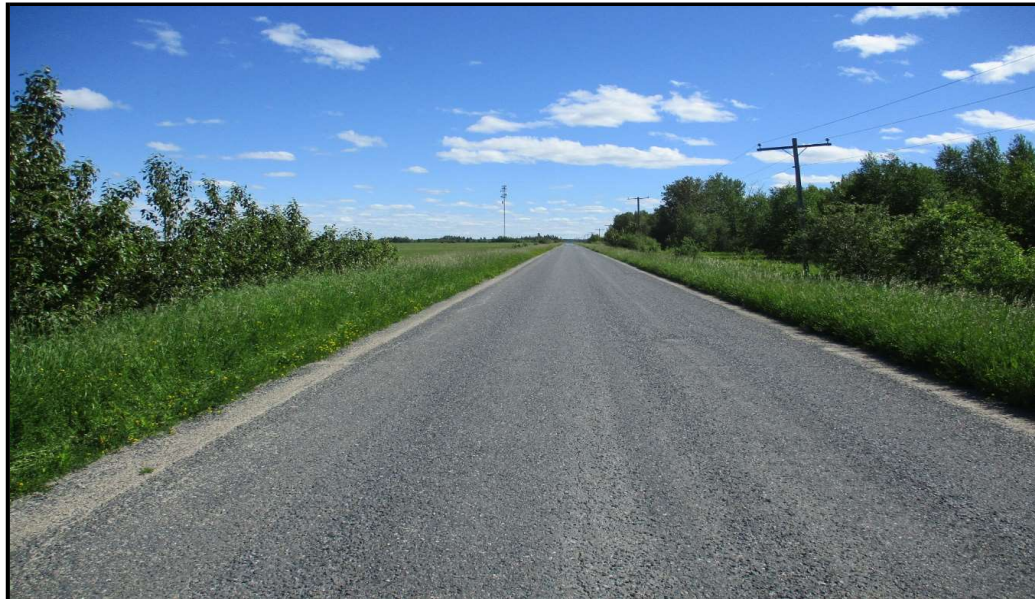
Photo No.: 1

View of road heading South. Cut brush in shoulder & ditches
