DAWSON
TOWNSHIP

2024 ASSET MANAGEMENT PLAN

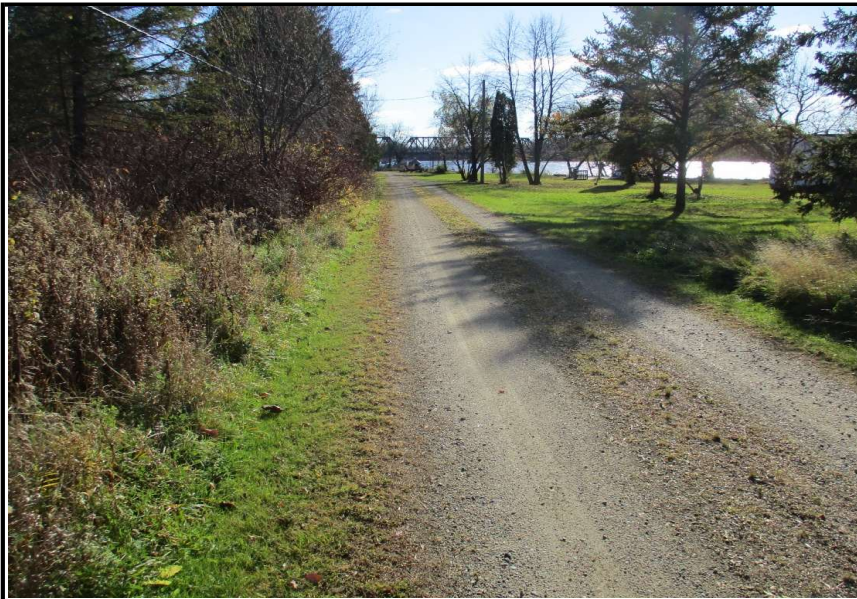
Photo No.: 1

View heading South
Widen road by 2.5 m
road

Grade

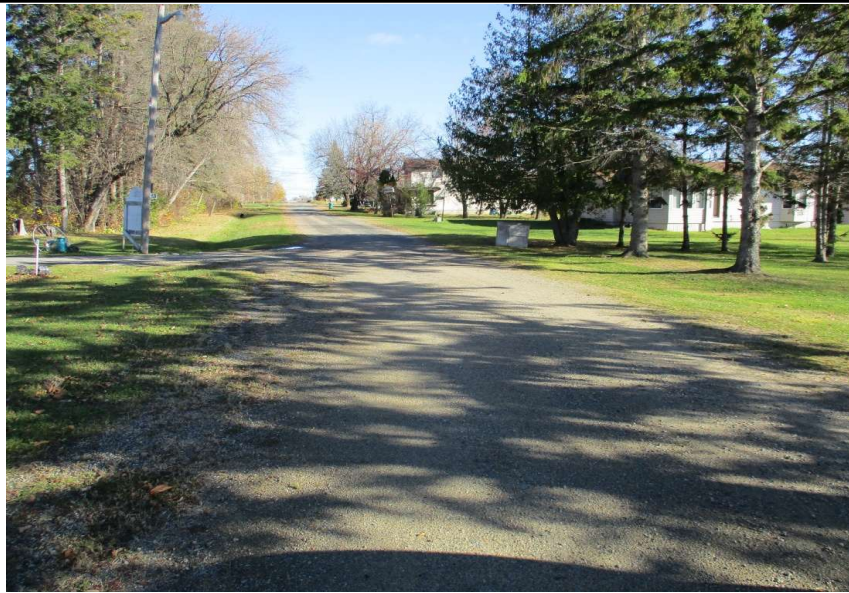
Photo No.: 1

Description:
View heading East
Widen road by 1.5 m

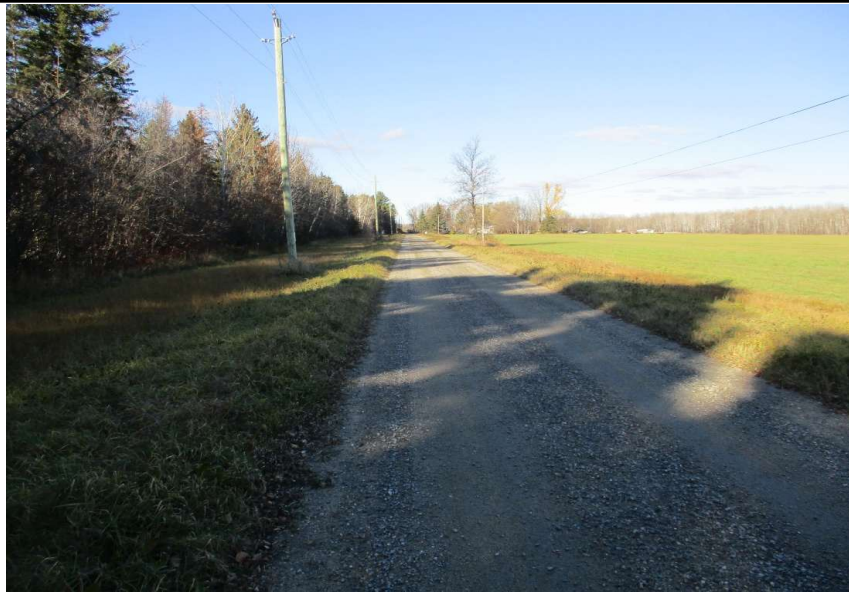
Photo No.: 1

Description:
View heading North
Widen road by 2 m

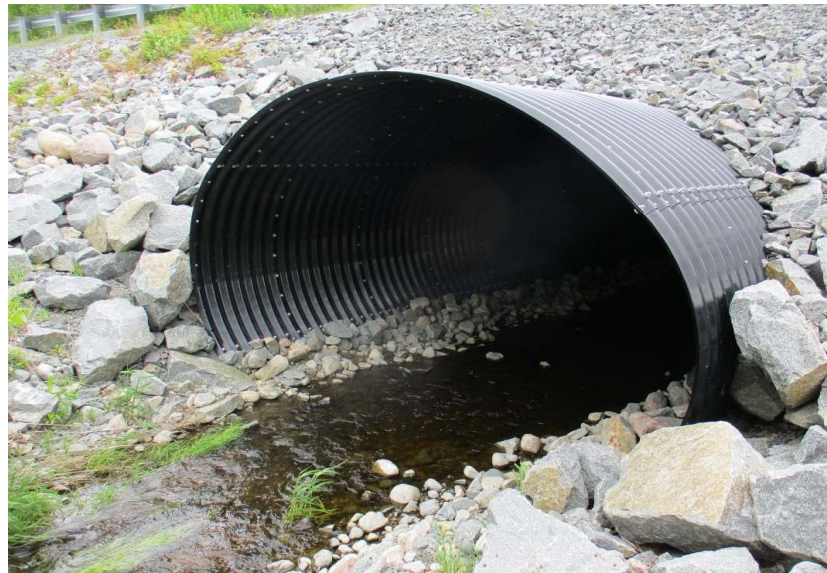
Photo No.: 6

Description:
View of culvert

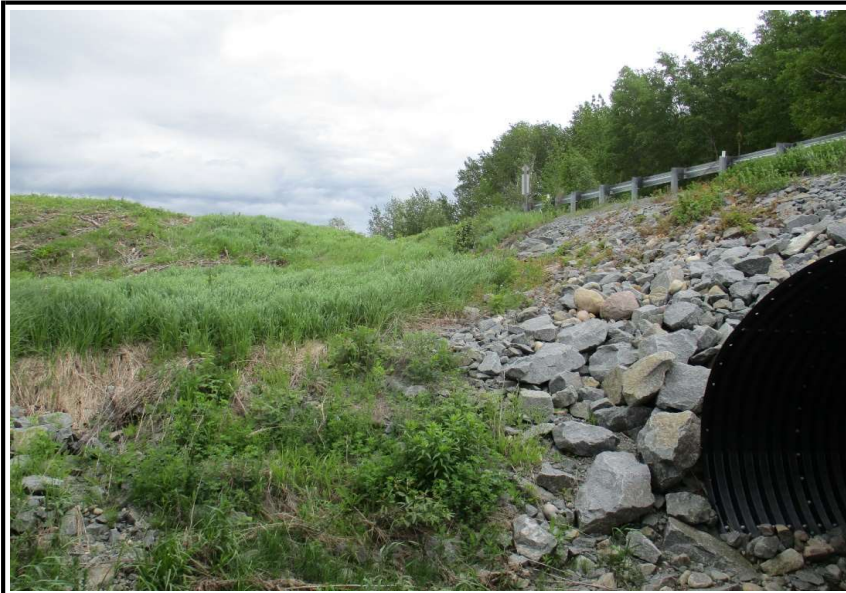
Photo No.: 7

Description:
North end of culvert

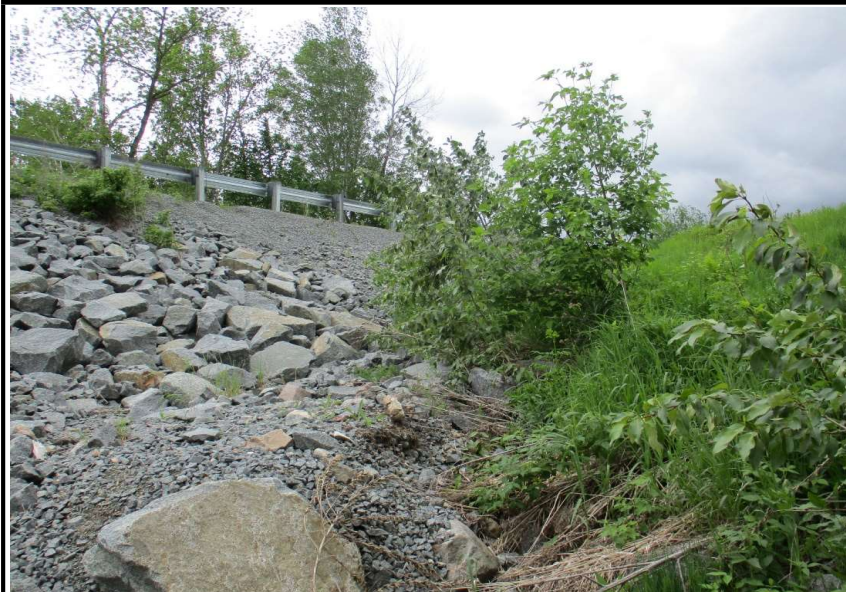
Photo No.: 8

Description:
Rip rap at culvert

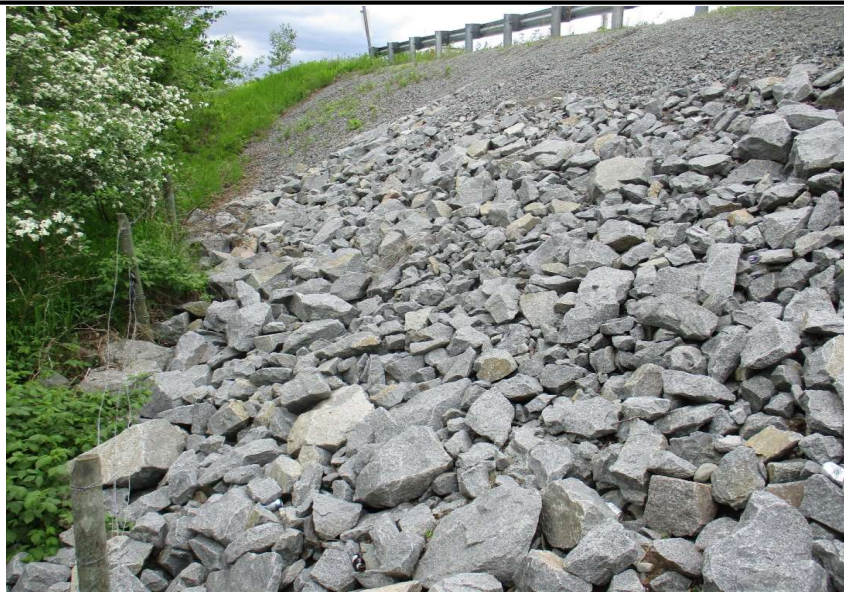
Photo No.: 9

Description:
Rip rap at culvert

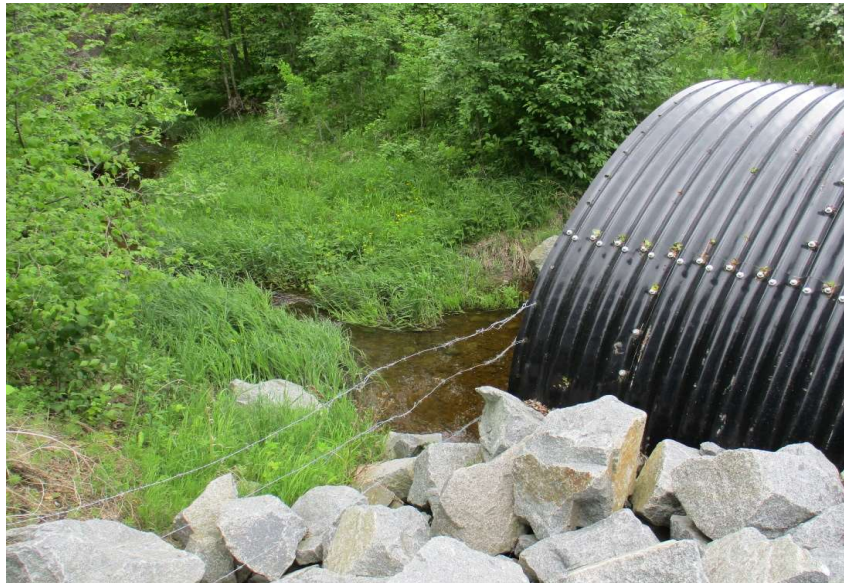
Photo No.: 10

Description:
South end of culvert

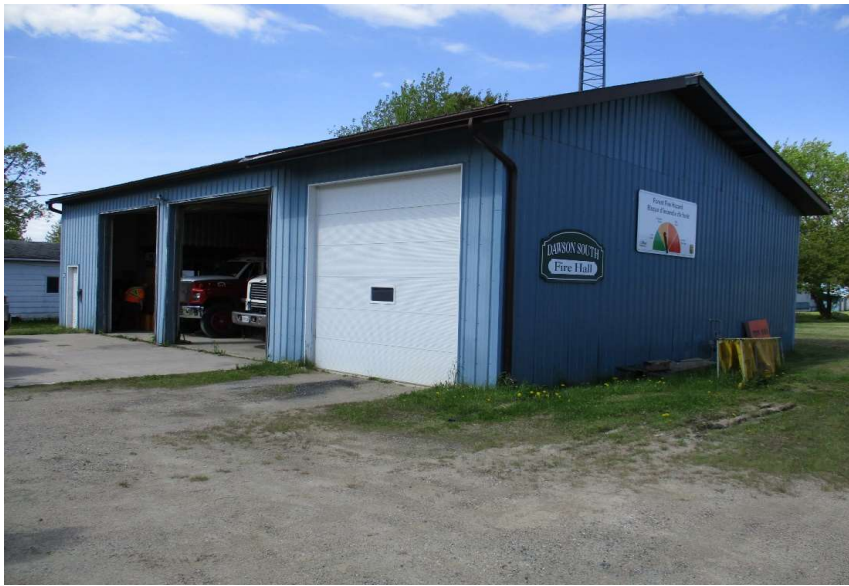
Photo No.: 1

Exterior view of building
Grading required on North side of building

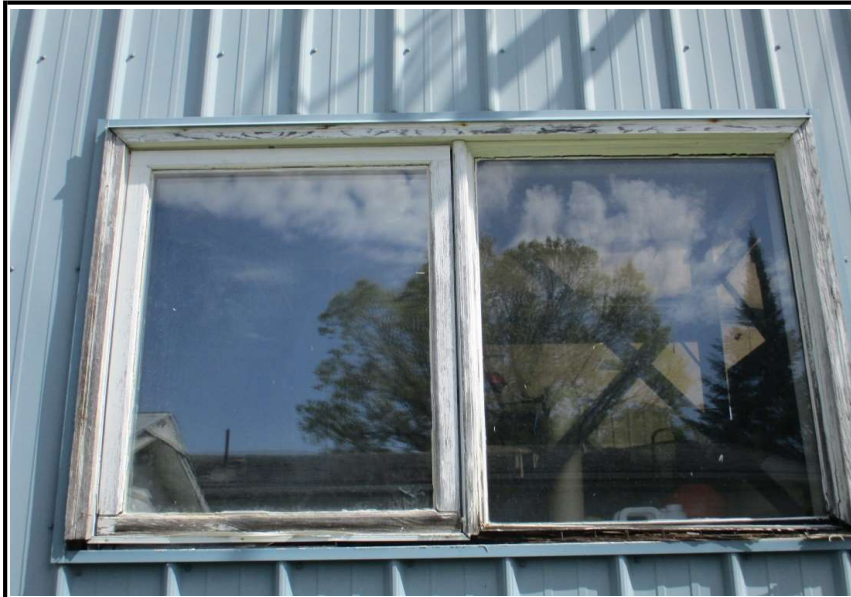
Photo No.: 7

Exterior view of building
Replace window on South side
of the building

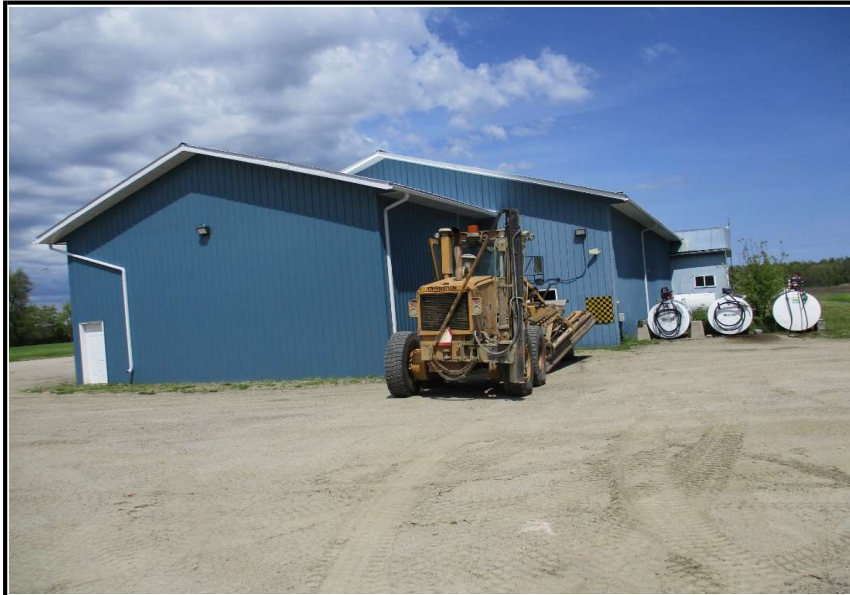
Photo No.: 3

Exterior view of building

Provide splashpads @
downspouts

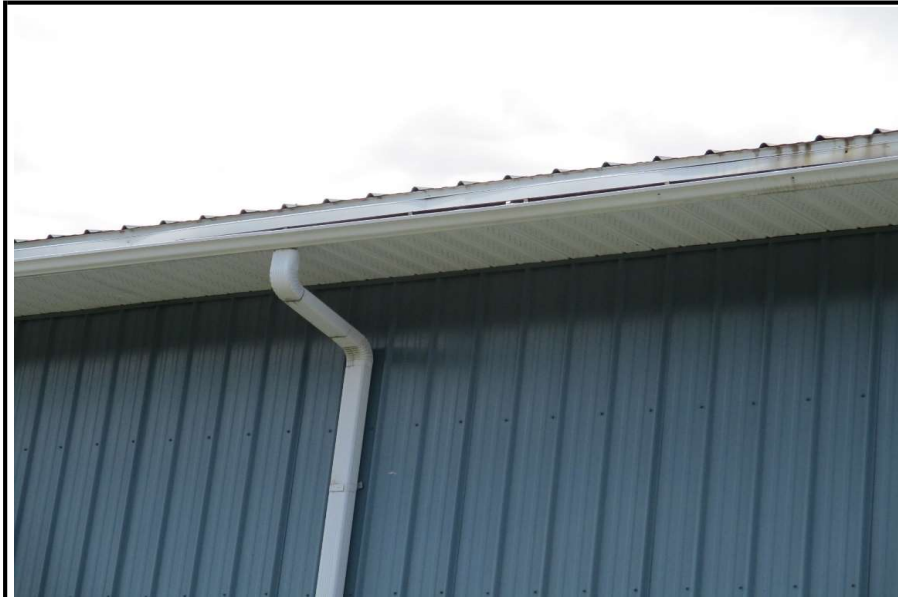
Photo No.: 7

Exterior view of building

Repair damaged eavestrough

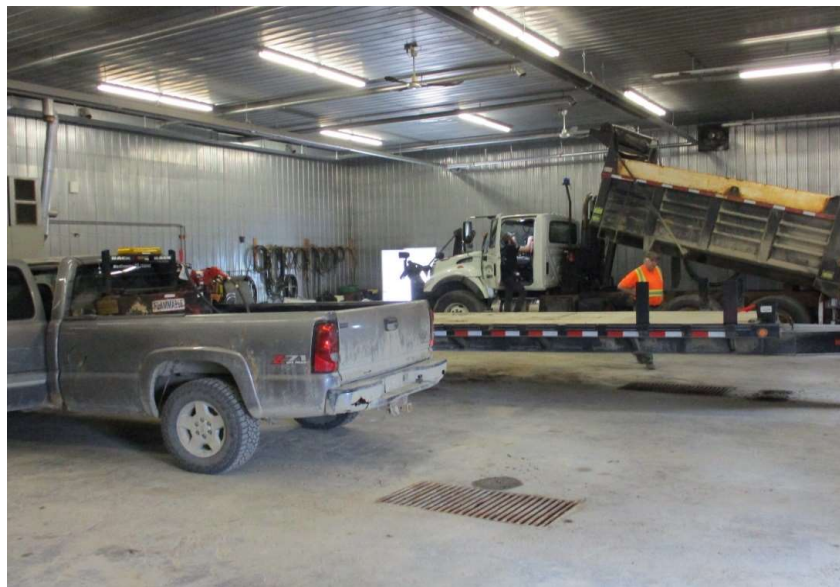
Photo No.: 9

Interior view of building

Upgrade lighting inside building

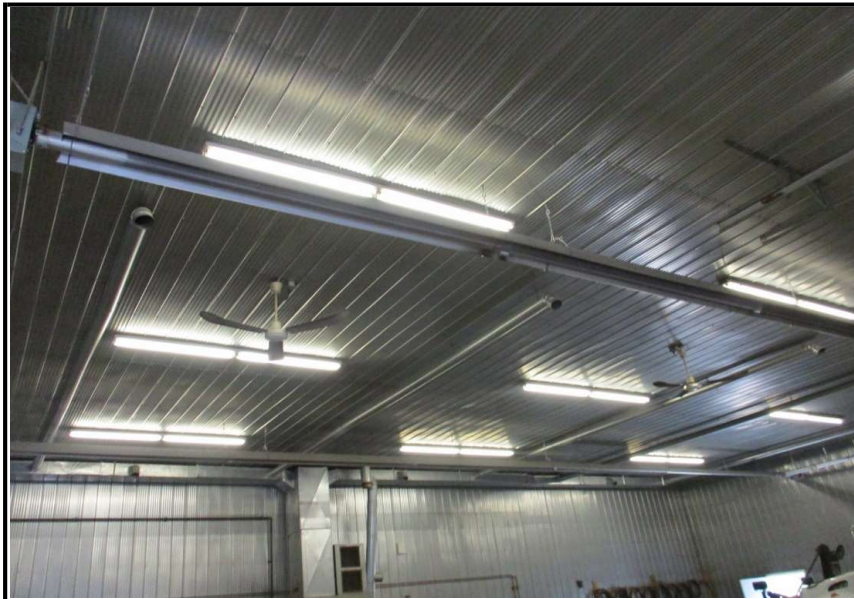
Photo No.: 11

Interior view of building

Upgrade lighting inside building

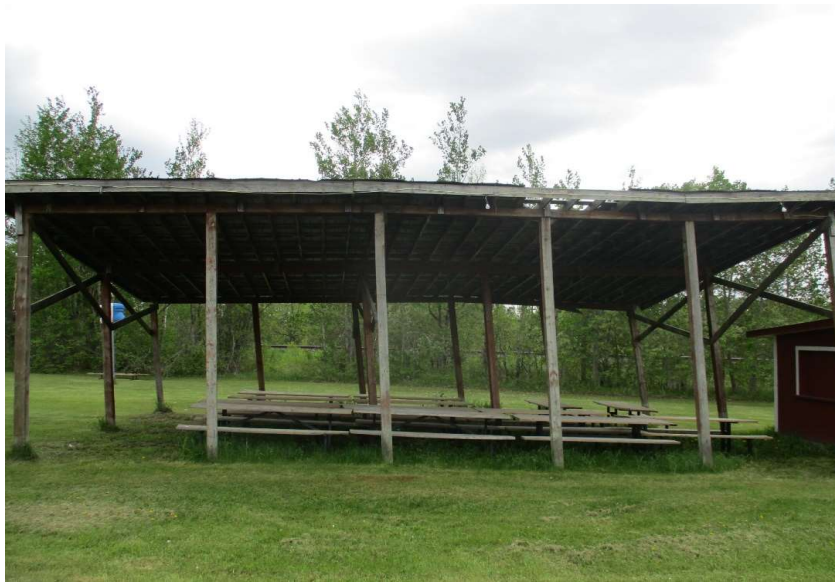
Photo No.: 1

Pavilion is in very poor condition, Structually it is in poor condition, required to hire structural consultant and have structural review. Damaged roof, broken bridging and rotten parts of the building reduces general condition of the building to 1.

Description:
View of pavilion

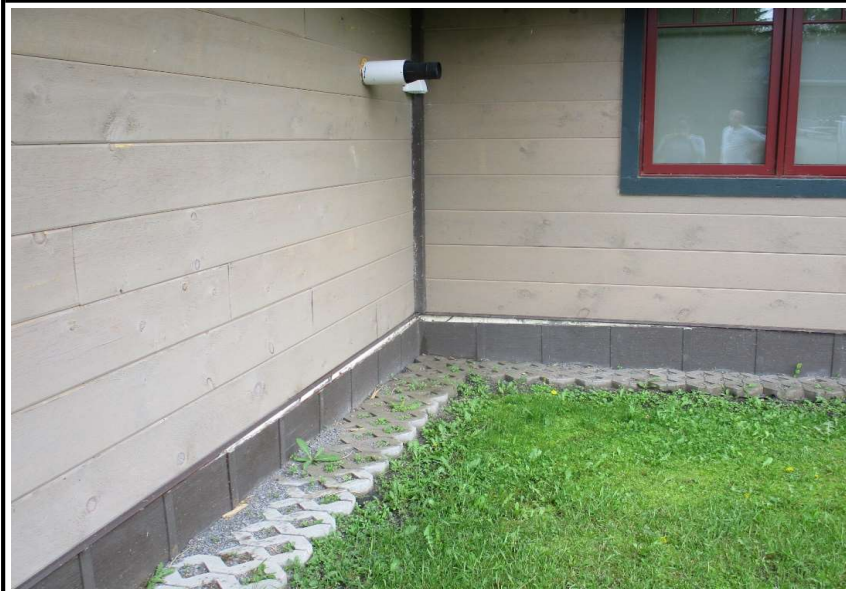
Photo No.: 3

Exterior view of building

Restain siding/ trim as needed

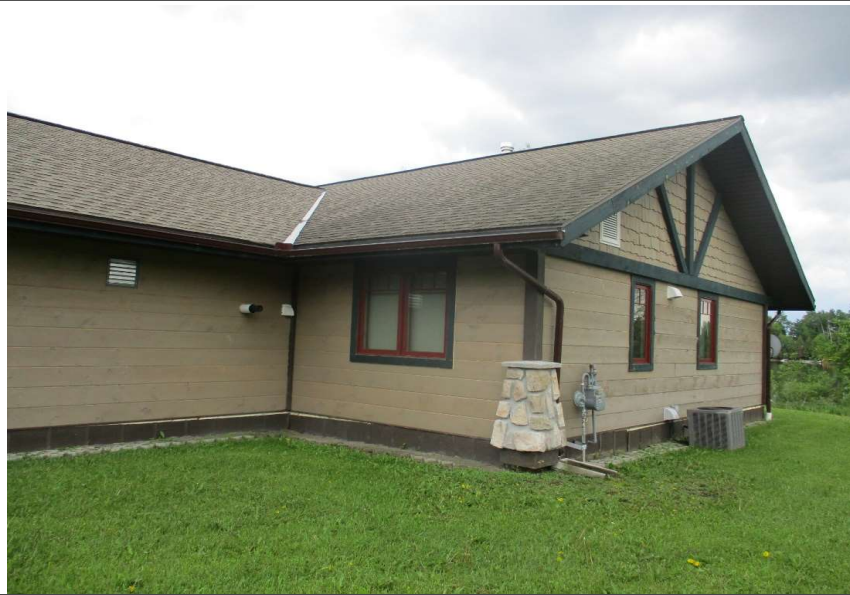
Photo No.: 5

Exterior view of building
Reattach skirting where loose
Upgrade siding in 5 years
Recaulk siding joints

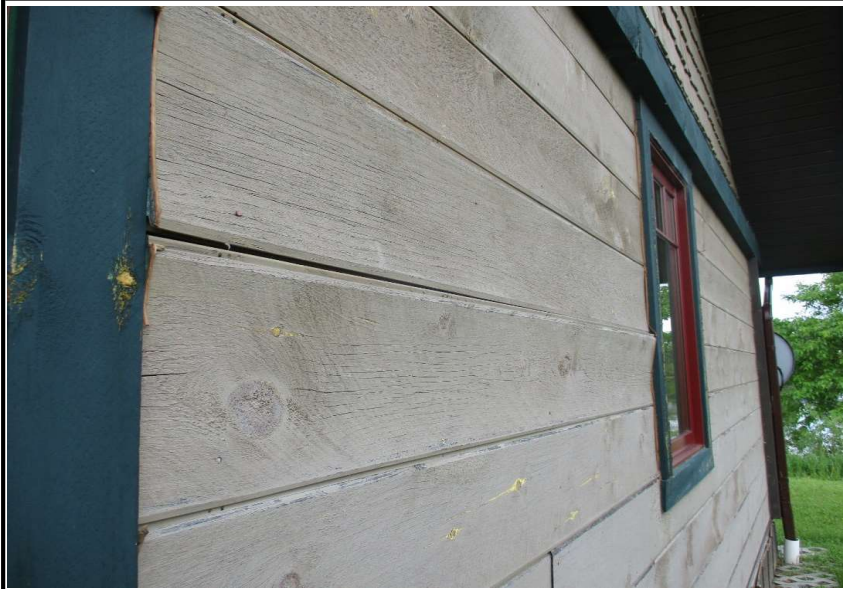
Photo No.: 7

Exterior view of building
Reattach loose siding
Replace warped siding pieces

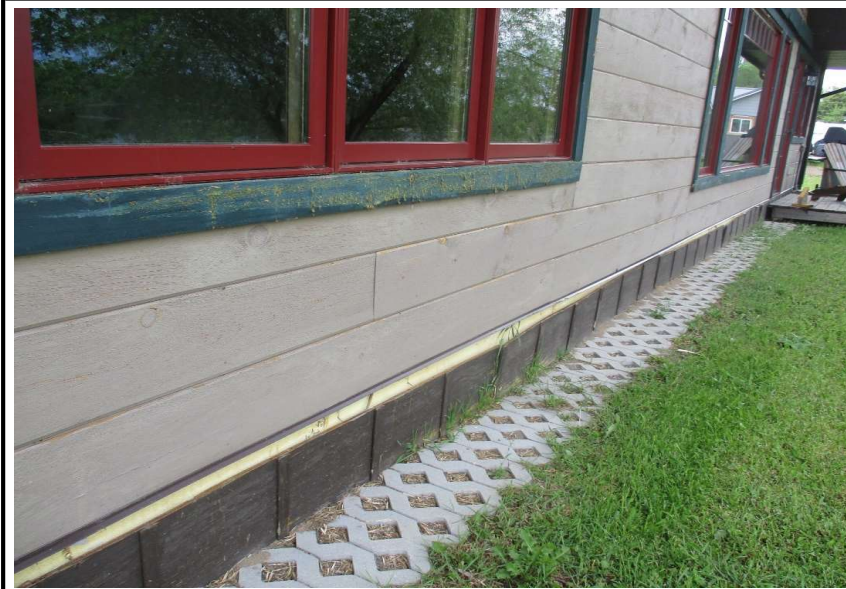
Photo No.: 9

Exterior view of building
Restain siding/ trim as needed

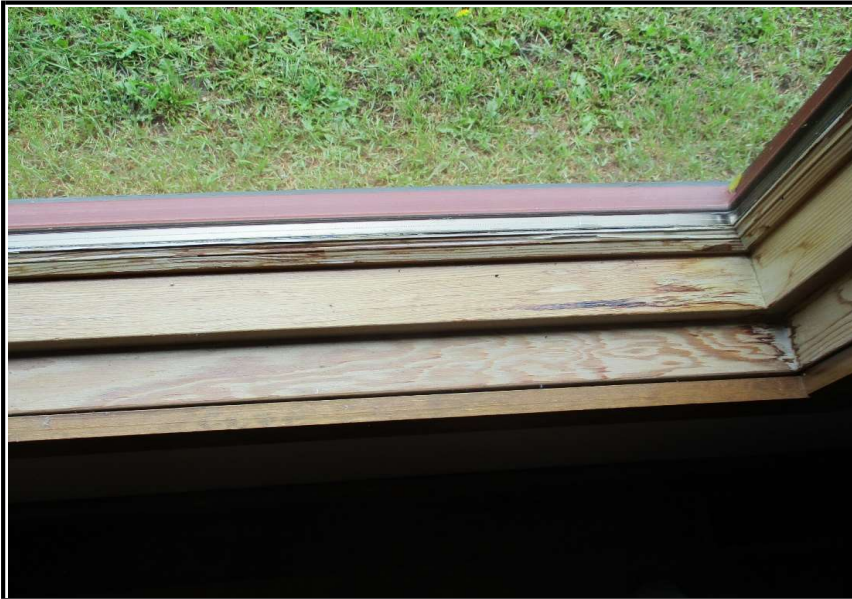
Photo No.: 11

Interior view of building
Restain interior window
frames(faded)

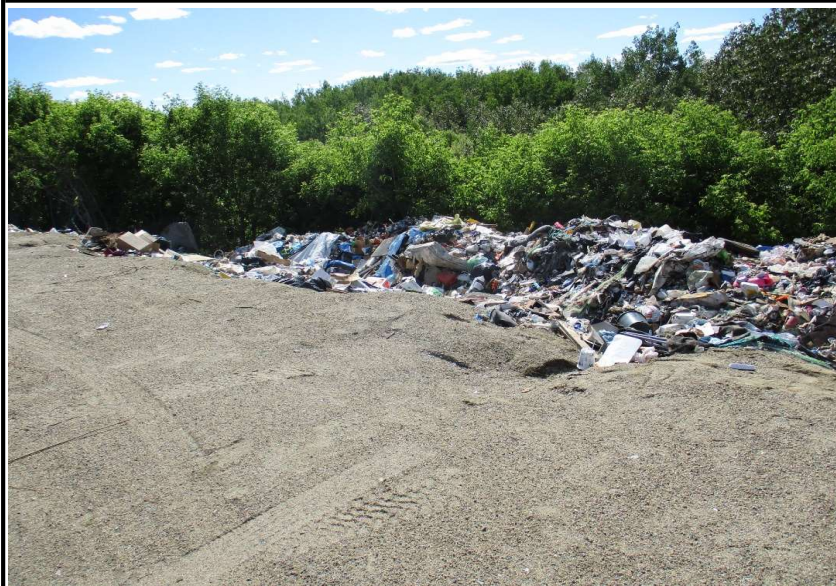
Photo No.: 3

View of house hold waste

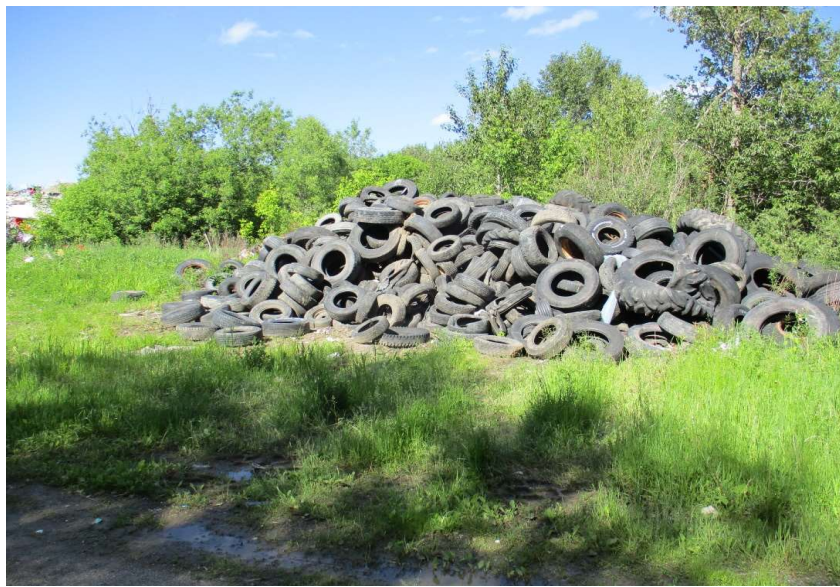
Photo No.: 5

Description:
Tires

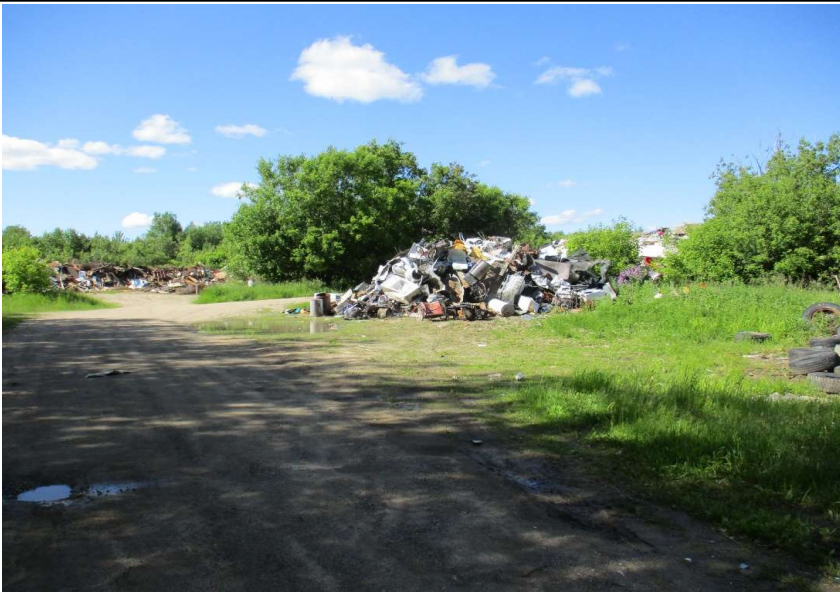
Photo No.: 6

Description:
Metals & Wood waste

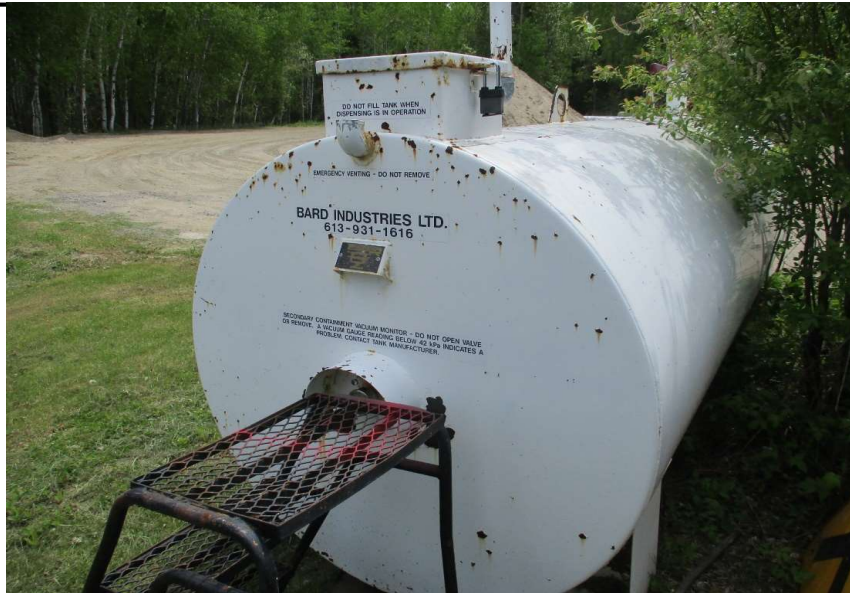
Photo No.: 1

Description:
Diesel tank 2012-4550L
Repaint rusing tank

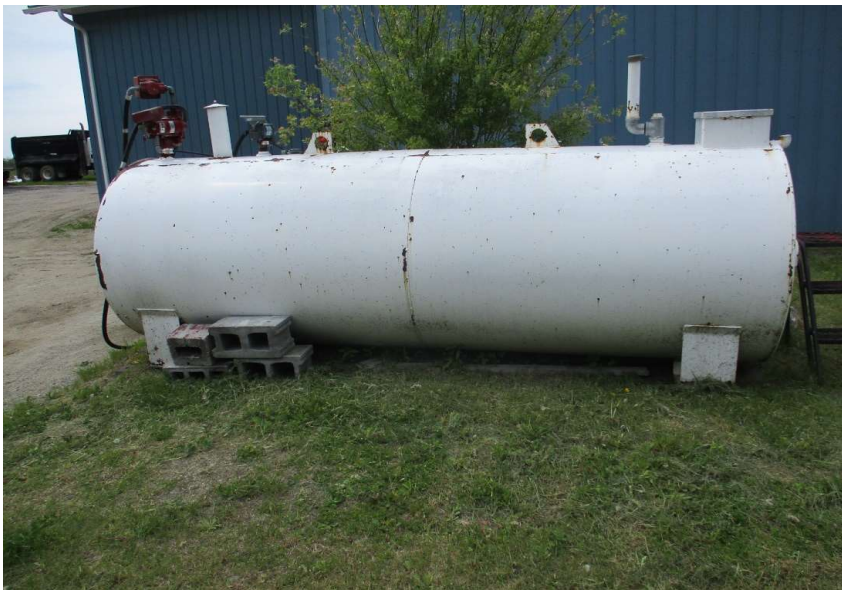
Photo No.: 2

Description:
Diesel tank 2012-4550L
Repaint rusing tank

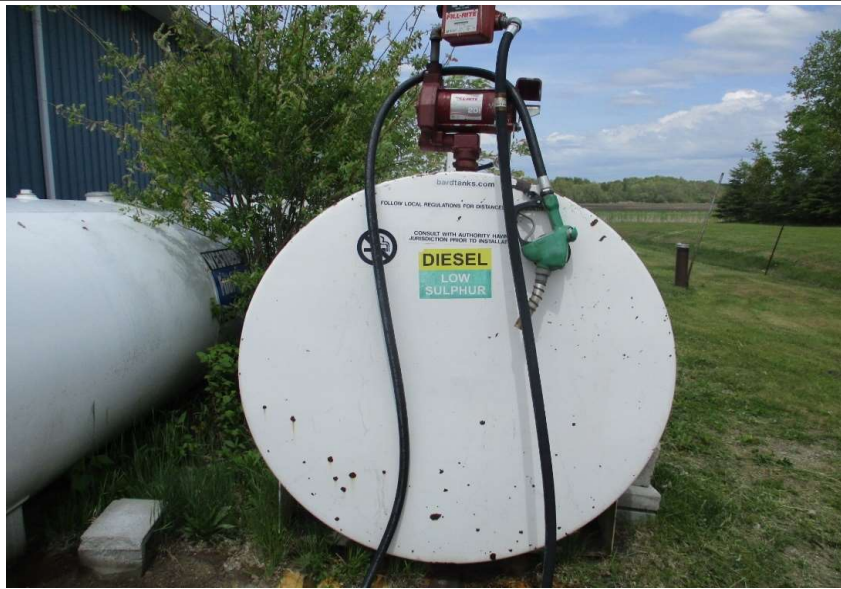
Photo No.: 3

Description:
Cut trees between tanks

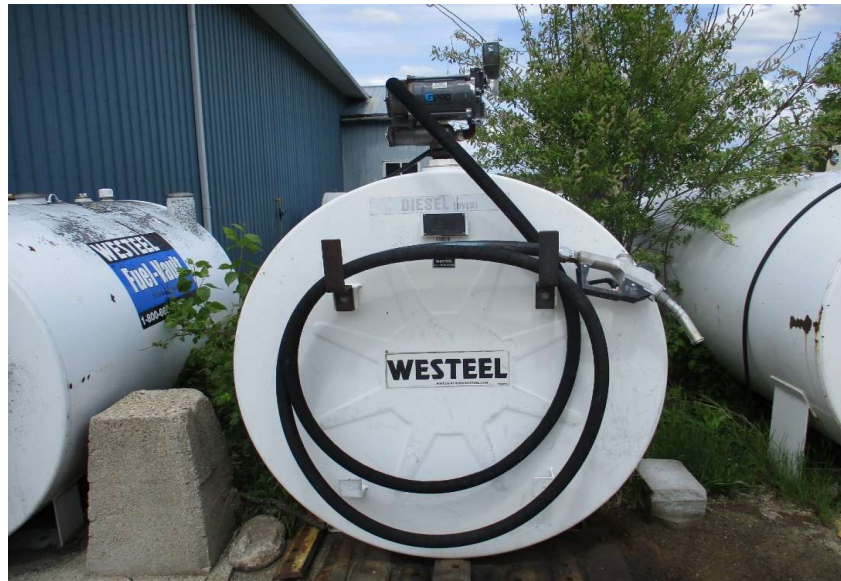
Photo No.: 4

Description:
Diesel tank 2010-4546L
Dyed diesel tank

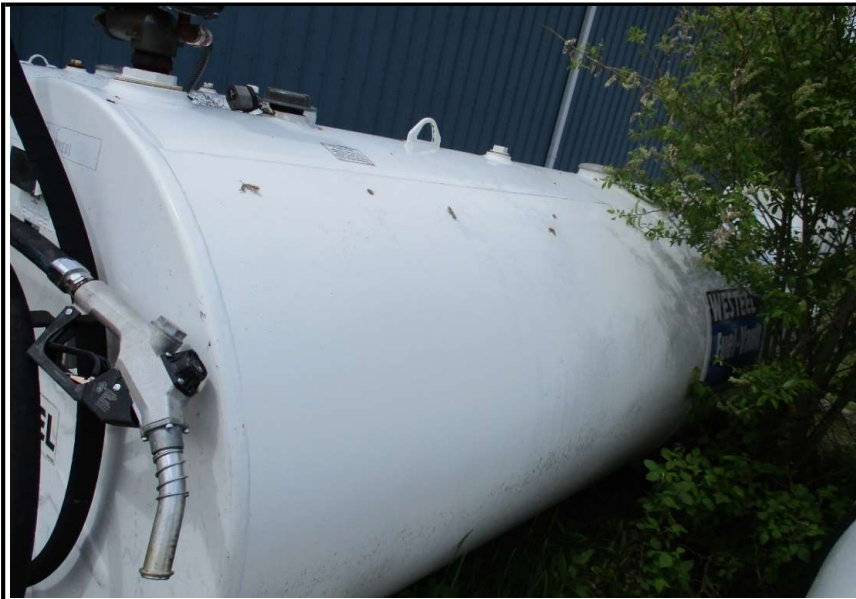
Photo No.: 5

Description:
Diesel tank 2010-4546L
Dyed diesel tank

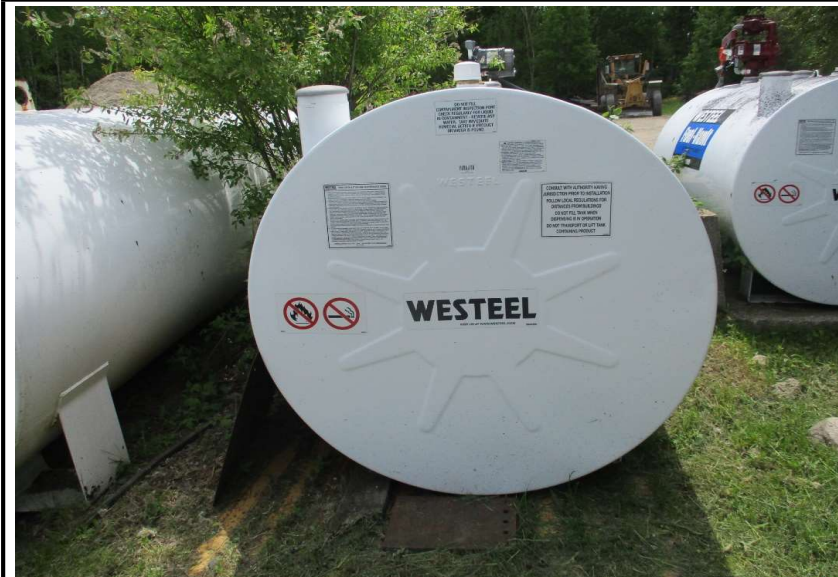
Photo No.: 6

Description:
Diesel tank 2010-4546L
Dyed diesel tank

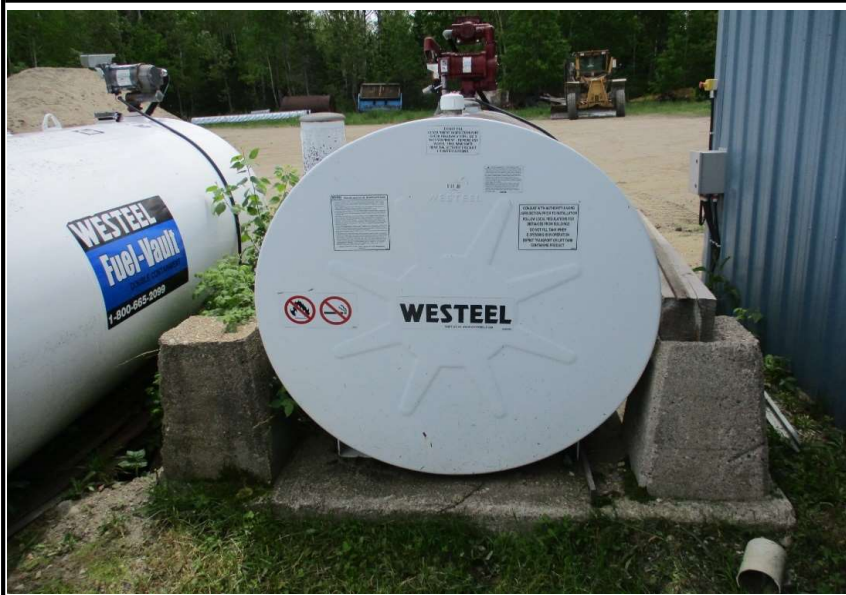
Photo No.: 7

Description:
Gasoline tank 2010-4546L

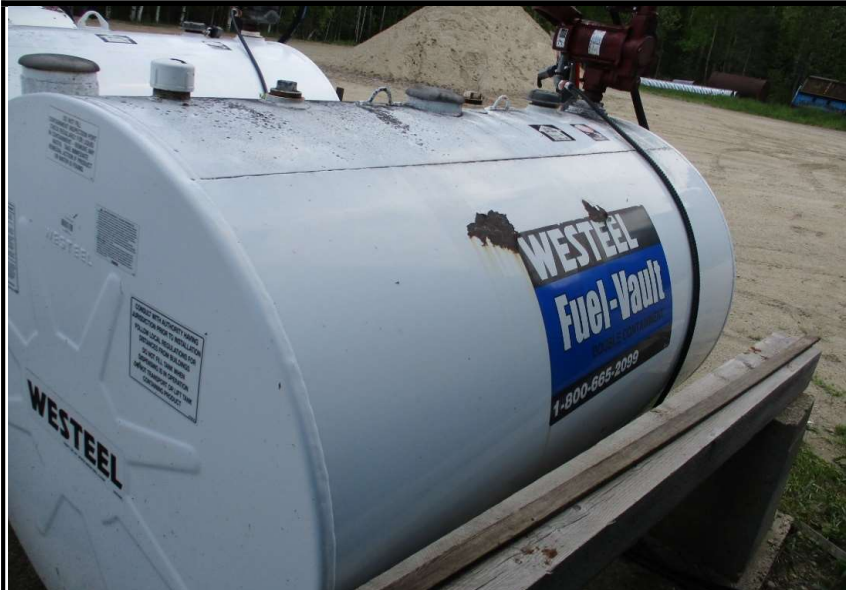
Photo No.: 8

Description:
Gasoline tank 2010-4546L

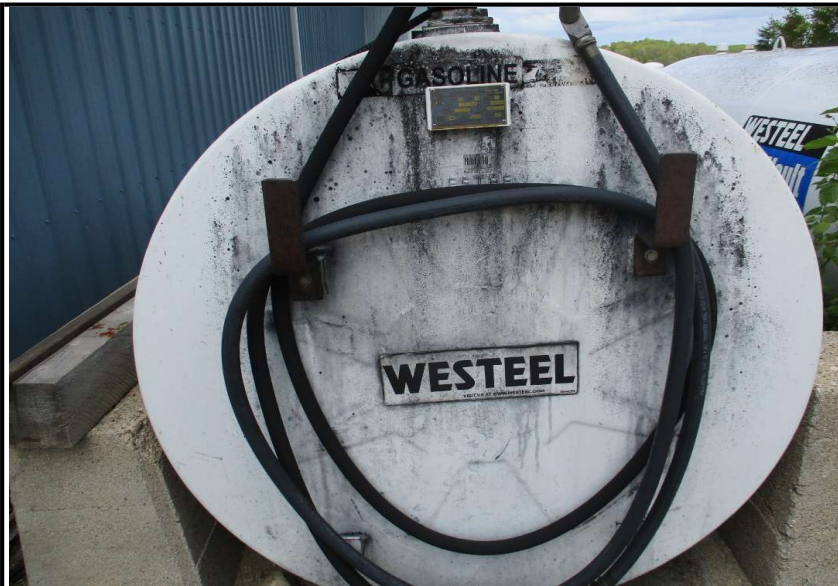
Photo No.: 9

Description:
Gasoline tank 2010-4546L

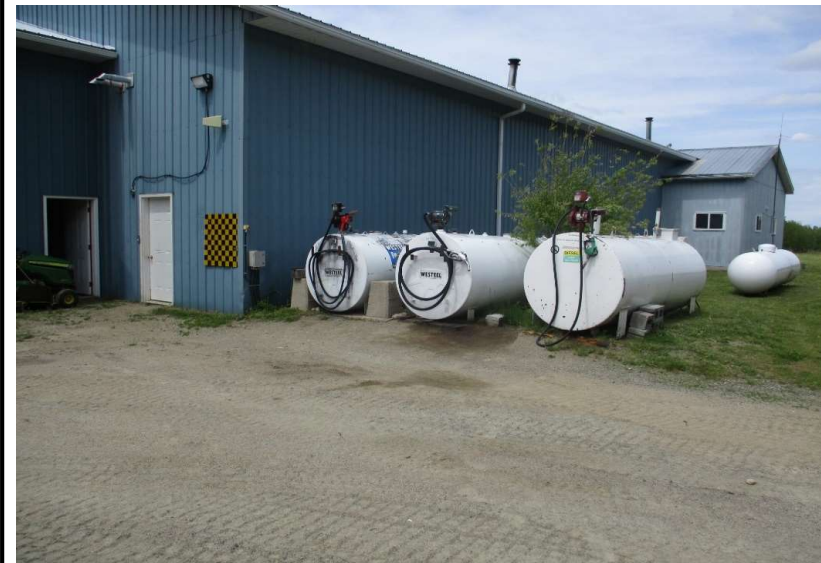
Photo No.: 10

Description:
View showing all tanks

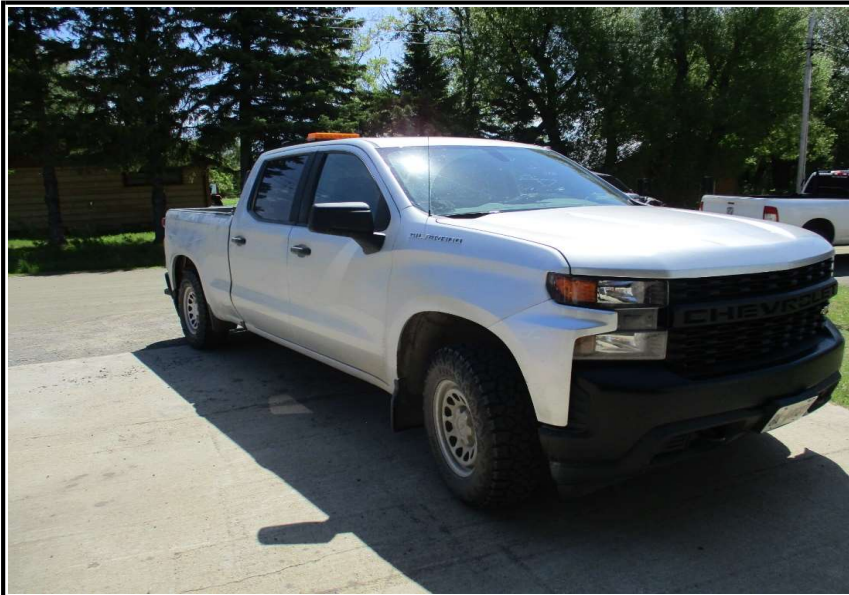
Photo No.: 1

Description:
Front of the truck

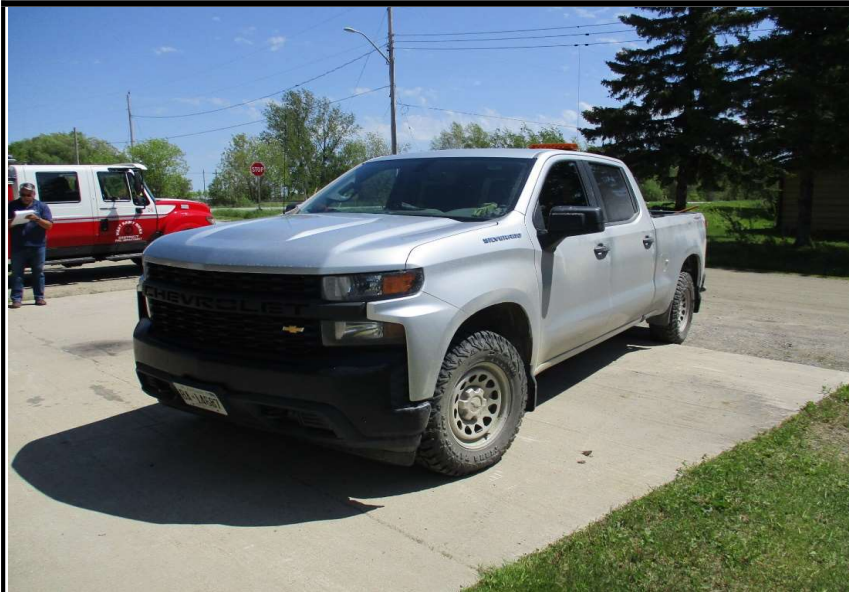
Photo No.: 2

Description:
Front of the truck

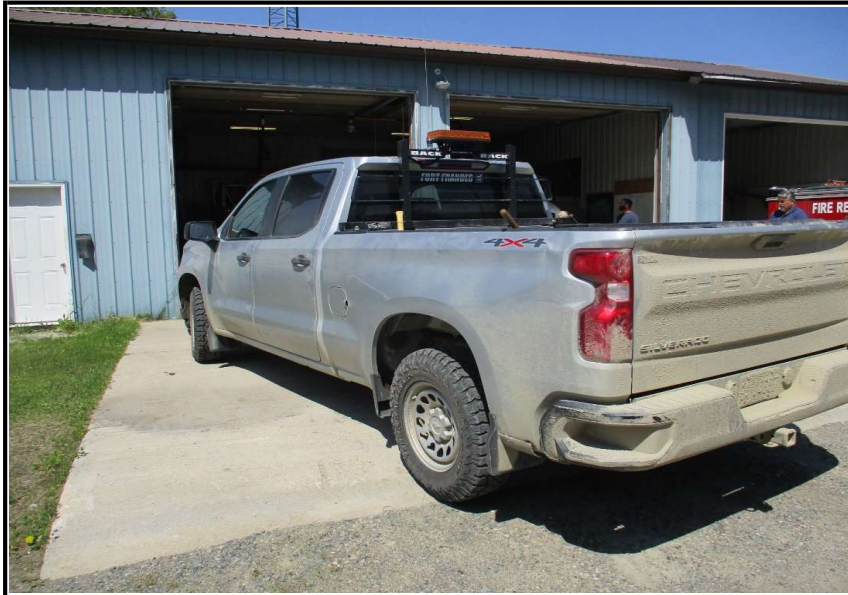
Photo No.: 3

Left side of the truck

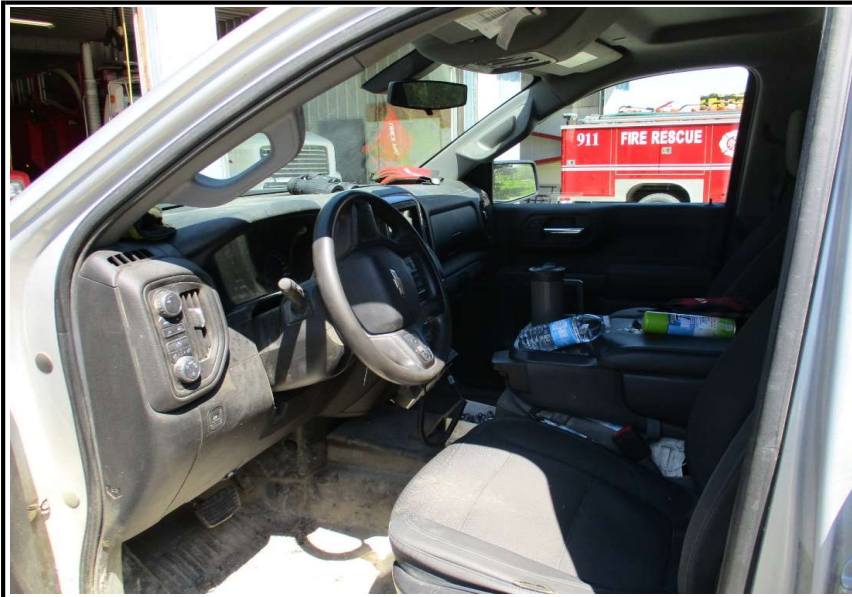
Photo No.: 5

Description:
Interior of the truck

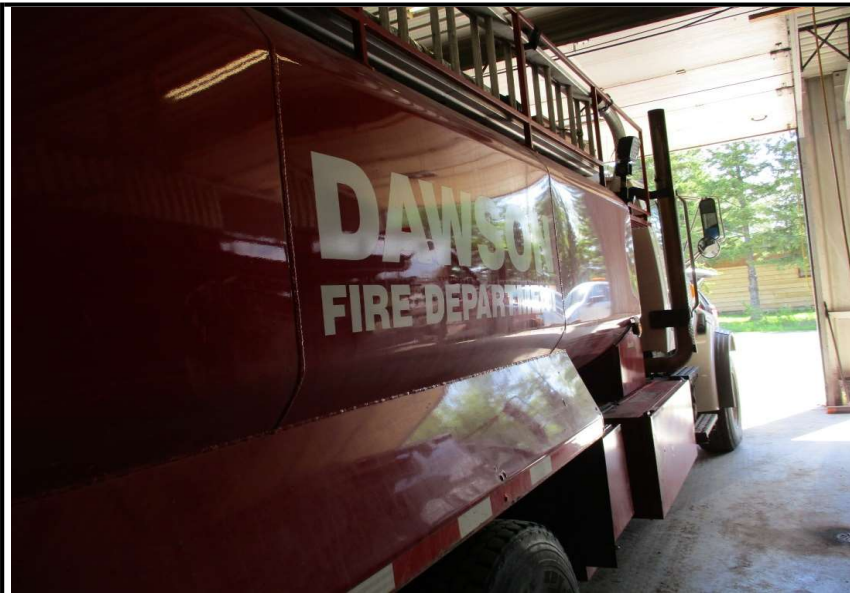
Photo No.: 3

Description:
Right side of the truck

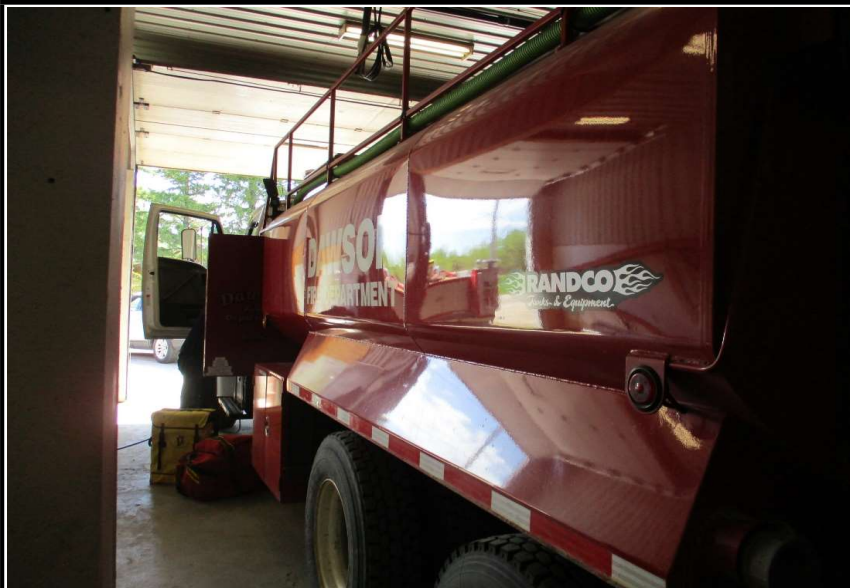
Photo No.: 4

Description:
Left side of the truck

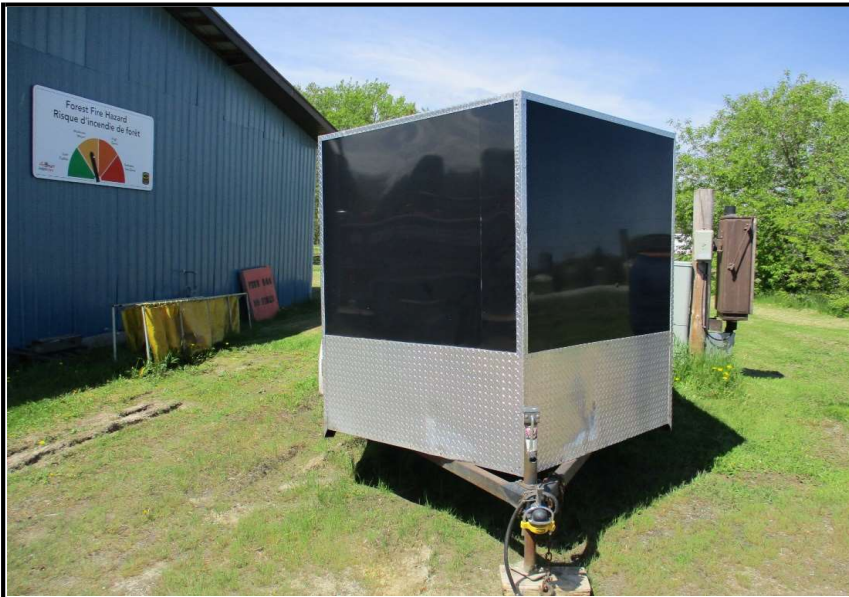
Photo No.: 1

Description:
Front of trailer

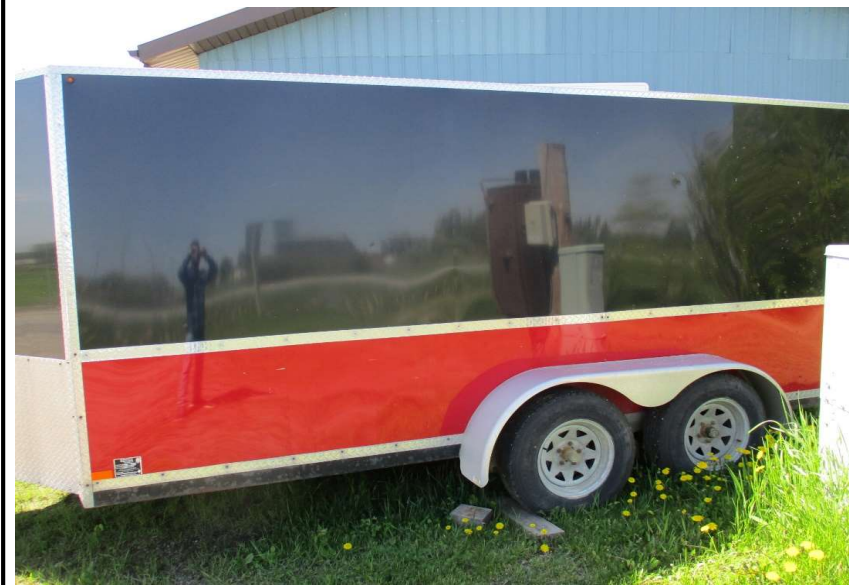
Photo No.: 2

Description:
Side view of trailer

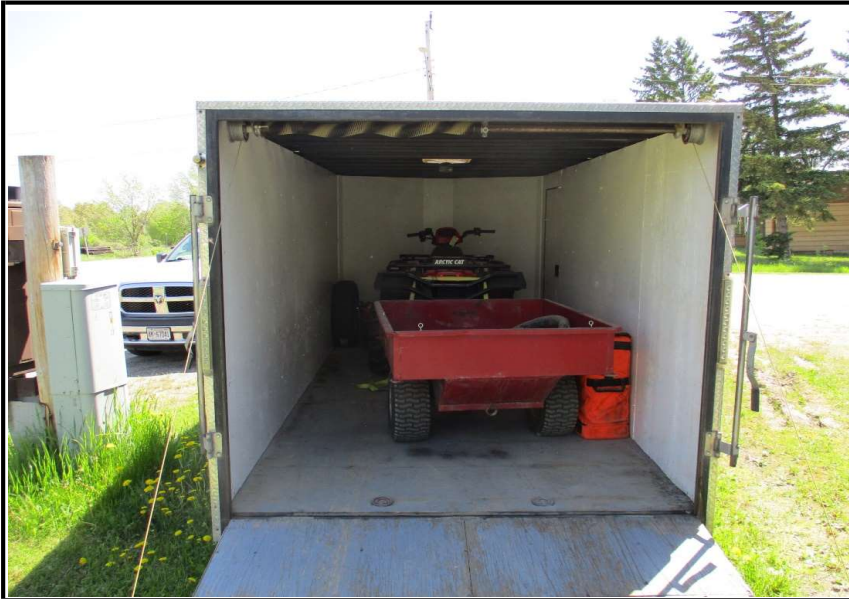
Photo No.: 3

Description:
Rear view of trailer

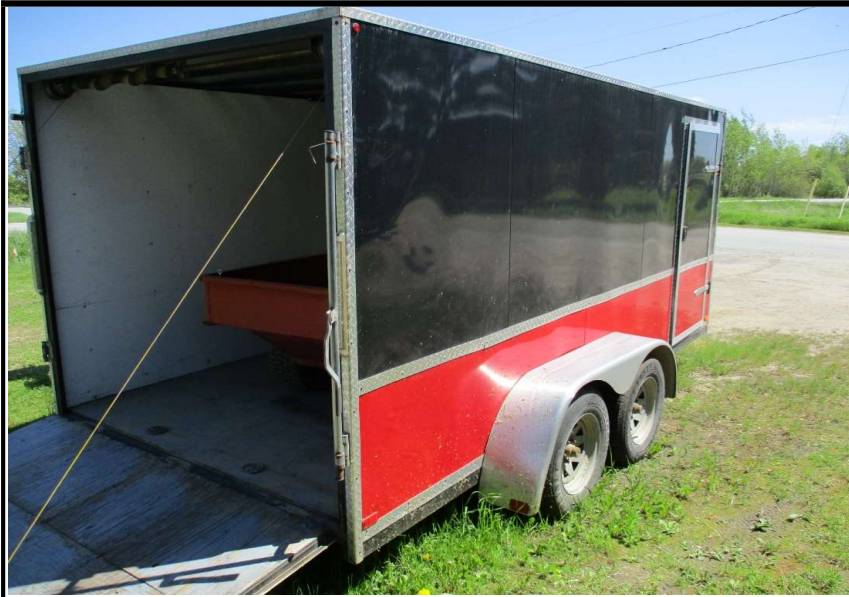
Photo No.: 4

Description:
Side view of trailer

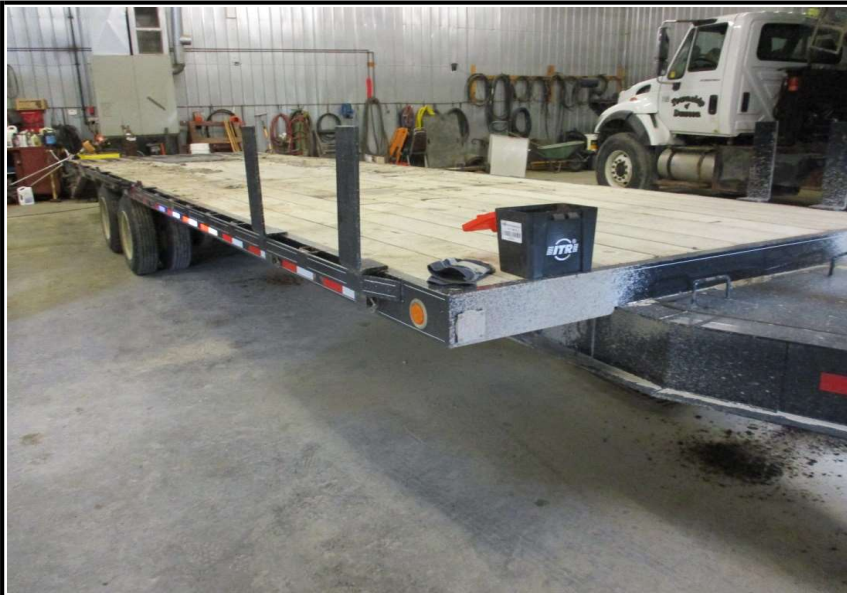
Photo No.: 1

Description:
View of trailer

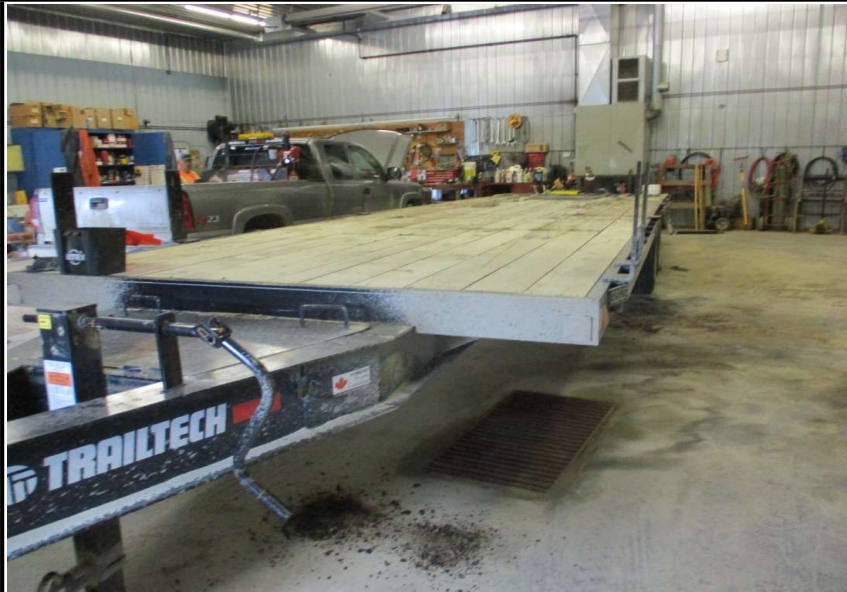
Photo No.: 2

Description:
View of trailer
