DAWSON
TOWNSHIP

2024 ASSET MANAGEMENT PLAN

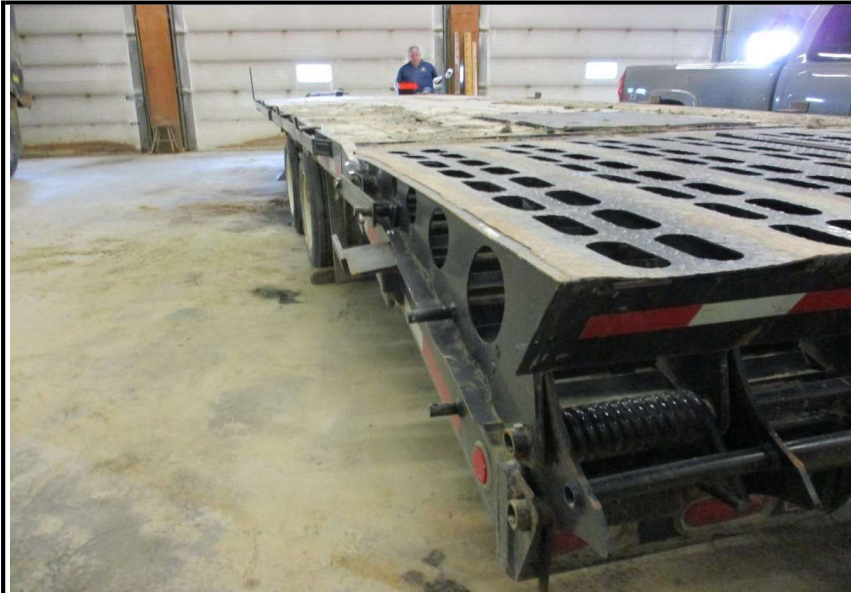
Photo No.: 3

Description:
View of trailer

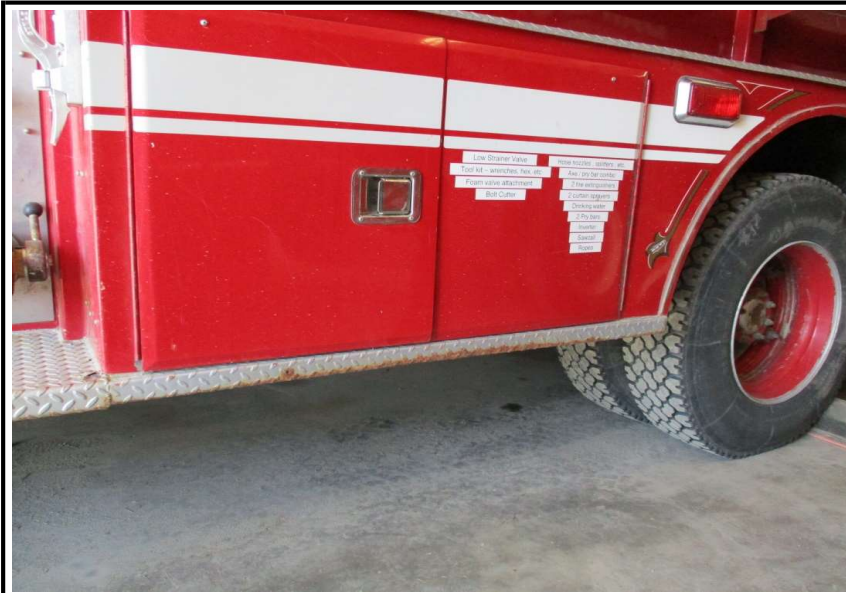
Photo No.: 7

Description:
View of fire truck

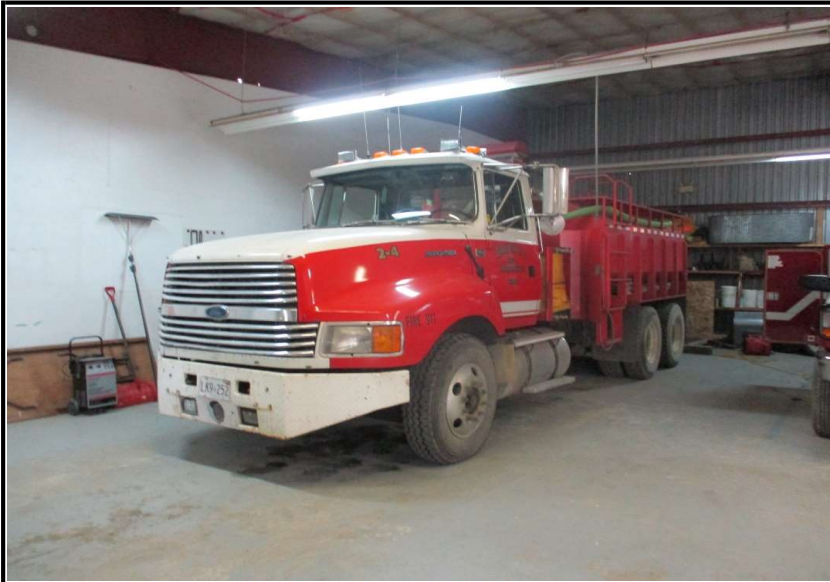
Photo No.: 1

Description:
View of fire truck

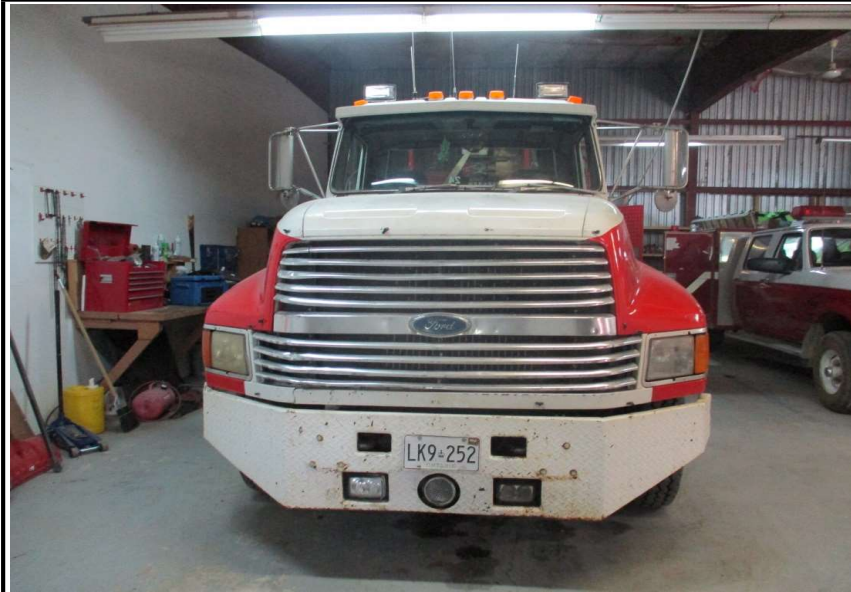
Photo No.: 2

Description:
View of fire truck
Repaint front bumper- minor
dust

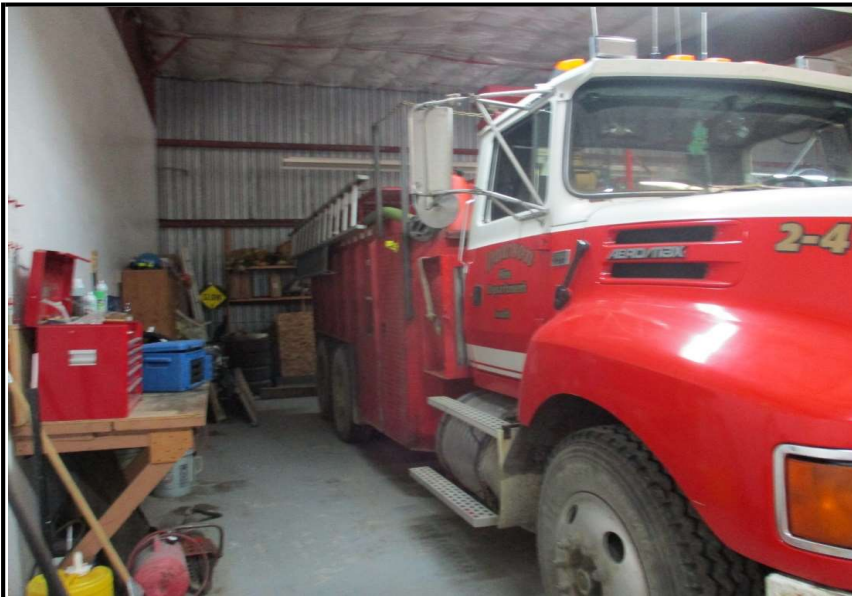
Photo No.: 3

Description:
View of fire truck

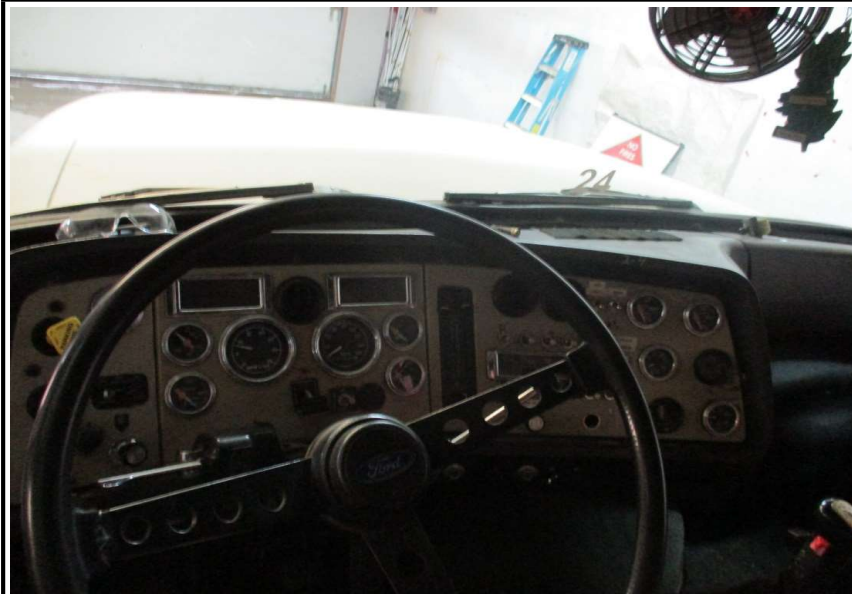
Photo No.: 4

Description:
View of fire truck

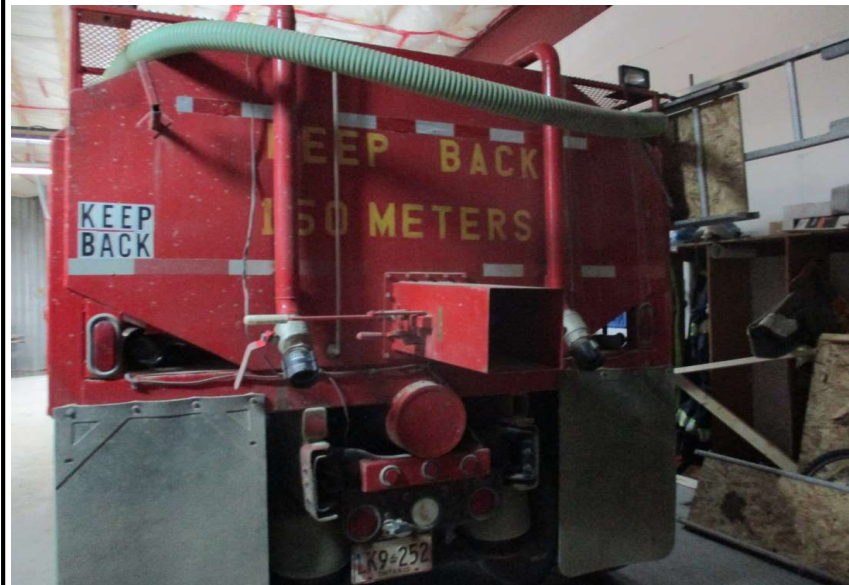
Photo No.: 6

Description:
View of fire truck

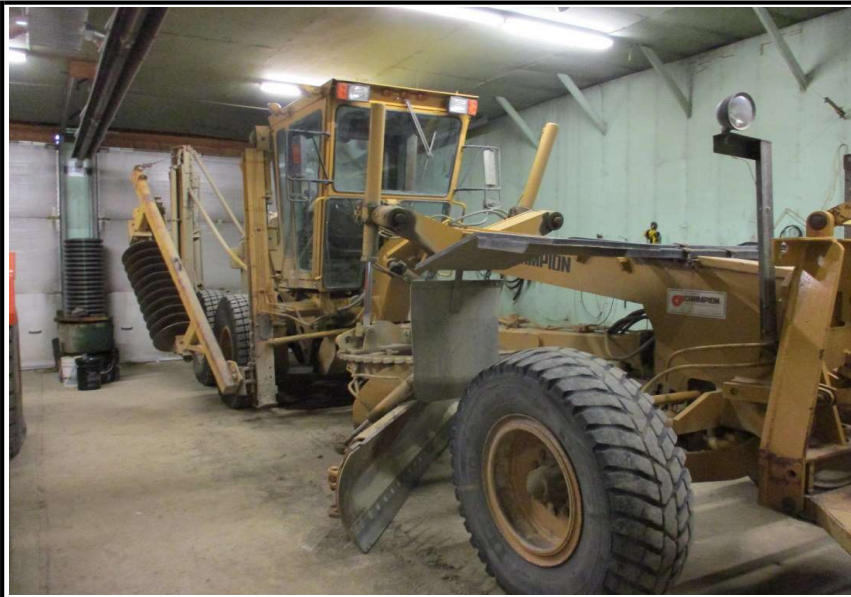
Photo No.: 1

Description:
Front view of grader

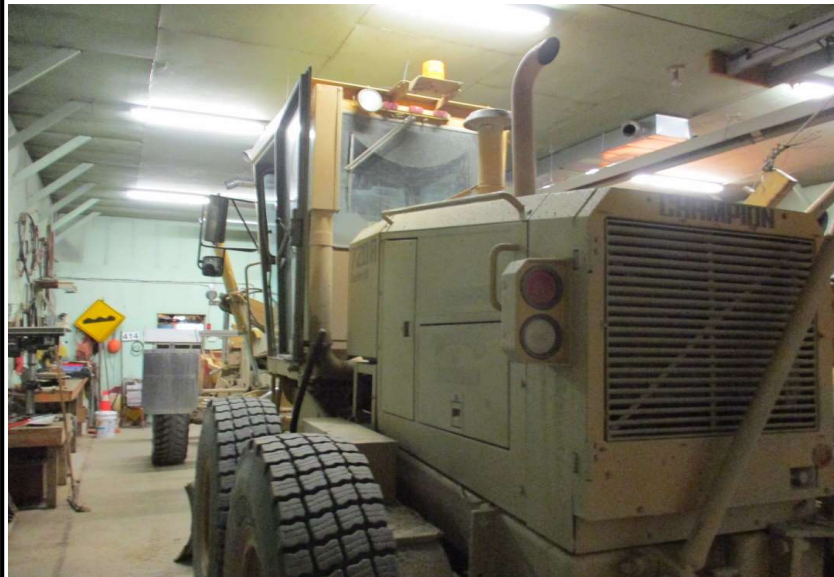
Photo No.: 2

Description:
Rear view of grader

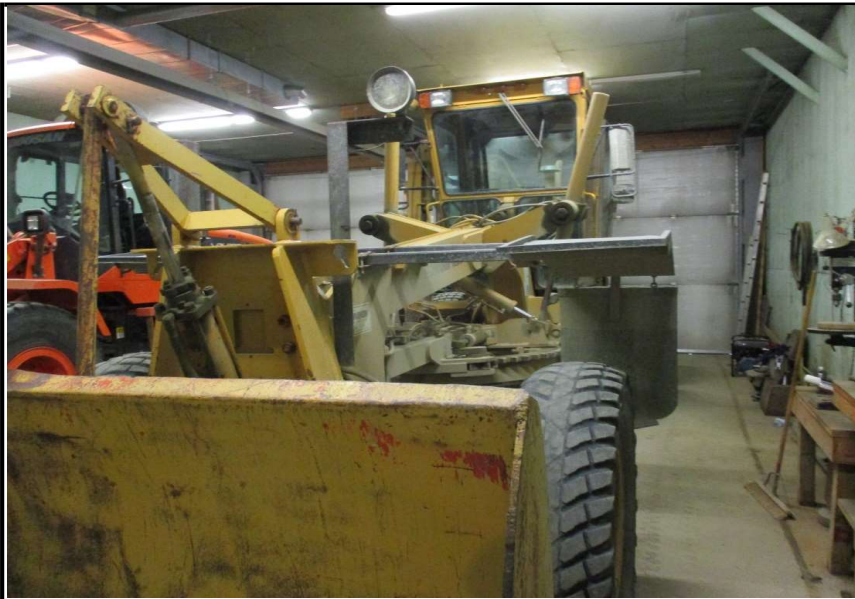
Front of grader

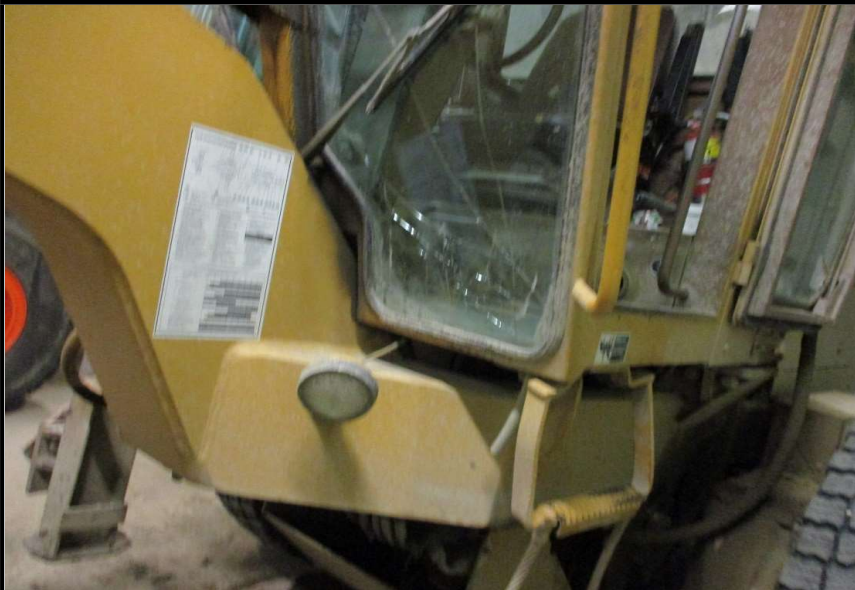
View of broken glass

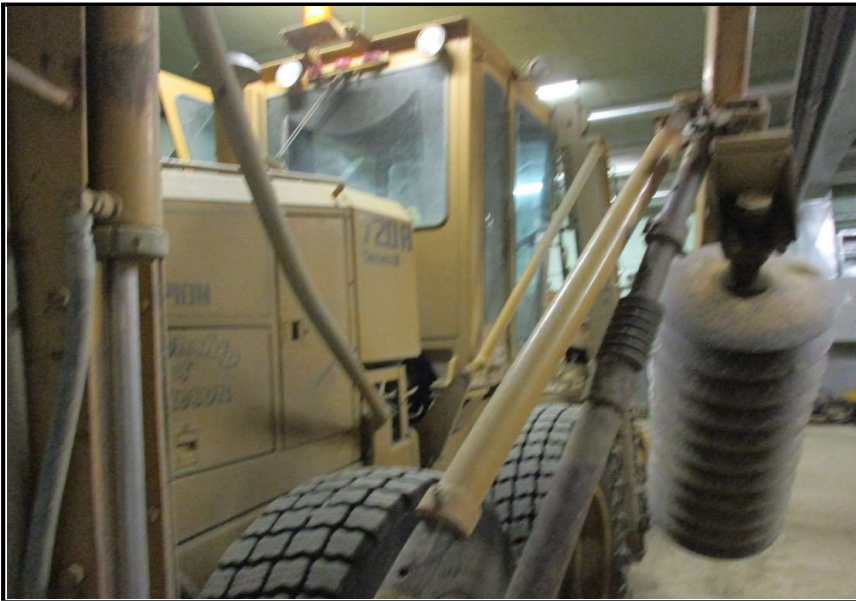
Photo No.: 5

Description:
View of grader

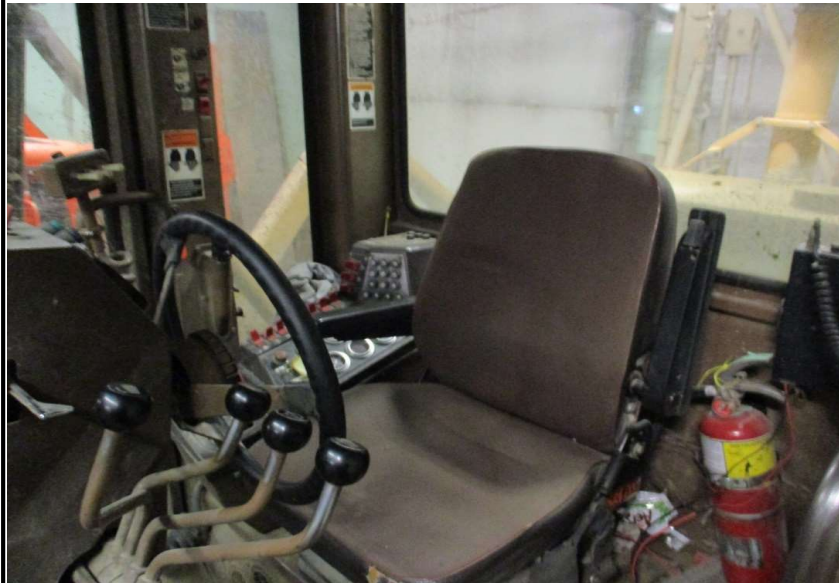
Photo No.: 6

Description:
Interior view of grader
